Marco Island South Beach Project Update

- Project Description
- Scope of Work
- Historic Shoreline & Volume Changes
- Numerical Modeling Study

*CEC File No. 10.094
February 17, 2011*

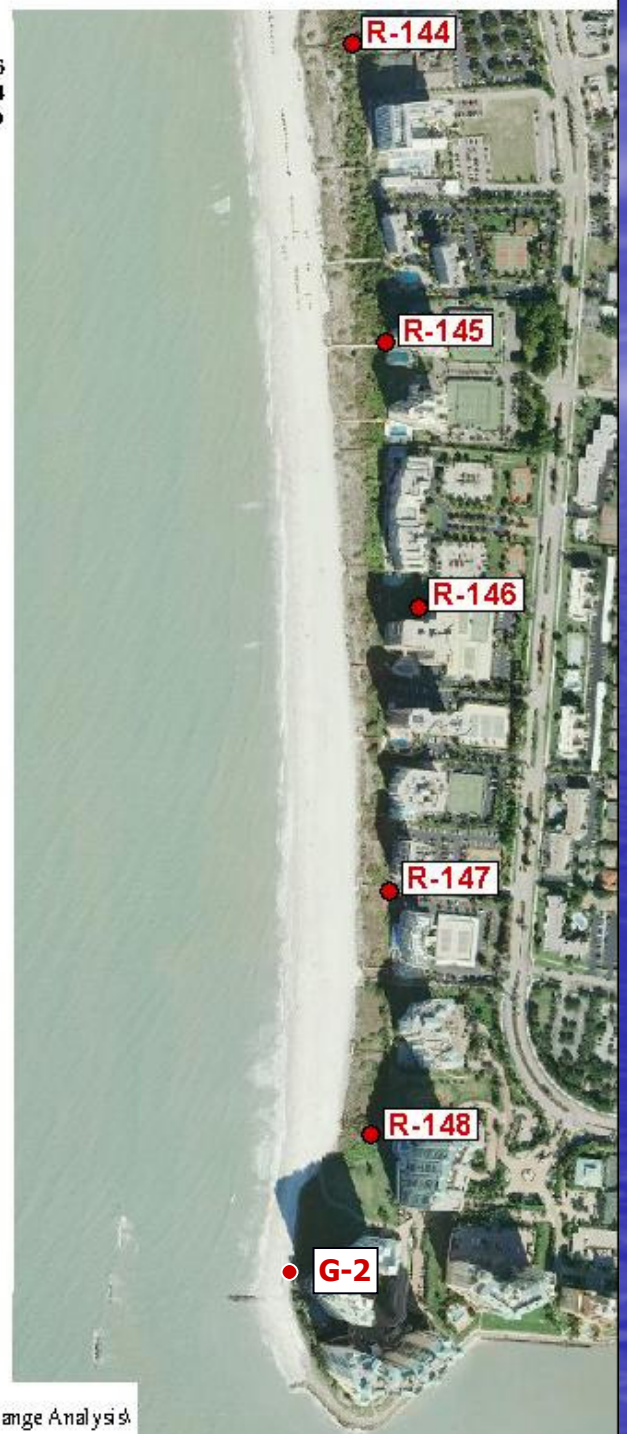
HISTORIC SHORELINE CHANGES

Monument	1991-1996 (ft/yr)	1997-2004 (ft/yr)	2007-2009 (ft/yr)
R144	-6.1	0.0	6.7
R145	-4.2	-0.3	4.5
R146	-4.8	-9.0	2.9
R147	-20.6	-9.5	-18.5
R148	-36.0	11.0	-25.8

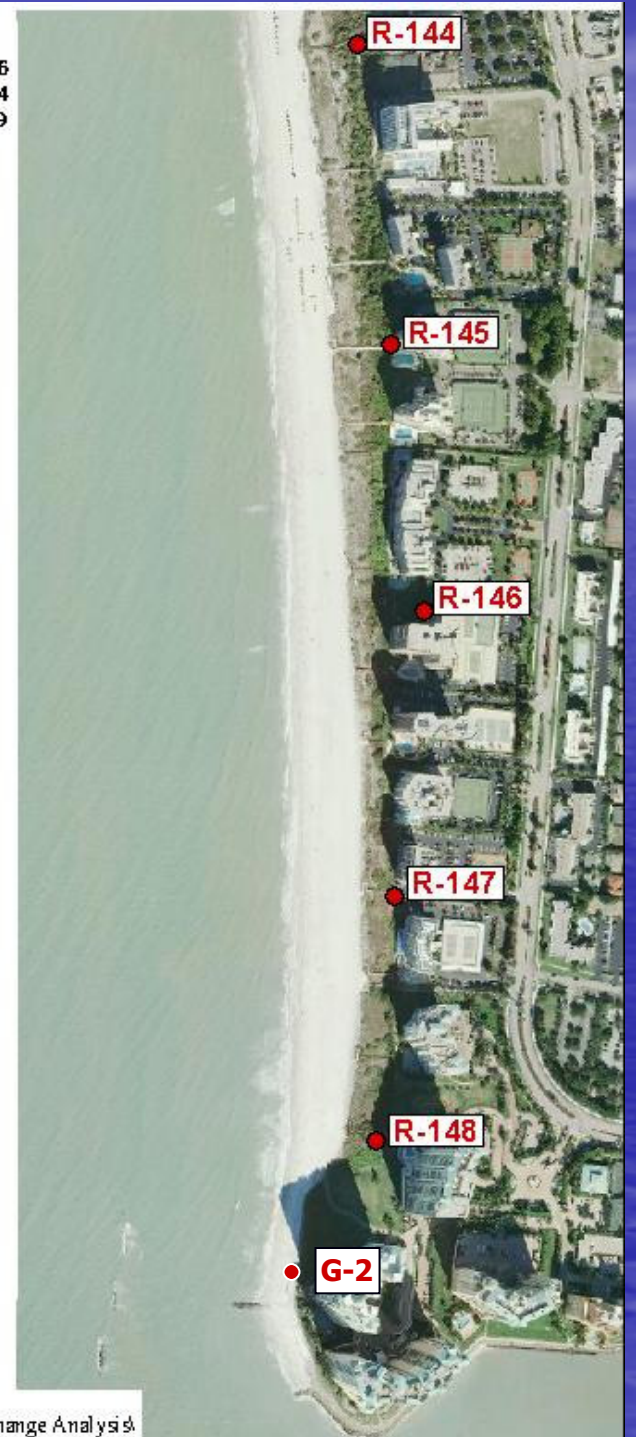
HISTORIC VOLUME CHANGES

Monument	1991-1996 (cy/yr)	1997-2004 (cy/yr)	2007-2009 (cy/yr)
R144	-3,935	3,995	1,891
R145	-3,593	1,831	4,814
R146	-3,097	-3,696	3,382
R147	-11,522	-2,304	-4,425
R148	-10,391	-814	-4,775

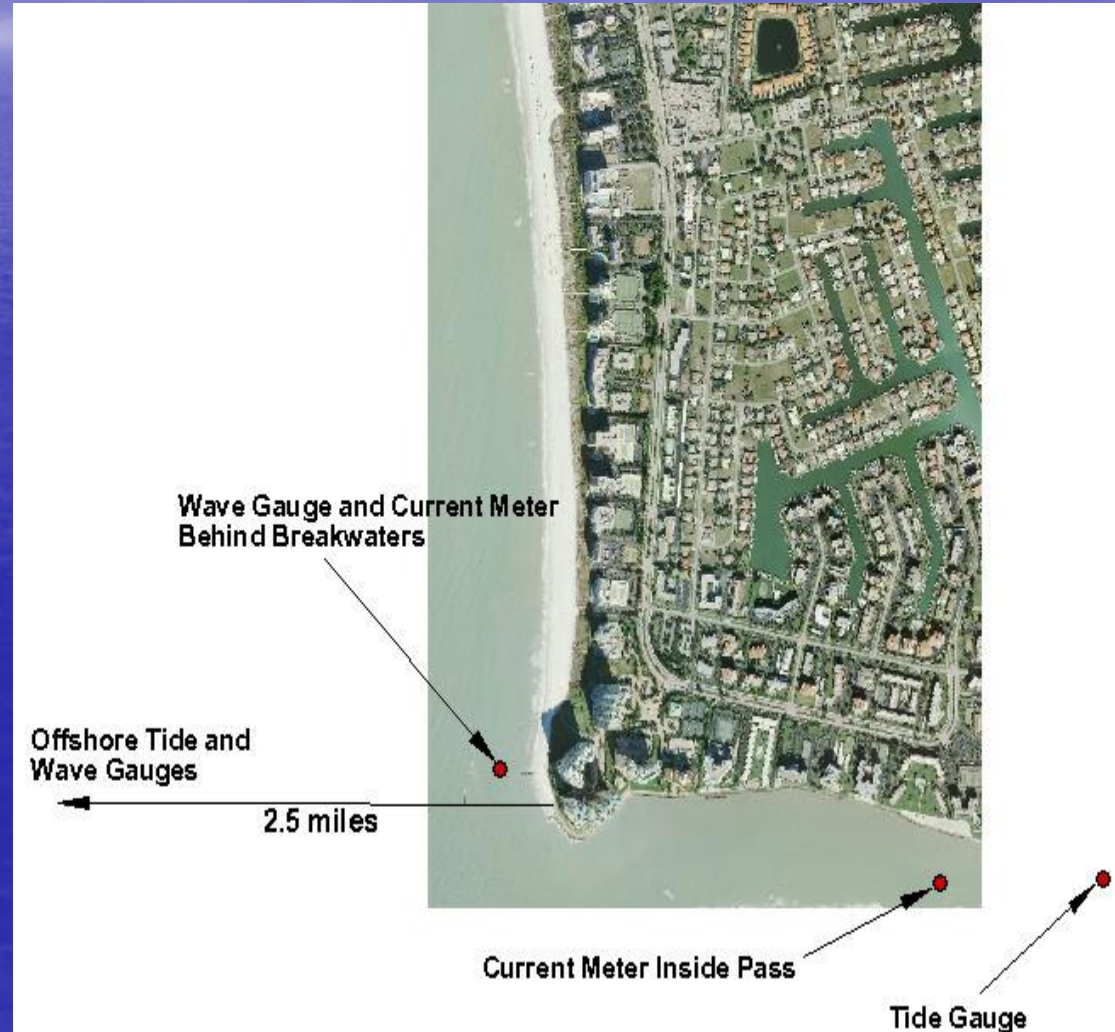
- Calibration Data
 - 1999-2001 Measured Wave Data and Surveys
- Validation Data
 - Deployed Wave & Tide Gauges & Current Meters; Measuring Surveys
