# SUMMARY OF NITROGEN LEVELS IN AND AROUND MARCO ISLAND WATERS

FEBRUARY 2019

TURRELL, HALL & ASSOCIATES, INC  
3584 EXCHANGE AVENUE, STE B  
NAPLES, FL 34104  
(239) 643-0166

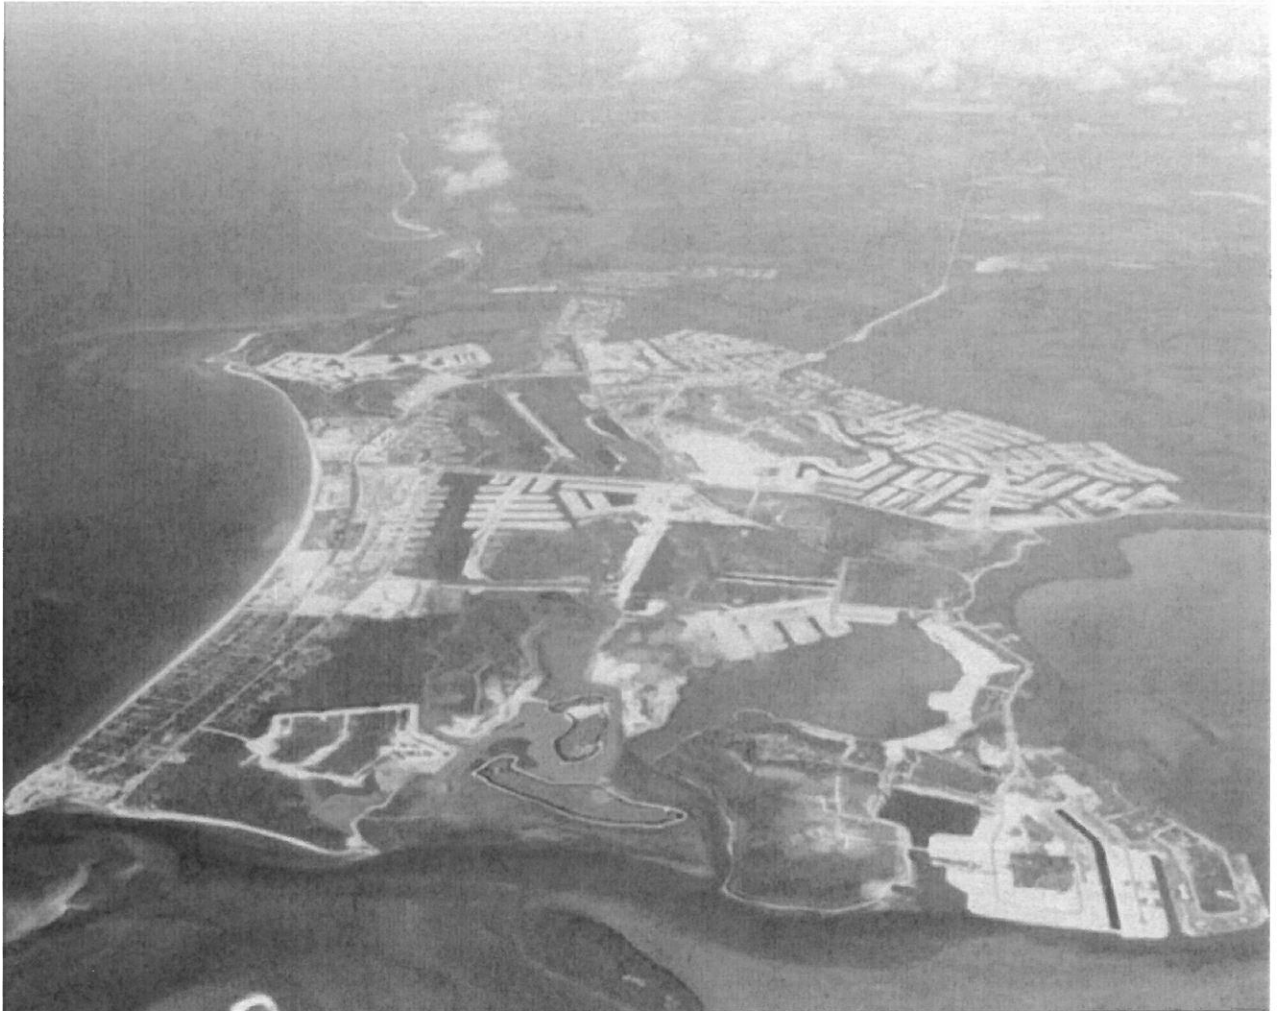
Figure 2: Dredge and Fill Operations under way on Marco Island

Major development on Marco Island was started by the Mackle Brothers of the Deltona Corporation in the early 1960's. Development of the Island was a massive dredge and fill project involving clearing, excavating, and filling hundreds of acres of mangrove wetlands to make way for the waterfront lots, commercial areas, schools, and parks that we see today. The work involved hydraulic dredges and draglines along with seawall construction to create the miles and miles of canals and waterways throughout the Island.

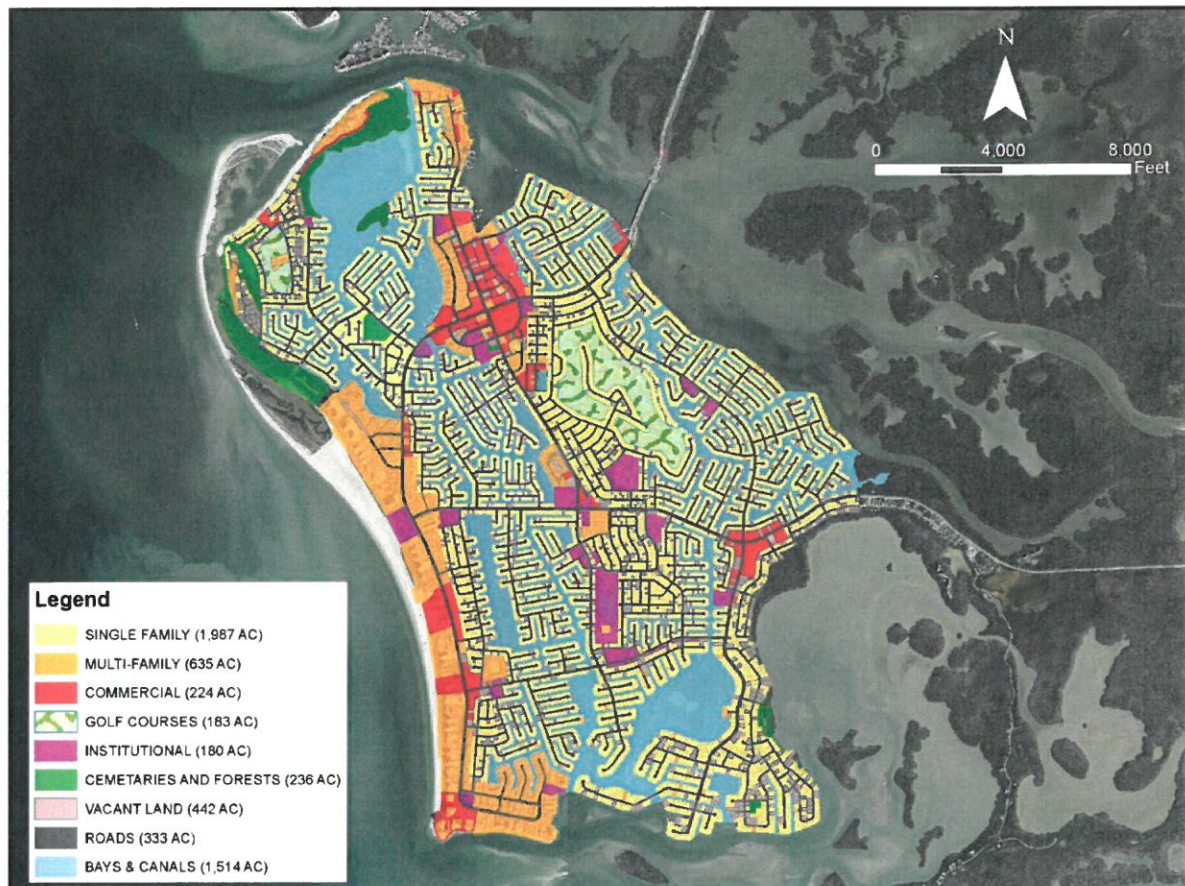
Figure 3: Current Land Use on Marco Island

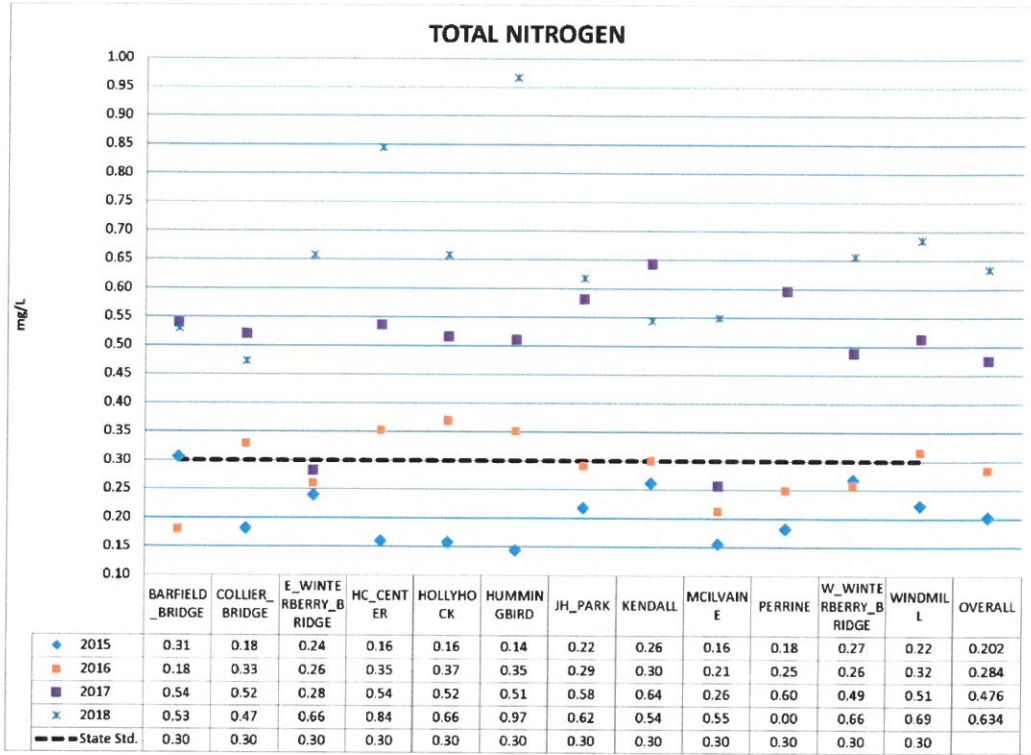
Figure 7: Annual Geometric Means of TN levels for Marco Island Waters

Over the period analyzed two of the individual sampling sites (Collier Bridge and Hummingbird) exceeded the state criteria for TP. Three of the sites (East Winterberry, Hummingbird, and Windmill) exceeded the state criteria for Chlorophyll-*a*, though the overall watershed was still below. All eleven of the sites exceeded the state criteria for TN. The elevated TN levels are a result of higher levels in samples collected throughout the year (34 of 43 individual samples collected were above standard). All of the stations were over the criteria for the May, August, and November sampling events. Eight of the eleven annual location results were higher than the 2017 levels. As a result, the watershed was over the state criterion for TN.

Based on the 2018 sample results, the Marco Island waterways have been over the State criteria for two consecutive years and so would meet the standard to be determined impaired for TN. However, the State looks at other water quality data within the WBID boundary along with the Marco Island data and in the most recent Verified Assessment Period of the Impaired Waters Rule (IWR) ending June 30, 2018, there were no nutrient parameters identified as meeting the listing threshold (IWR\_Run55\_07022018). If the current trend of increasing values continues, it is likely that the Marco Island WBID would meet the listing threshold on the next IWR run. It is

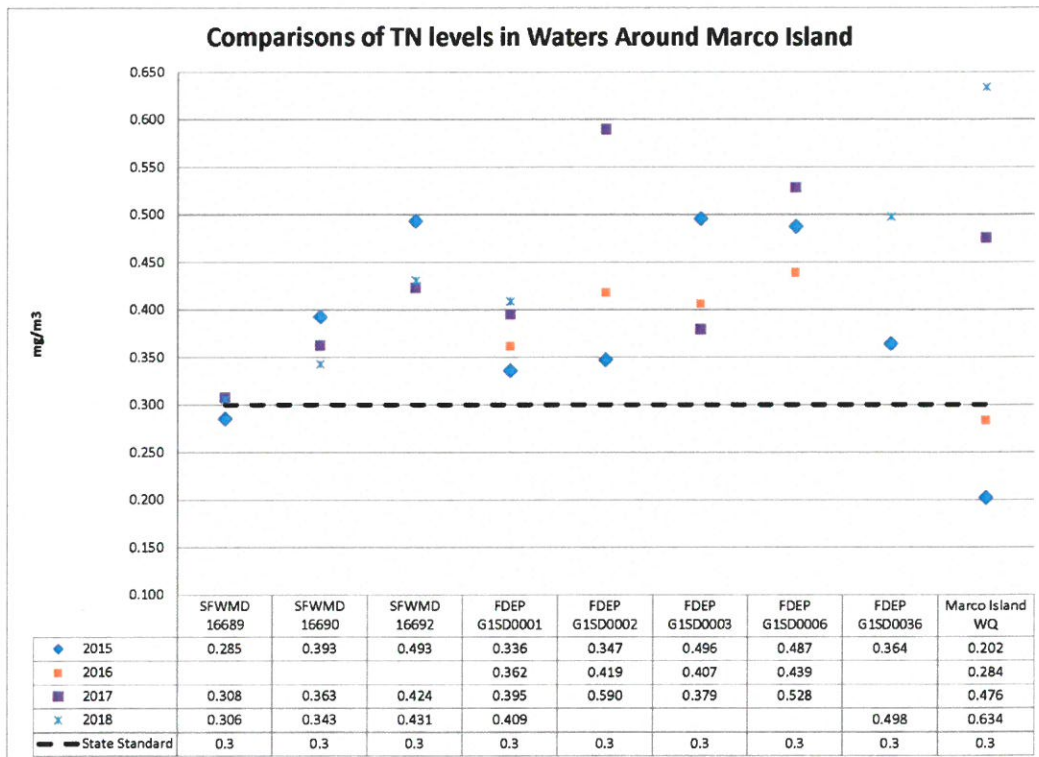
Figure 9: Comparison TN data from surrounding waters

The three SFWMD sites are located just offshore to the northwest of Marco (16689), in the center of the intracoastal waterway by the Jolly Bridge (16690), and in the intracoastal waterway by the Goodland Bridge (16692). The FDEP sampling stations are located in the open waters at the north tip of the island (G1SD0001), at the south end of Cape Romano to the south of the island (G1SD0002), at the south end of Marco Island (G1SD0003), in the intracoastal waterway near the Goodland Bridge (G1SD0006), and in the open channel between Kice Island and Helen Key (G1SD00036),

As can be seen, all of these stations had TN levels over the state standard during 2017 and 2018 so it appears the elevated levels are not limited to the Marco canals. Potential reasons for the elevated levels are discussed later in this report.

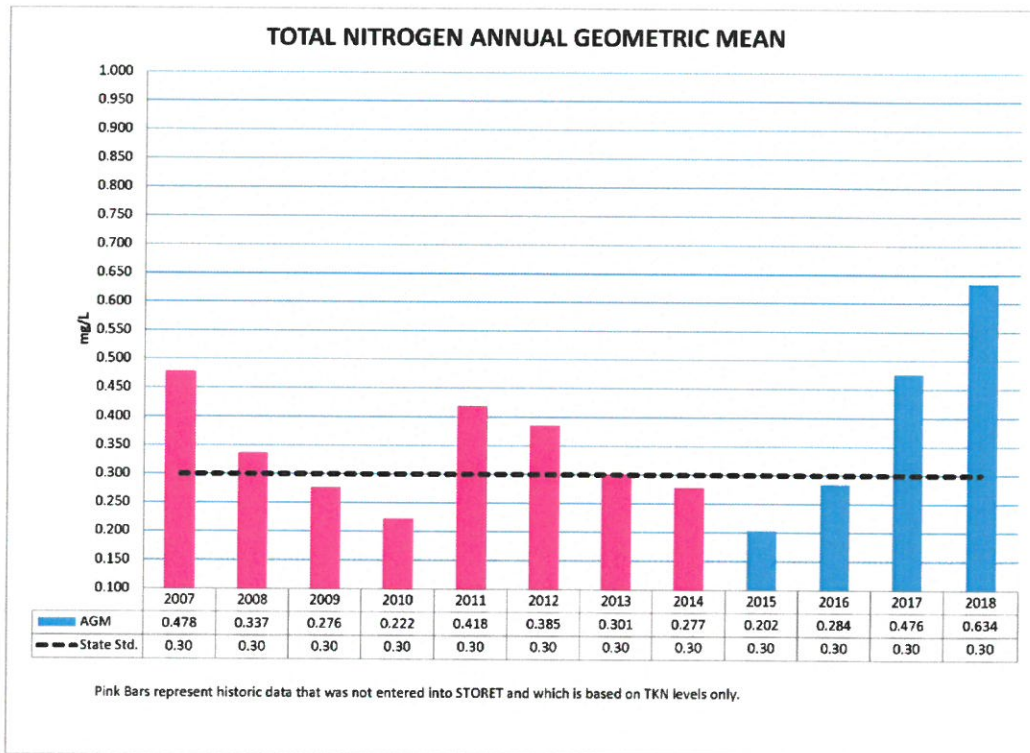
Figure 10: Comparison of Marco Island Nitrogen data from Previous Years

Another question that was asked is if the current trend of increasing TN levels is a recent occurrence or if it has happened in the past. To investigate this, Marco Island water quality data for 2007 through 2014 was examined and compared to the more recent data. The historic data only contained the TKN component of the nitrogen suite, so the values used are less than actual but since the TKN component is the vast majority of the TN component, it does allow for some comparison. As with the current data, the annual geometric mean was calculated for each year and the resulting level is depicted in the figure below.

Based on this information, it appears as though the TN levels can vary significantly from year to year. These variations do not appear to be linked to rainfall or salinity though no salinity data was available for the 2007 through 2014 data set. The increases and decreases do not consistently follow any rainfall pattern either. One item of interest is that three of the years showing higher peaks (2007, 2011, and 2017) are also years where severe wildfires burned in western Collier County. No correlation can be made at this time between the fires and the elevated nitrogen levels, but it is a data point to keep note of going forward.

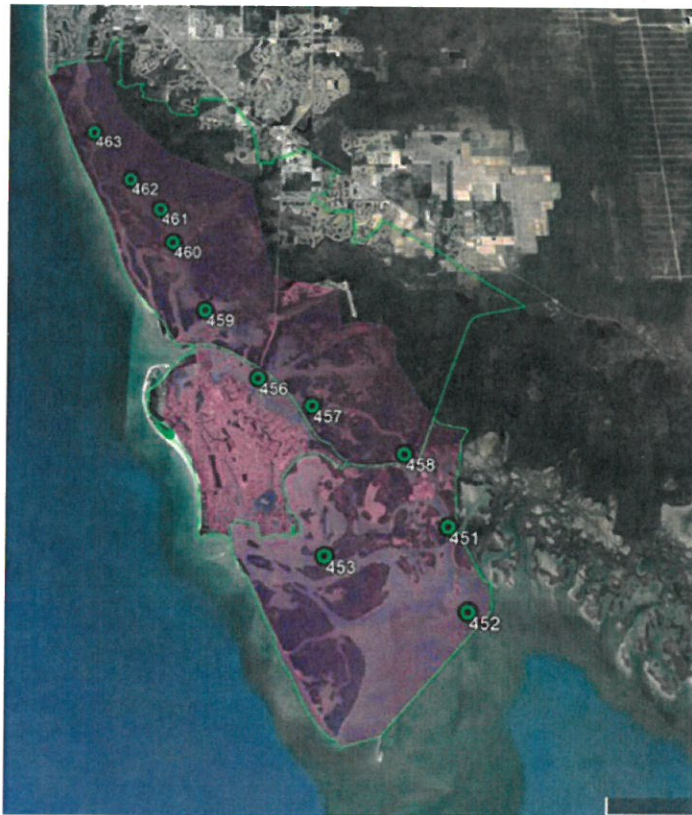
Figure 11: Data Collection Locations Used to Help Establish Numeric Nutrient Criteria

Looking at the locations that were sampled to establish the NNC for the Estuary Nutrient Region (ENR), it is interesting to note that only one data point falls within WBID 32780 and that is in the center of the intracoastal waterway at the Jolly Bridge.

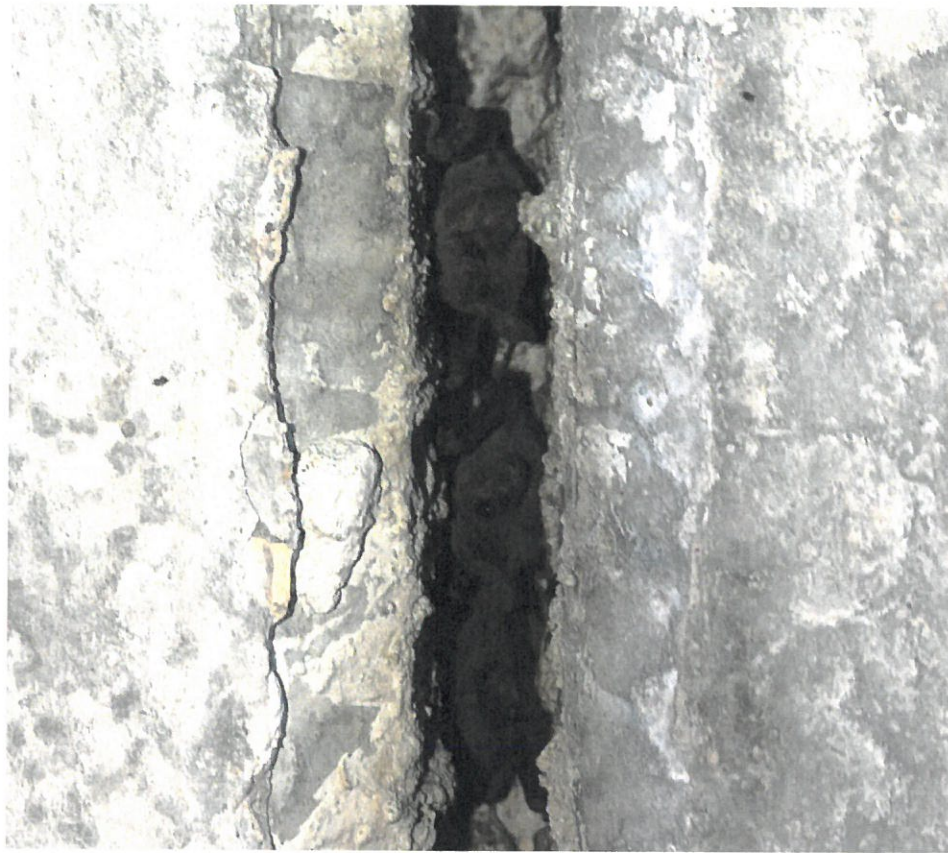
Figure 12: Bats under the East Winterberry Bridge

Marco Island is home to a diverse array of wildlife species. Bird rookeries, bat colonies, pets, and other animals can all contribute to nutrient loading into local waterways either transported via stormwater or directly into the local waters. Four of the bridges on Marco Island either are currently or have in the past supported bat colonies. Guano from the bats falls directly into the water under the bridges and is then transported throughout the waterways. Likewise, the multitude of birds flying and roosting around the Island also contribute nutrients into the local waters.

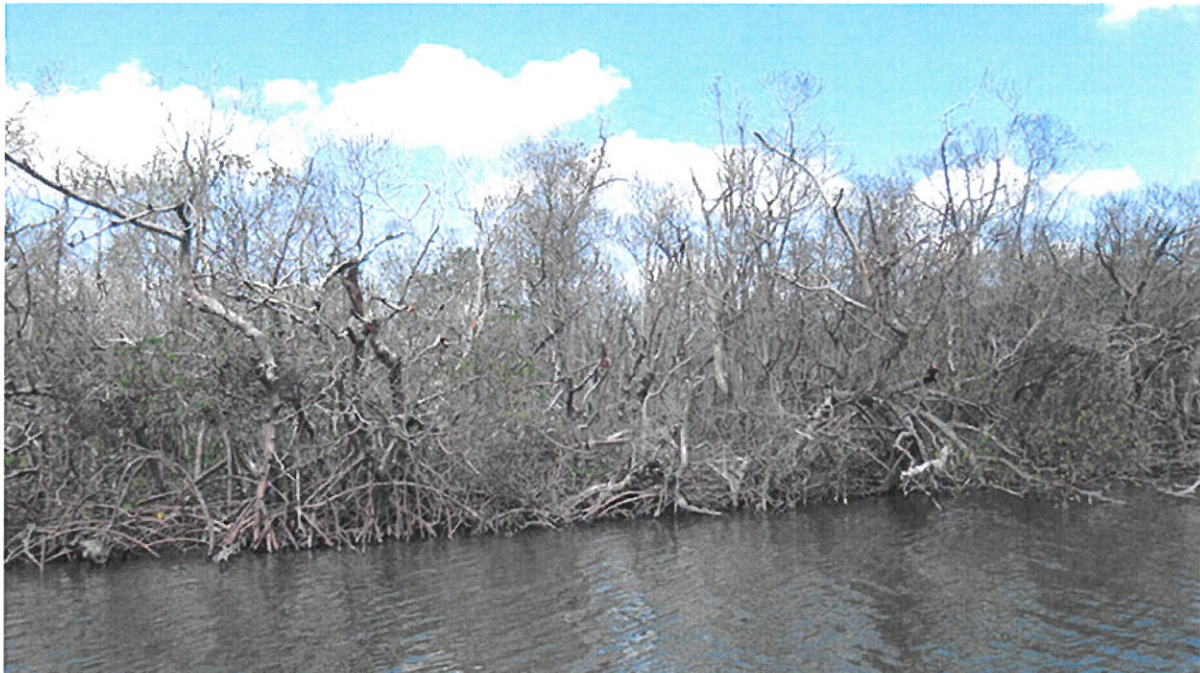
Figure 14: Mangroves stripped of leaves by Hurricane Irma

Hurricanes and tropical storms have the ability to greatly increase the amount of organic material within the local waterways. Leaves, limbs, and soil driven by storm force winds can be blown from adjacent upland and wetland areas to be deposited into the local waterways. Heavy rainfall and storm surges can also transport material from adjacent lands into the waterways. As this material rots and is broken down, the nutrient components enter the water column and sediment components of the waterways. In the sediment, the nutrients are susceptible to re-suspension every time the waters are agitated either by natural winds and storms, or by boat wakes and propellers.

Studies have shown that leaf debris such as mangrove or oak leaves can take 9 to 12 months to break down, depending on environmental conditions, so effects on the water quality from large inputs of this type of material can take over a year to be observed and may linger for quite a while until flushed or exported from the system.

It is impossible to calculate the amount of debris that hurricane Irma deposited into the Marco Island waterways but it is likely that this material is still present and having an effect on the water quality nutrient levels.

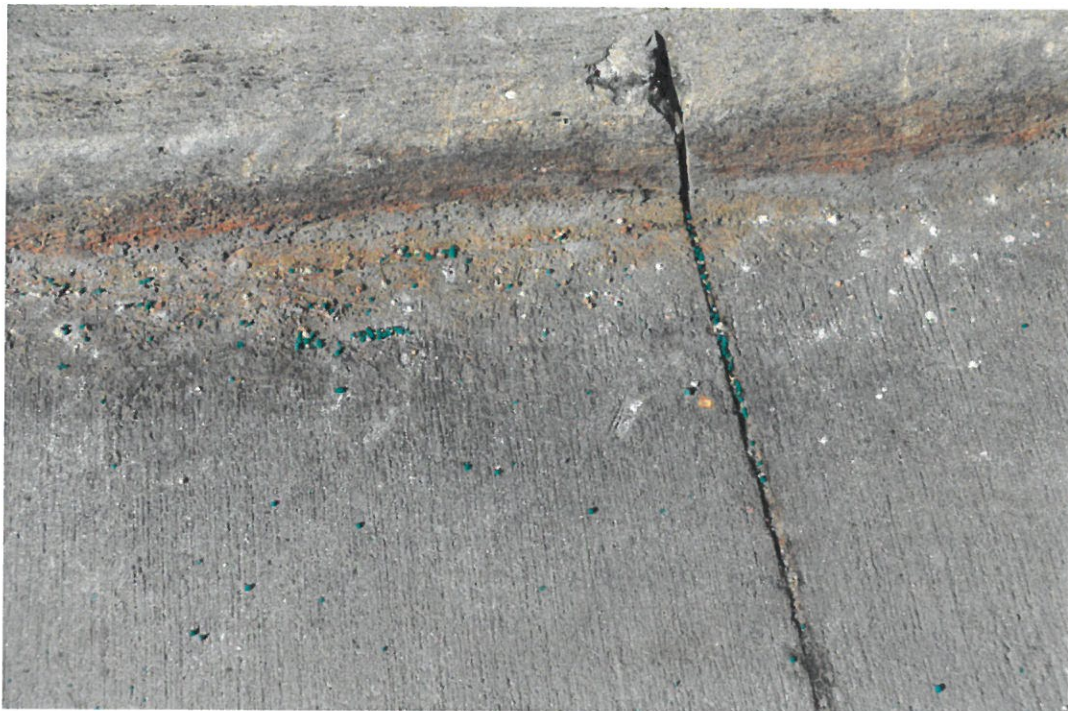
Figure 16: Fertilizer overcast onto adjacent curb

Improper fertilization or utilization of the wrong fertilizers can also contribute nitrogen to local waters. It is important to use fertilizers with only the correct amounts and forms of nitrogen that can be readily used by the plants being fertilized. Fertilizer that are spread or overcast onto impervious surfaces can then be washed directly into the stormwater system and transported to the local waters where they contribute to algal growth and blooms rather than to the landscape plants or grass for which they were intended. Fertilizers that are not incorporated into the soils can also be more susceptible to being washed away into the adjacent waterways.

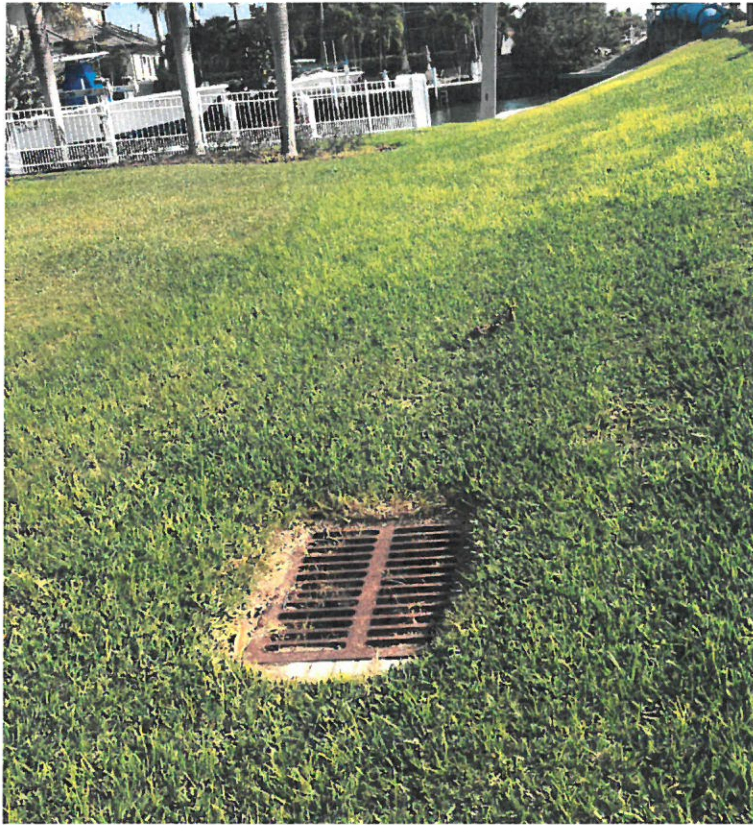
Figure 18: Stormwater grate at the low point of the swale.

The City has a lot of the biofilter type of treatment areas throughout the Island, but most are designed to pass water as quickly as possible rather than trying to retain it at all. Stormwater grates within the swales are placed at the bottom of the swale so during storm events, the water runs out immediately rather than being retained for any time.

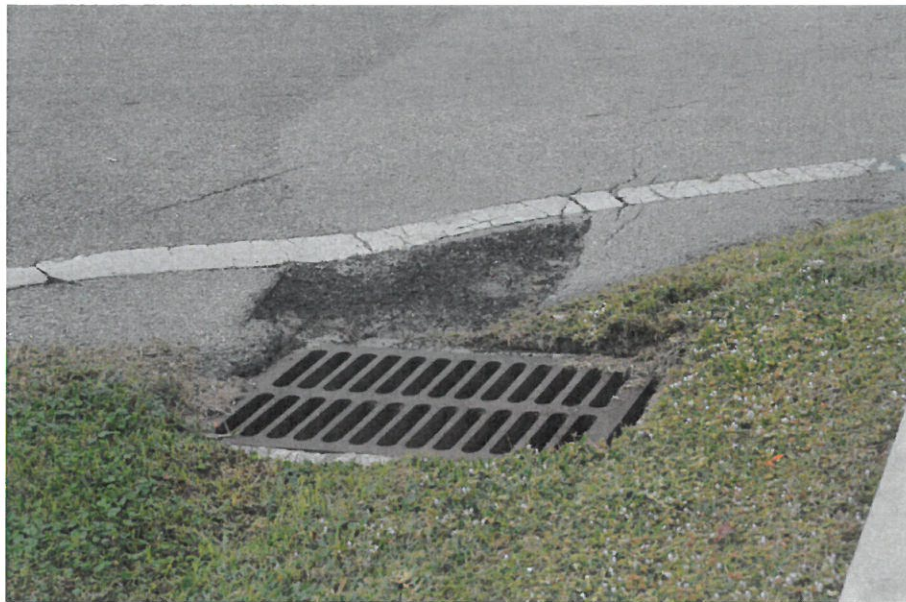
Figure 19: Road run-off directed immediately into stormwater grate

The City also has several areas where no treatment or retention at all occurs before stormwater flows into the adjacent waterways. Areas such as this should be a priority for modifications to reduce direct flow into the adjacent waters.

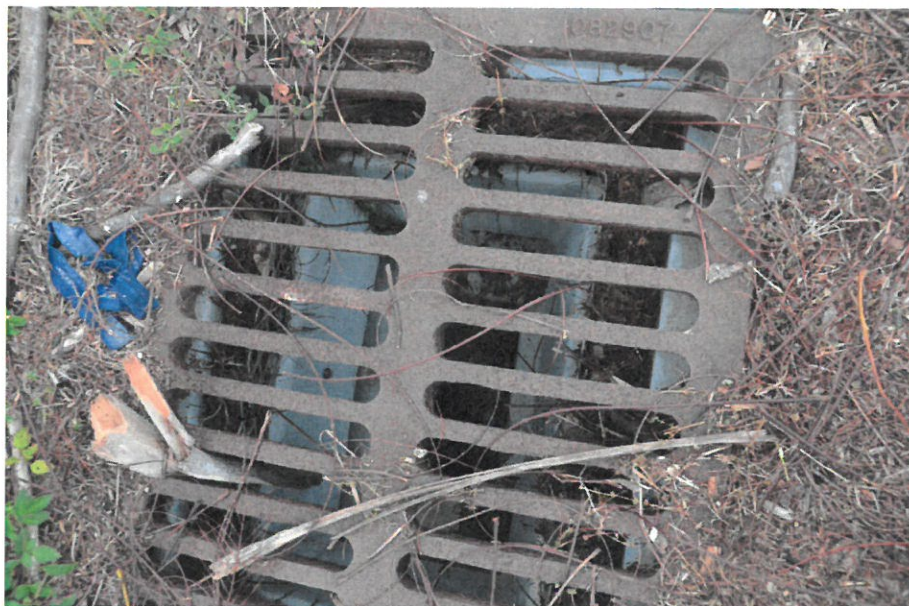
Figure 21: Storm drain insert becoming blocked with vegetative debris

- Vendor-supplied systems include a variety of proprietary and miscellaneous systems including catch basin inserts, hydrodynamic devices, and filtration devices. The City currently has examples of these inserts scattered around the Island. Some can be very effective but can be expensive to maintain (both from an equipment and a labor aspect), especially if used for direct run-off without settling basins or filtering from biofilters as outlined above. They can also be susceptible to clogging and reduced efficiency when grass and vegetative debris flows into them.

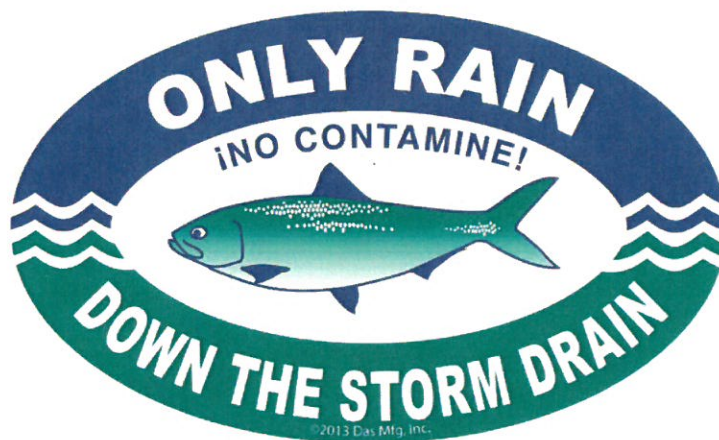
Figure 22: Example of basin inlet stencil/plaque

and volunteer monitoring programs. Residents are frequently unaware that materials dumped down storm drains may be discharged to a local water body. A simple program of stenciling the inlets can be an effective means of alerting residents of this fact.

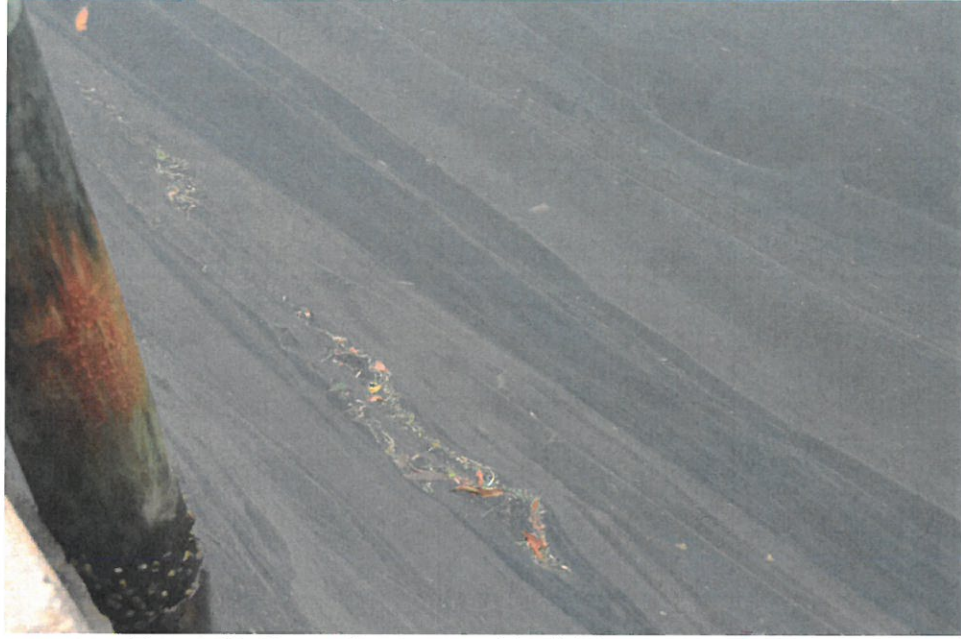
Figure 23: Grass clippings and leaf debris in canal

- **Lawn Debris Management.** Lawn debris such as grass trimmings and leaves require proper management in order to reduce impacts to adjacent waters. Grass trimmings and leaves can be carried away by runoff or wind and can find their way into adjacent waters where they

rapidly decompose and release nutrients. Grass trimmings and leaf litter can be controlled by composting lawnmowers, bagging and composting or by community curbside collection programs. Composted yard debris can be an excellent source of mulch for residential landscape and gardens. Use of mulch can greatly reduce the need for inorganic fertilizers, which also helps to keep nutrient loadings to a minimum.

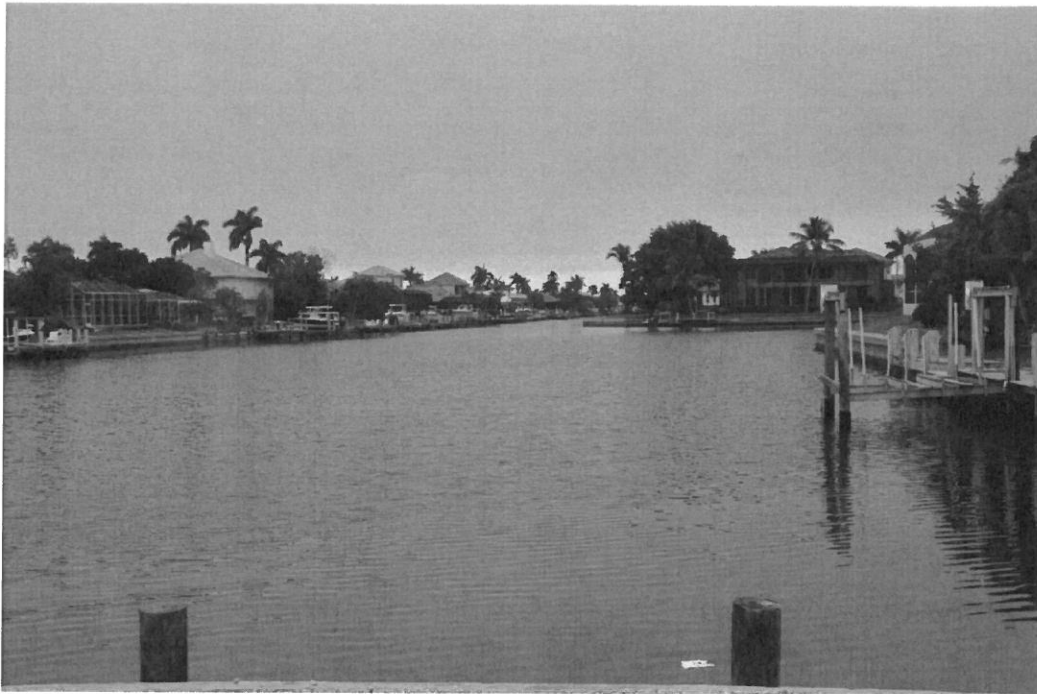
Figure 25: Canal ringed with vertical seawalls

When Marco Island was originally constructed, the entire waterway system was lined with vertical seawalls. Many of these seawalls are still present today but are approaching the end of their lifespan. Many have also been replaced but still with vertical walls.

Vertical walls provide the minimum surface area for filter feeding organisms such as oysters, tunicates, and others to colonize. The vertical surfaces of seawalls also act as mirrors for boat wakes and waves and this refraction can result in higher turbulence and lower visibility within the canals. All of the docks located within the canals do provide some structure and can help break up wave energy but most are treated to prevent or discourage growth of organisms on the

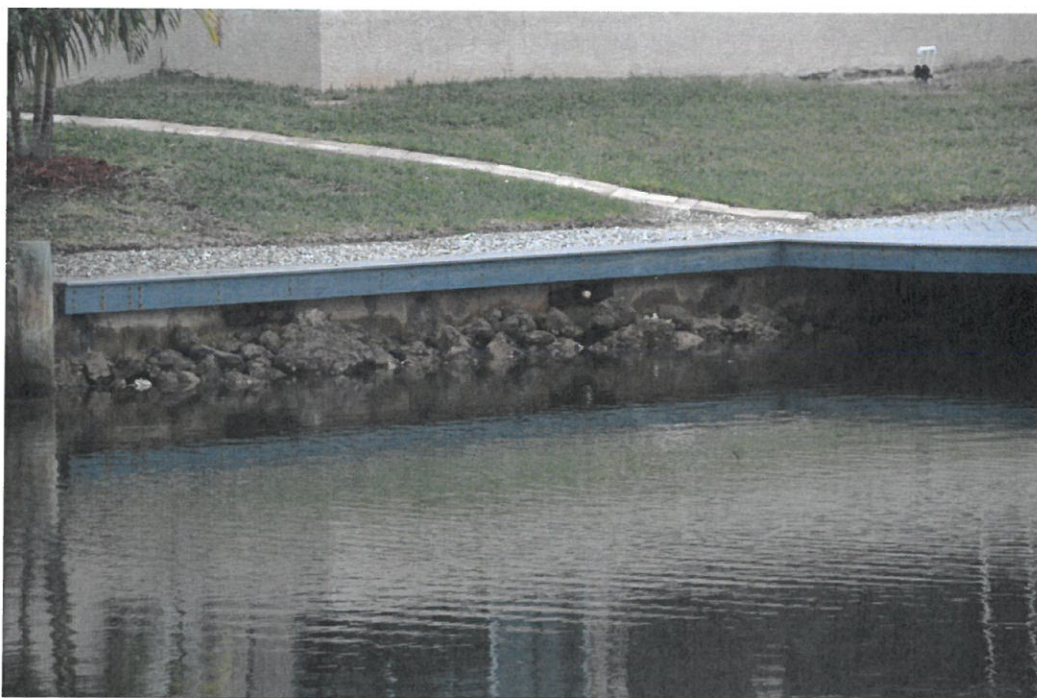
Figure 26: Older seawall with rip rap showing substantial benthic growth

pilings. Consideration should be given to providing more places for filter feeding organisms which can help to clean the water and could be a way to ameliorate background nutrients that are flowing into and out of the canals on every tidal cycle. Living shorelines, rip rap, and mangrove islands could all provide additional surface area for colonization, but all come with challenges that would have to be considered. Any changes to waterways would require permitting from state and federal agencies. While seawall replacement is an exempt activity, the placement of rip-rap in front of the wall is fill which requires federal permitting and would make seawall replacement a bit more complicated and potentially costlier. The benefits could be substantially more area for colonization by benthic organisms, relief from wave refraction, and the resultant improvements to water quality.
