MARCO ISLAND NUTRIENT SOURCE EVALUATION PROJECT

Final Report – September 2021

EXECUTIVE SUMMARY

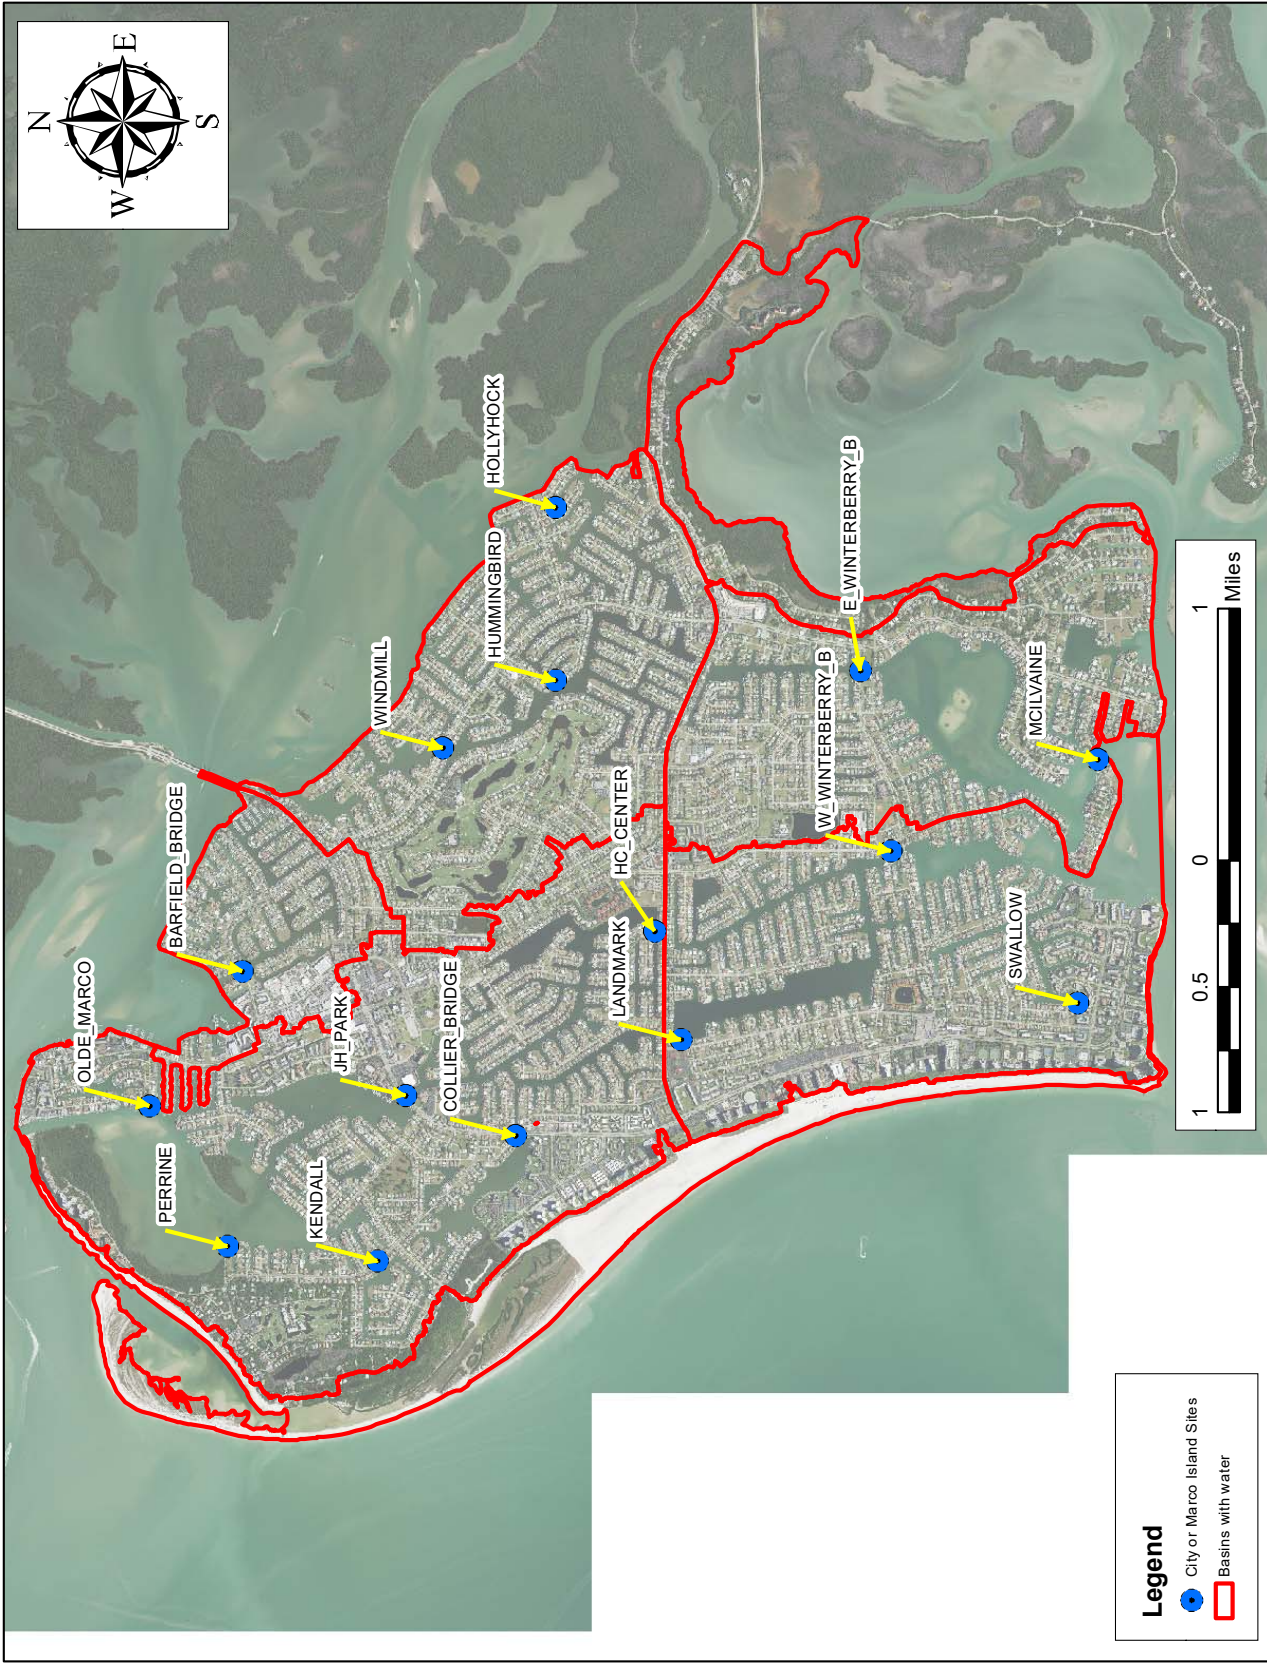
Figure 2-2. Locations of Historical Marco Island Water Quality Monitoring Sites.

ERD evaluated the historical data using a variety of methods. First, annual geometric mean values were calculated for each parameter and monitoring site for use in evaluating water quality trends. Trend analyses were conducted for total nitrogen, total phosphorus, chlorophyll-a, and Secchi disk depth at each monitoring site to evaluate water quality stability over the 6-year period from 2015-2020. In addition, graphics were generated which superimpose annual geometric mean values for measured parameters on the site map of water quality monitoring stations (provided in Figure 2-2) to provide an overview of spatial distributions for water quality parameters.

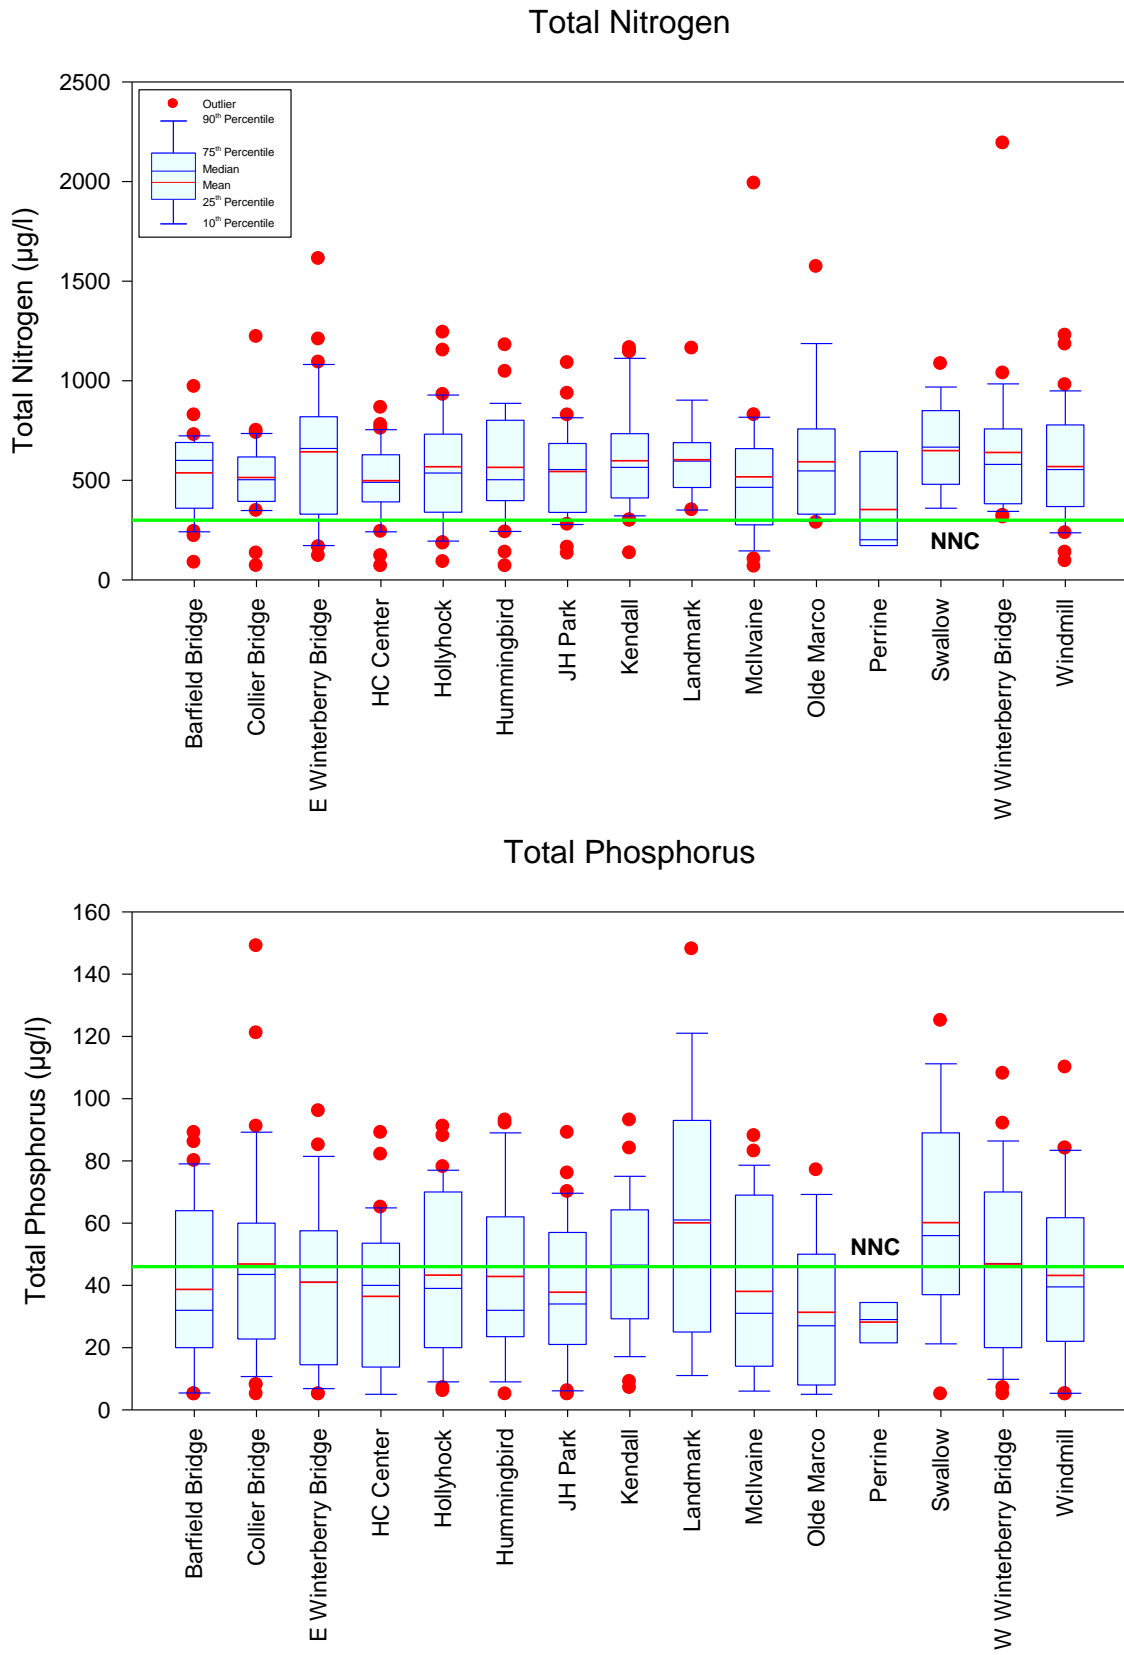
Figure 2-8. Statistical Comparison of Concentrations of Total Nitrogen and Total Phosphorus Measured in Marco Island Waterways from 2015-2020.

Measured concentrations of total phosphorus also exhibited a relatively high degree of variability in measured values, with concentrations ranging from less than 10 µg/l to more than 300 µg/l. In contrast to the trends observed for total nitrogen, approximately half of the measured total phosphorus values appear to be less than the applicable NNC criterion of 46 µg/l. A slightly lower degree of variability in measured phosphorus concentrations is also apparent at many of the sites exhibiting low variability in nitrogen concentrations, although the trends are not as significant as those observed for total nitrogen.

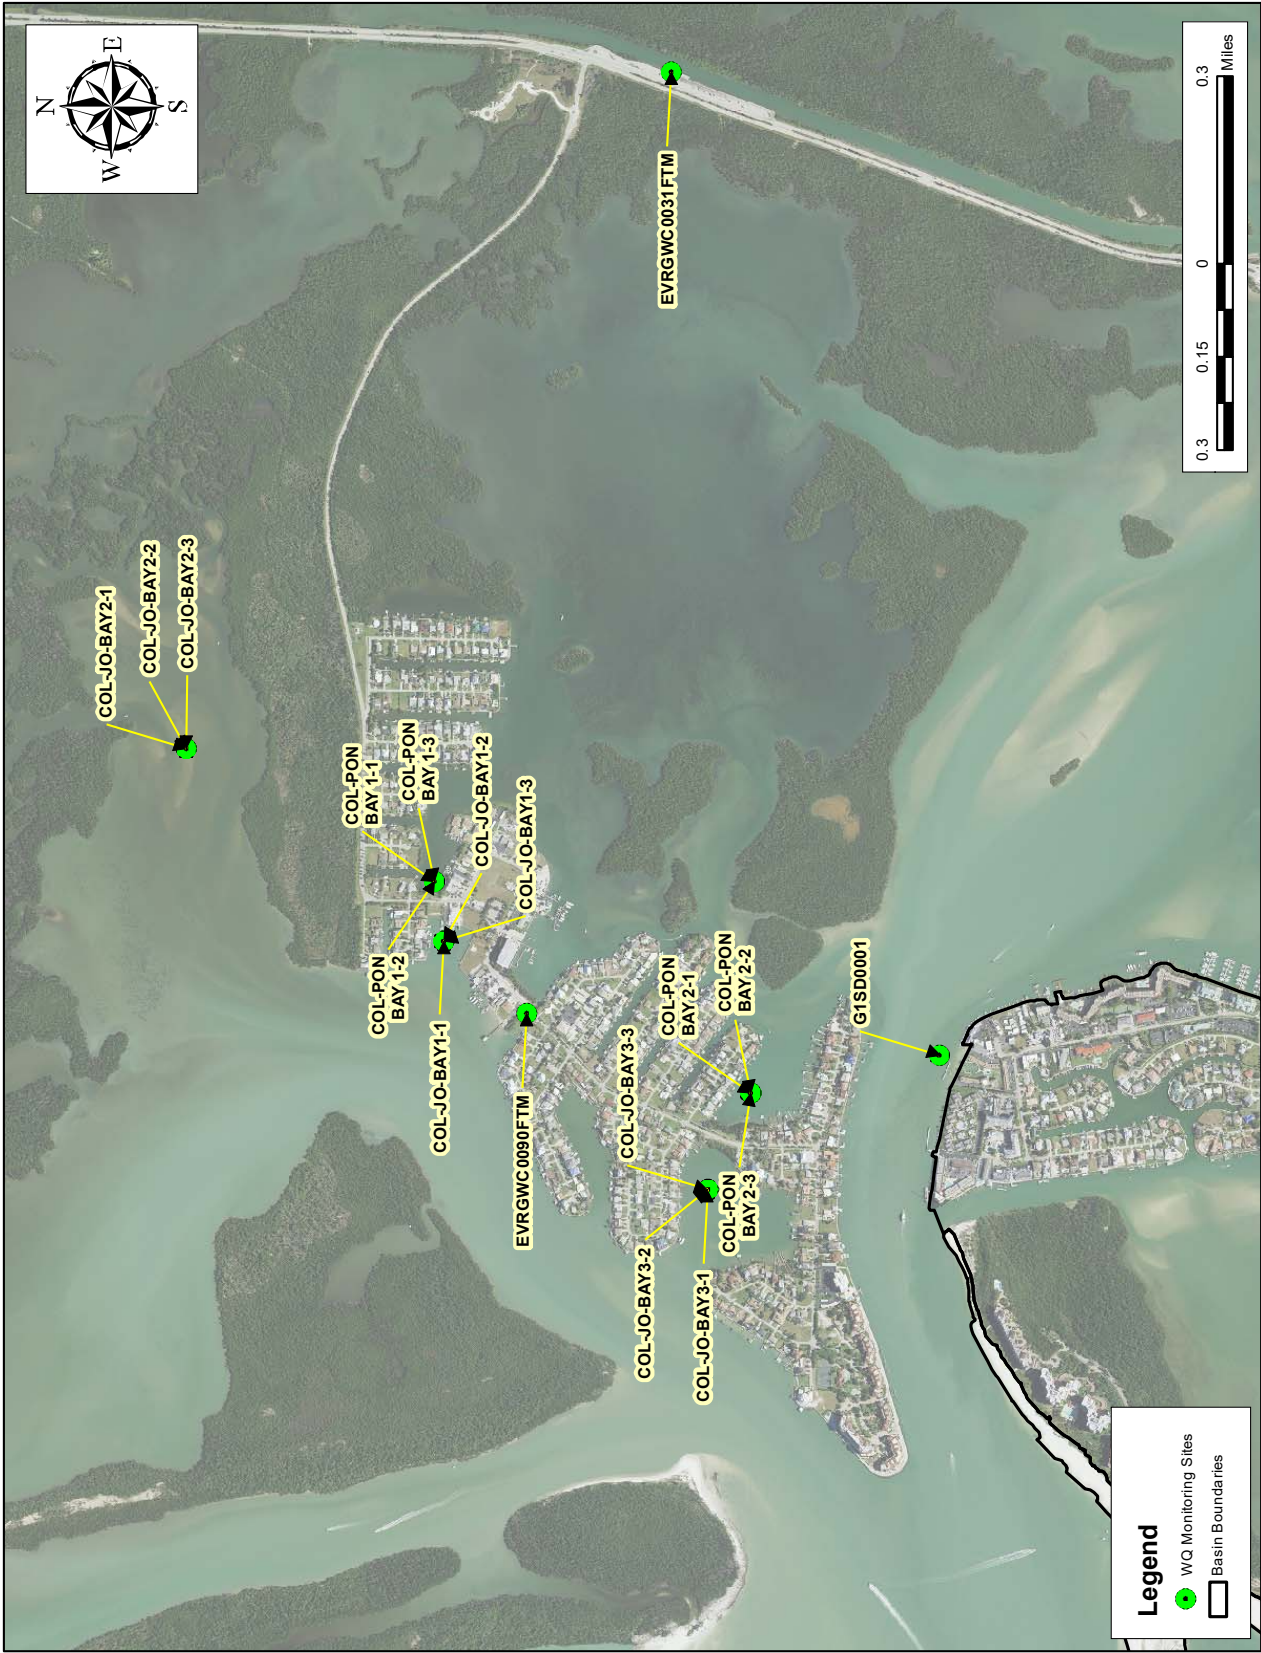
Figure 2-12. Expanded View of Off-Island Monitoring Sites North of Marco Island Near Isles of Capri.

An expanded view of off-island monitoring sites north of Marco Island is given on Figure 2-12. A large number of monitoring sites have been included in this area, although few of these historical sites have current water quality data.

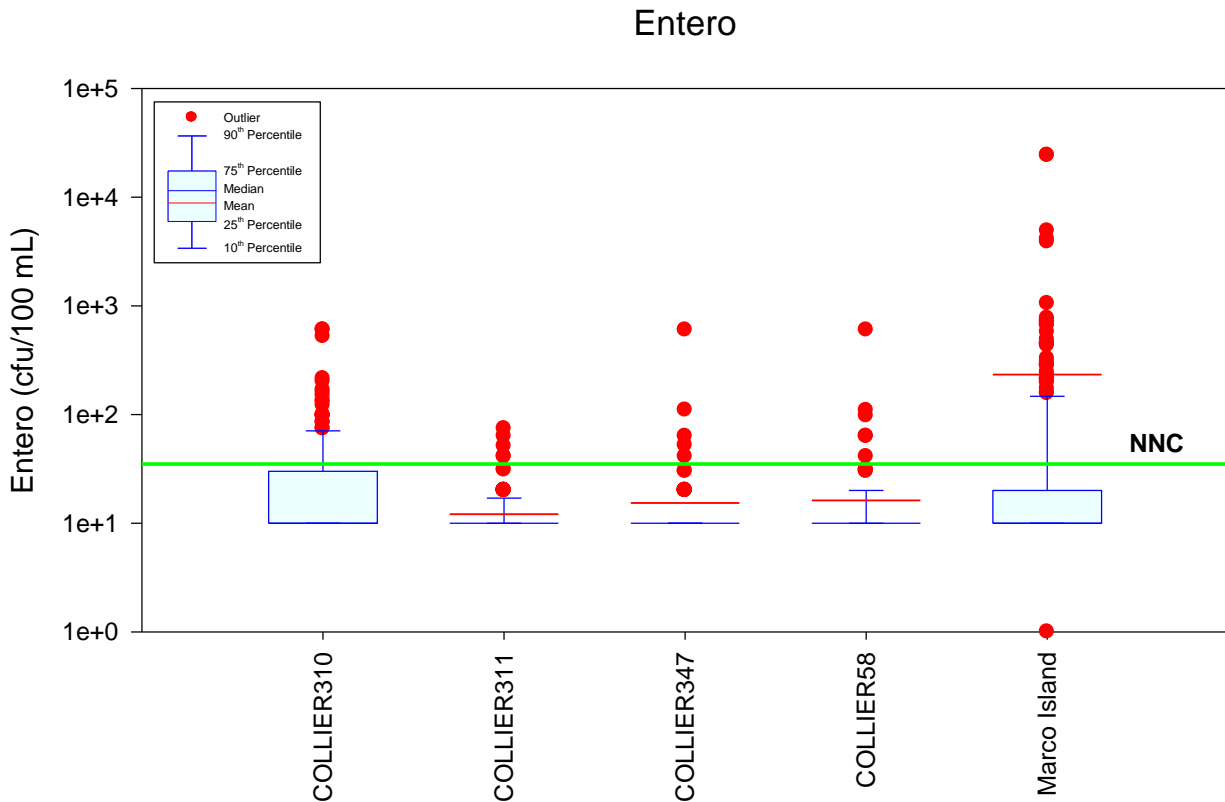
Figure 2-15. Statistical Comparison of Measured Enterococci Counts at On- and Off-Island Waterways from 2015-2020.

A statistical comparison of measured Enterococci values for on- and off-island waterways from 2015-2020 is given on Figure 2-15. The vast majority of collected samples in both the on- and off-island monitoring sites easily met the Enterococci criterion, although individual exceedances of the criterion have been observed at each site. The observed exceedances at the Marco Island waterways sites have included substantially higher values than observed at the remaining sites. Please note that the scale for Enterococci values is a logarithmic scale, suggesting that some values measured in Marco Island waterways have exceeded the NNC by 2 orders of magnitude or more, although in general Enterococci counts are typically low in value.

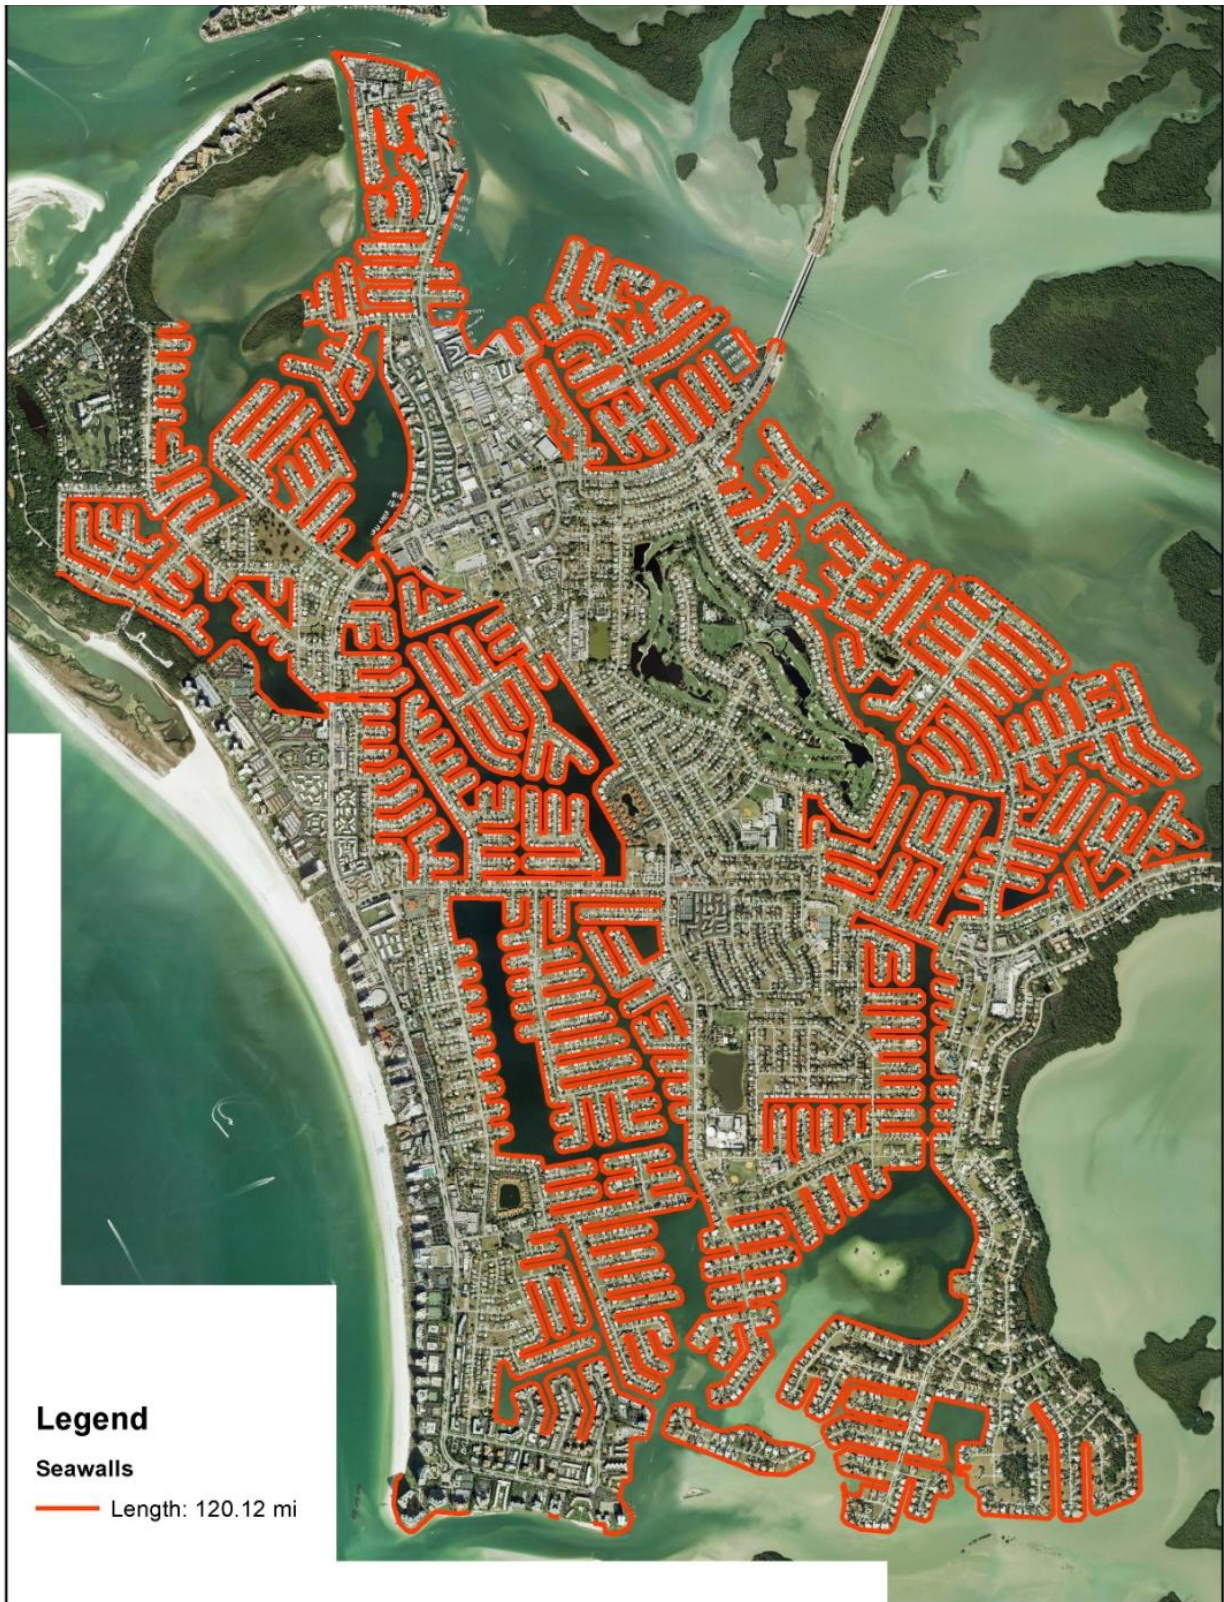
Figure 3-3. Locations of Marco Island Seawalls.
(Source: City of Marco Island Public Works Department)

Virtually all of the canals and waterways are excavated channels which are retained by seawalls constructed of pile-driven sheets of steel, aluminum or concrete sections. Locations of existing seawalls are indicated on Figure 3-3. Overall, the canal system for Marco Island contains approximately 120 miles of constructed seawalls. Efforts for repair or replacement of existing seawalls were commonly observed during the field monitoring program.

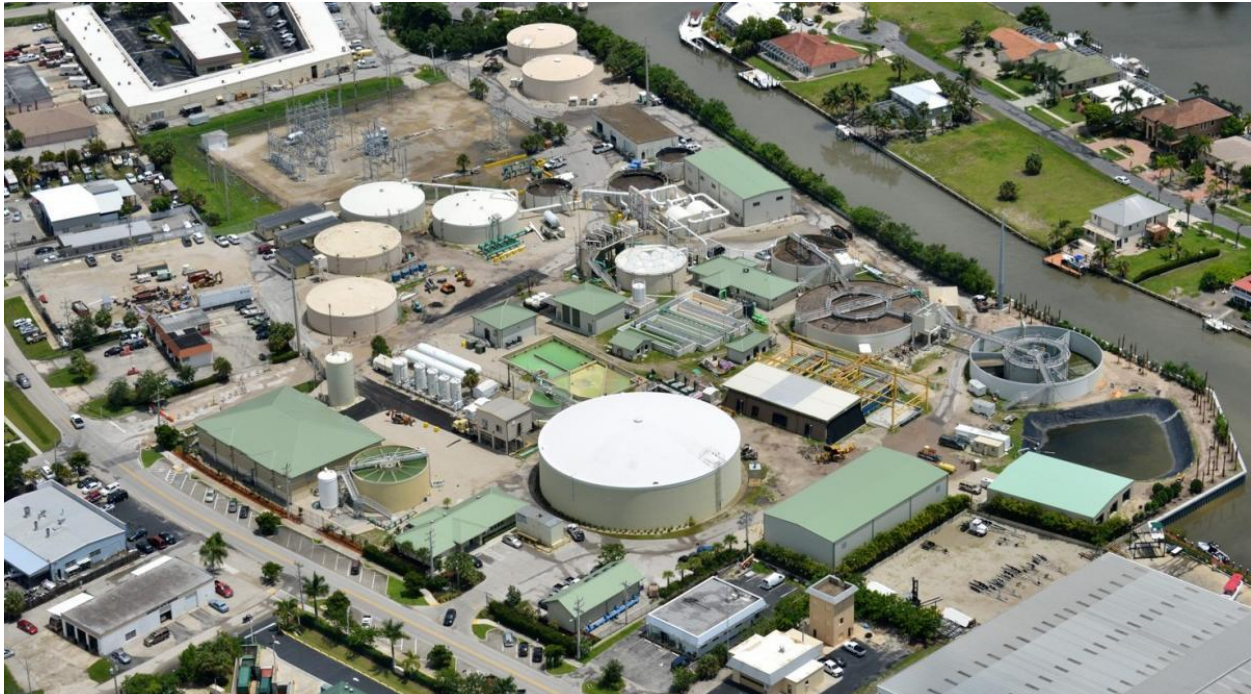
Figure 3-8. Photo of the City of Marco Island Wastewater Treatment Facility.
(Source: City of Marco Island)

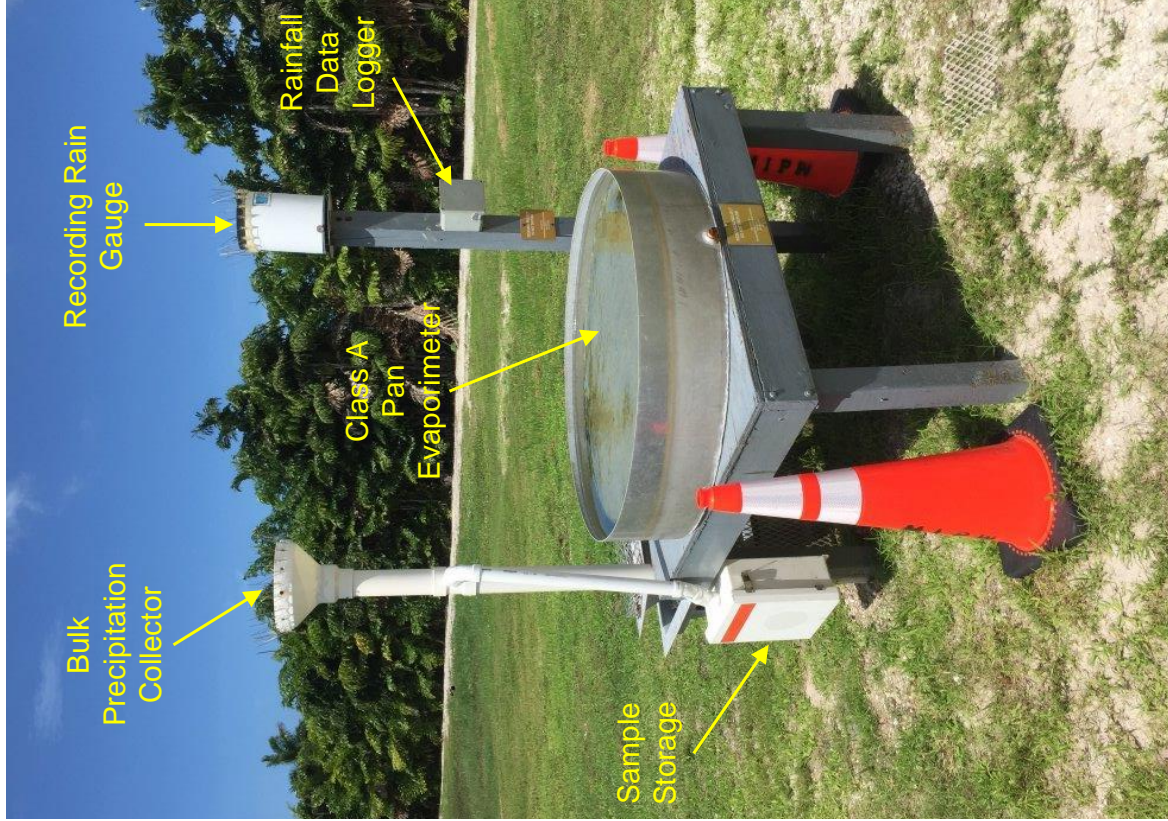
b. Hydrologic Instrumentation

Figure 4-2. Marco Island Hydrologic Instrumentation.

A photograph of the hydrologic instrumentation installed at the site is given on Figure 4-2b. Rainfall was monitored using an ISCO Model 674 tipping bucket rain gauge which was attached to a 4-inch x 4-inch wooden post. The rainfall recorder produced a continuous record of all rainfall which occurred at the site, with a resolution of 0.01 inch. Rainfall data were stored inside a digital storage device (Hobo Event Rainfall Logger) which was also attached to the wooden post inside a waterproof enclosure. The rainfall record was used to provide information on general rainfall characteristics during the field monitoring program from May-November 2020. A manual rain gauge was also installed at the site to corroborate rainfall records provided by the recording rain gauge.

In addition to the tipping bucket rain gauge and manual rain gauge, a bulk precipitation collector and pan evaporimeter were also installed at the site, as indicated on Figure 4-2b. However, the evaporation data are not used for this project since the monitoring program covered only a portion of an annual cycle.

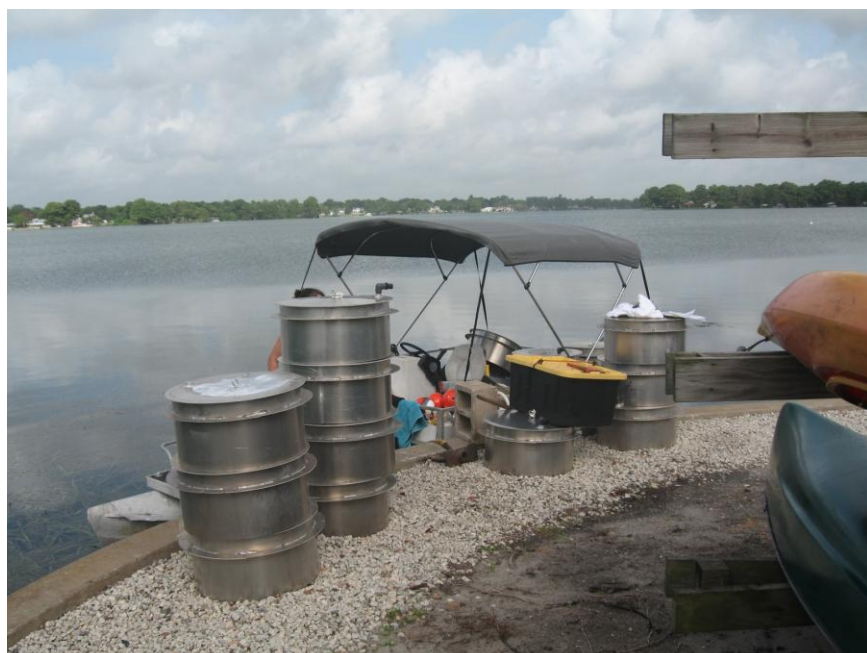
Figure 4-6.
Seepage Meters Being
Prepared for Installation.

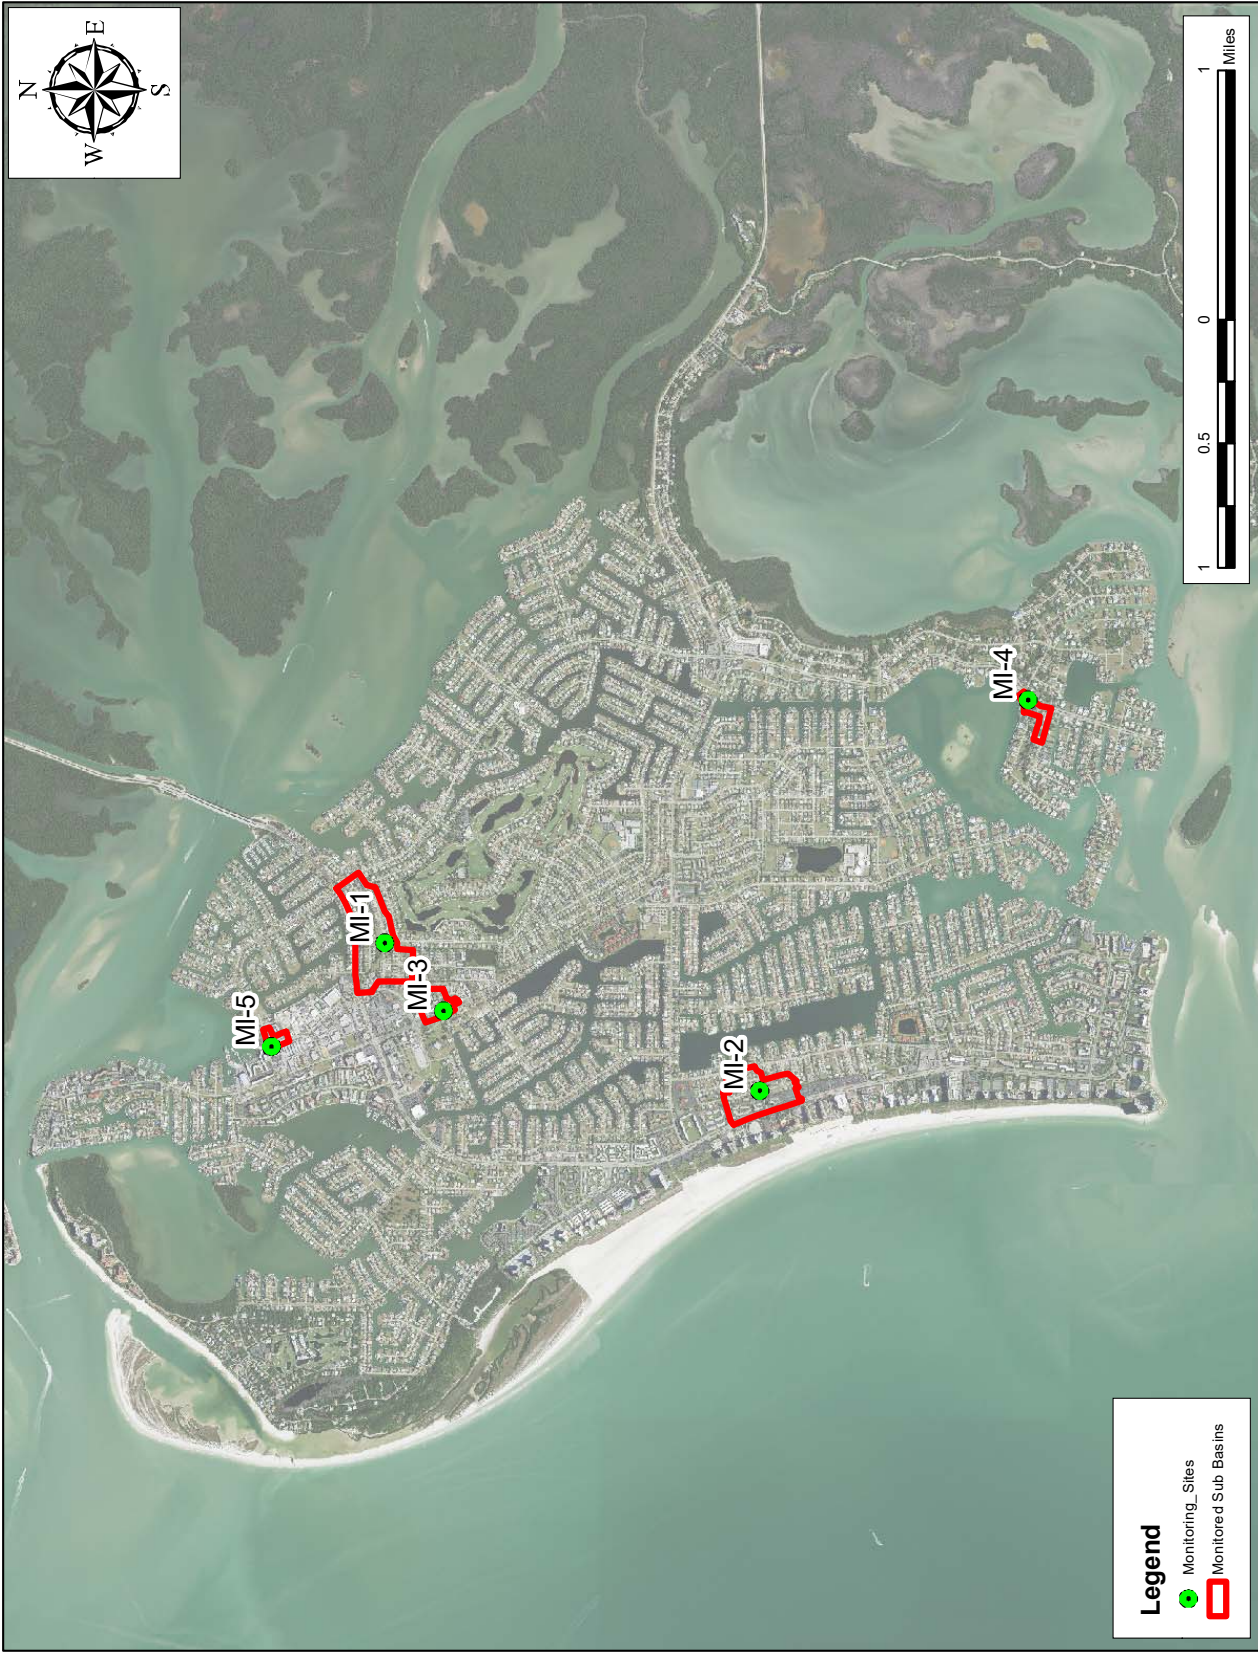
Figure 5-5. Locations of Stormwater Monitoring Sites.

Locations of stormwater monitoring sites used by ERD to characterize stormwater runoff within Marco Island are given on Figure 5-5. Five separate monitoring sites were selected which included commercial, residential, and industrial land uses in areas with and without reuse irrigation. Drainage basin areas discharging to each of the 5 monitoring sites are also illustrated on Figure 5-5.

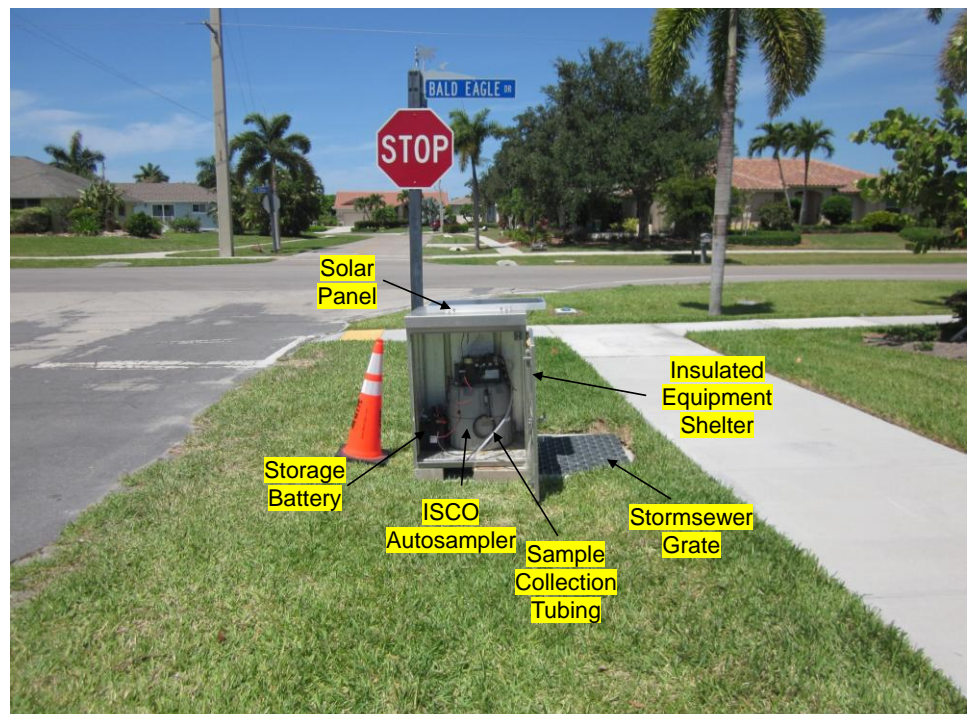
Photograph of Stormwater Monitoring Site MI-3.

(Commercial watershed with partial reuse irrigation)

A photograph of stormwater monitoring site MI-3 is given on Figure 5-10. An insulated equipment shelter was installed on top of a stormsewer grate which is connected to the primary drainage system beneath Bald Eagle Drive. Drainage in this area is collected initially in a series of roadside swales before discharging into a 24-inch RCP underground stormsewer system. An ISCO Model 6712 sequential autosampler was placed inside the insulated equipment shelter with sample collection tubing and flow meter cables extending into the stormsewer system. Flow-weighted composite samples of runoff were collected during both storm and baseflow conditions during the field monitoring program.

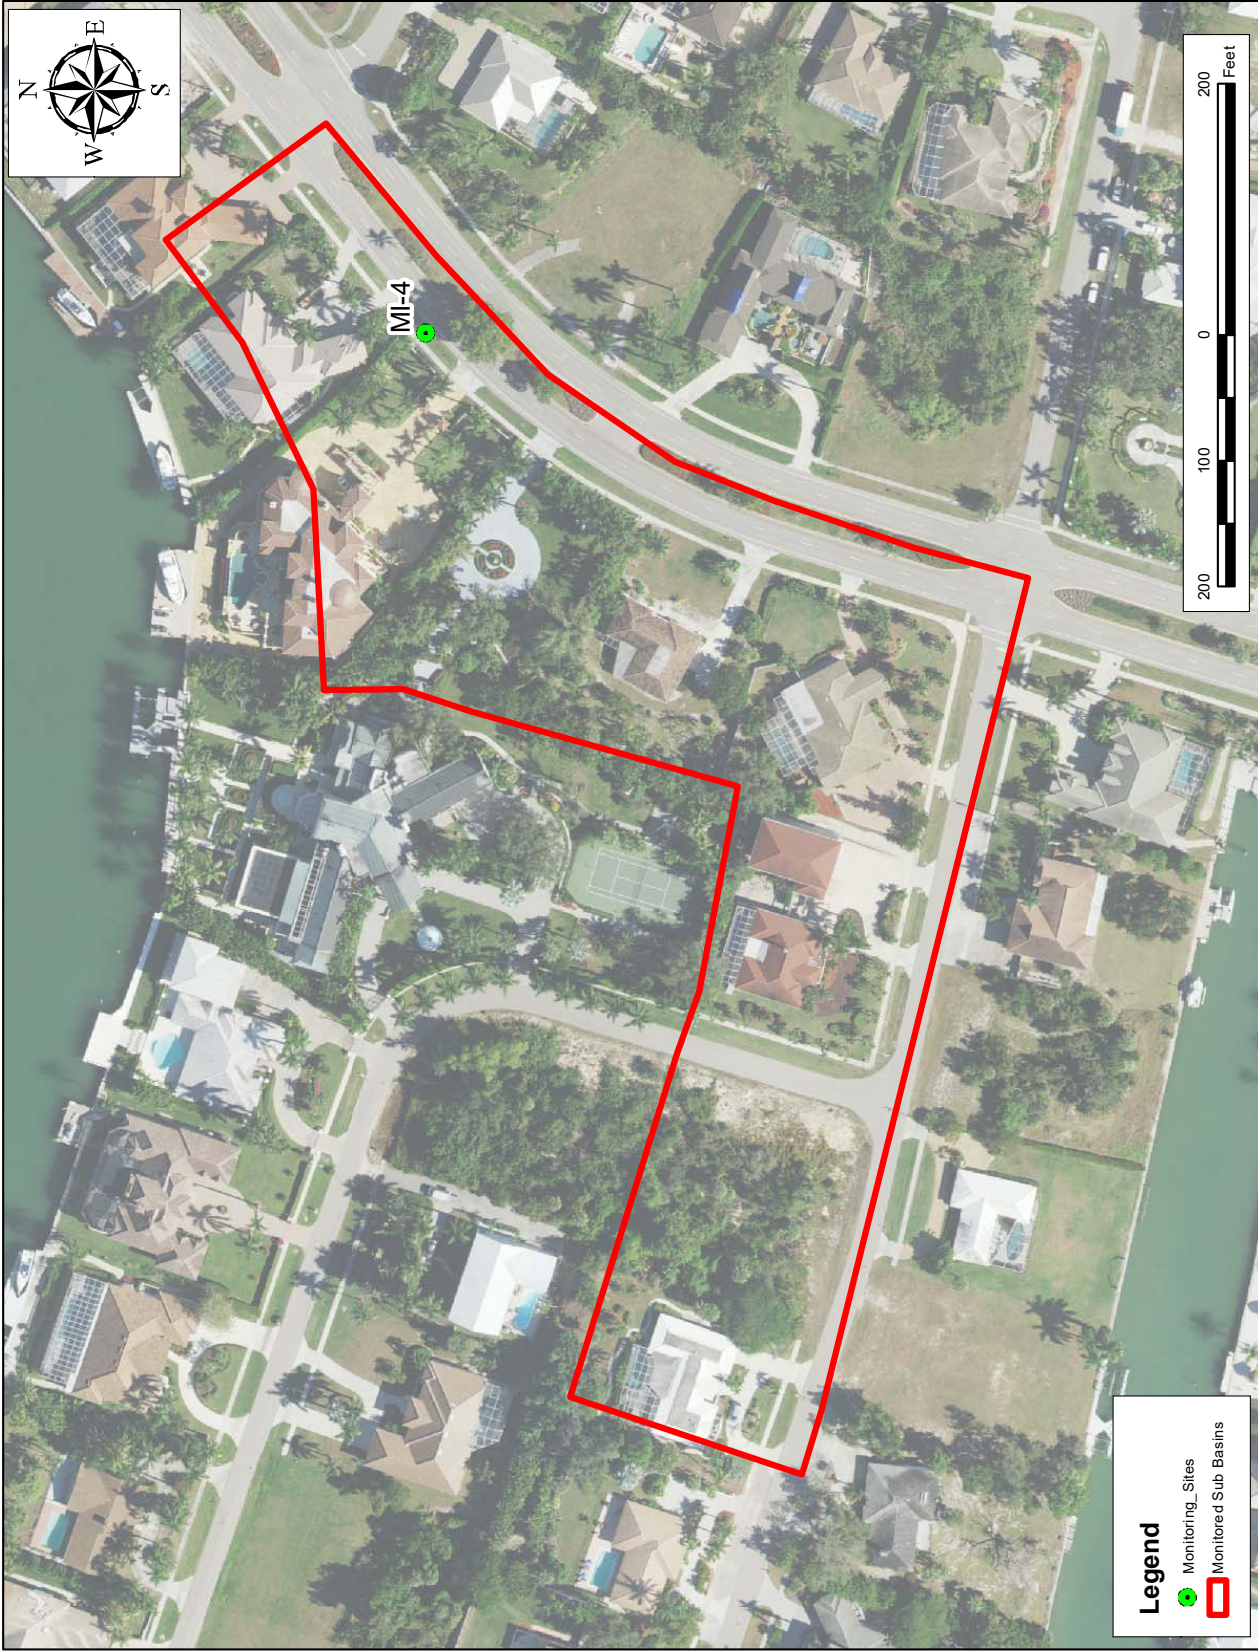
Figure 5-11. Overview of the Drainage Basin Area for Monitoring Site MI-4.

An overview of the drainage basin area for monitoring site MI-4 is given on Figure 5-11. This monitoring site receives runoff from a 6.04-acre drainage basin consisting of large residential homes with a high level of lawn care and maintenance activities. Runoff generated in this area is initially collected in a grassed roadside swale system with periodic inlet structures which collect the runoff from the swale and discharge it to an 18-inch underground stormsewer. Reuse irrigation is not available at this site, although the City applies reuse to median landscaping.

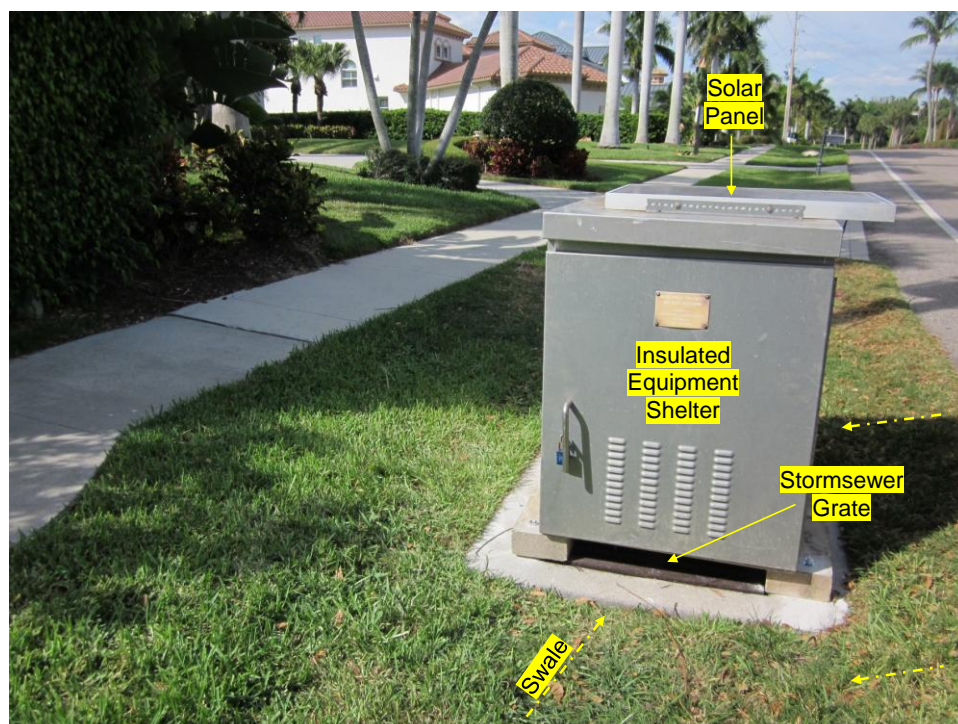
Photograph of Stormwater Monitoring Site MI-4.

A photograph of stormwater monitoring equipment installed at site MI-4 is given on Figure 5-12. The installation is identical to equipment installed at the previously discussed sites. An insulated equipment shelter was installed on top of a stormwater inlet grate located in the roadside swale system. An ISCO Model 6712 autosampler was installed inside the insulated equipment shelter, with sample collection tubing and flow meter cables extended into the manhole structure. The area-velocity flow meter instructed the autosampler to collect the samples in a flow-weighted mode during monitoring rain events.

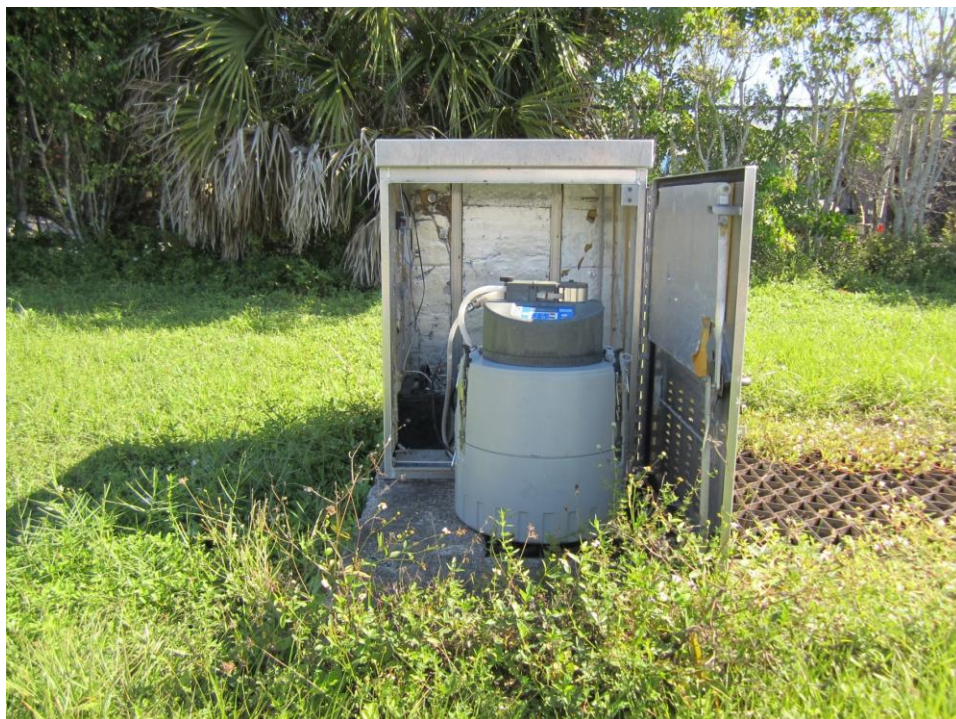
Photograph of Stormwater
Monitoring Site MI-5.

A photograph of stormwater monitoring site MI-5 is given on Figure 5-14. An insulated aluminum equipment shelter was mounted on top of a grate inlet connected to the primary stormsewer system consisting of a 48-inch RCP which discharges from this area to Factory Bay. The stormwater monitoring equipment at this site was identical to the equipment used at the previous sites, consisting of an ISCO Model 6712 sequential autosampler which was programmed to collect flow-weighted composite samples during storm events.

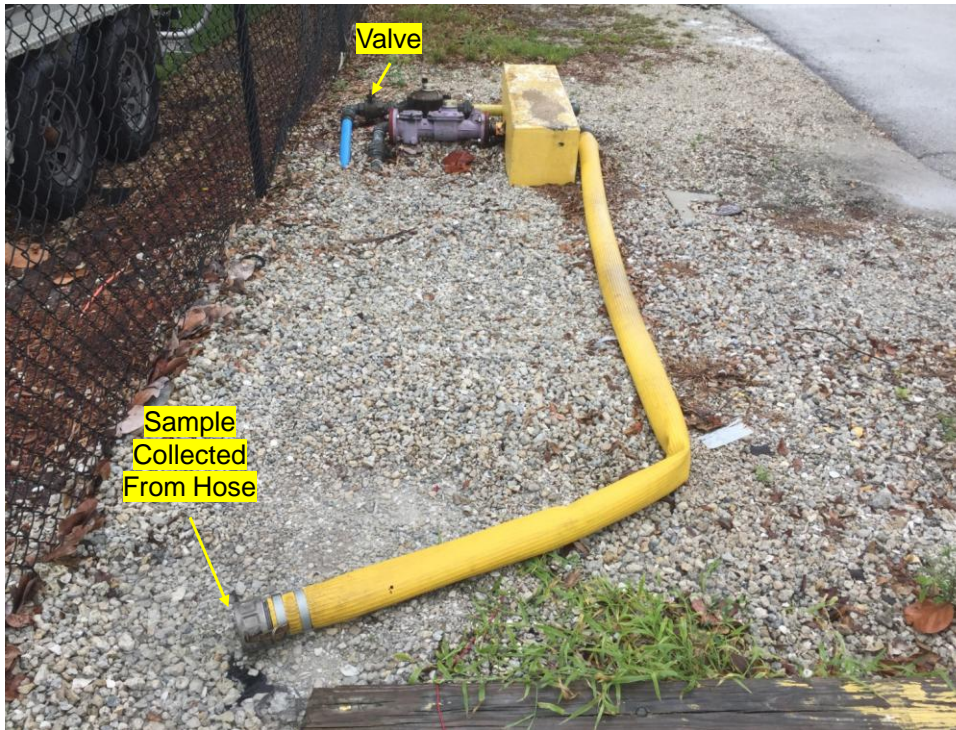
Figure 5-15.

Photograph of the Reuse
Monitoring Site.

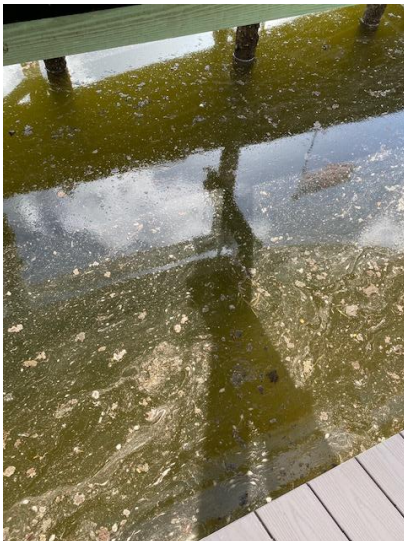
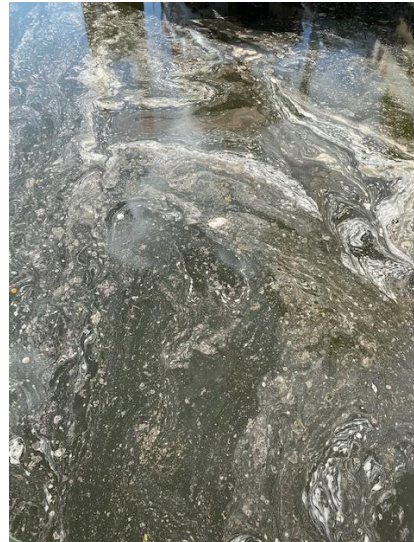
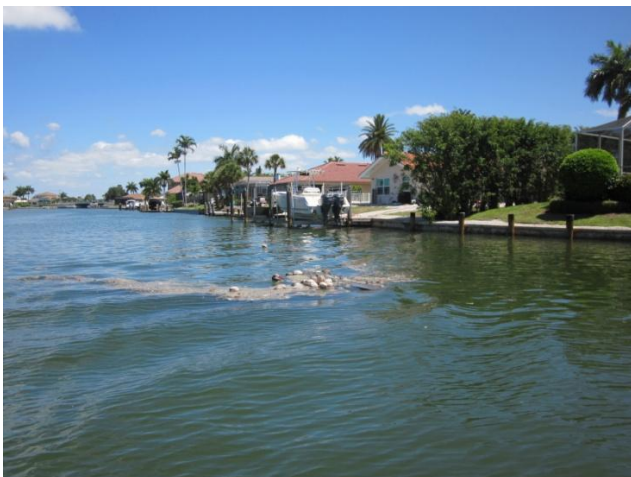
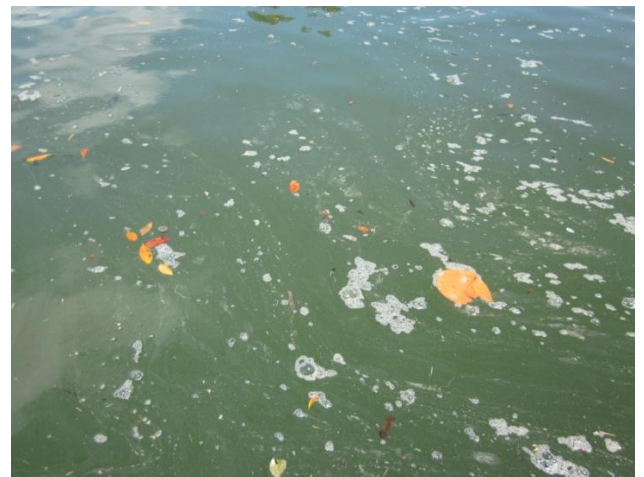
a. Photographs provided by area residents

b. Photographs taken by ERD

Figure 7-1. Photographs of Observed Water Quality Issues.

Photographs of canal water, taken by local residents and ERD field personnel, are shown on Figure 7-1. Each of these photographs illustrate water quality concerns from material floating on the surface, but the floating material is not necessarily related to excessive nutrients. Some of the photos appear to show surface scum from pollen, vegetation debris, and perhaps zooplankton which feed on algae, while the floating foam results from organic molecules generated by decomposition of organic matter. Photographs taken by ERD show floating patches of vegetation and grass clippings from on-shore areas. Each of these items tends to accumulate in undisturbed or stagnant areas near boat docks. This material is visually unaesthetic and should be addressed as part of a management plan, but this type of pollution originates from issues other than elevated nutrients and chlorophyll-a.

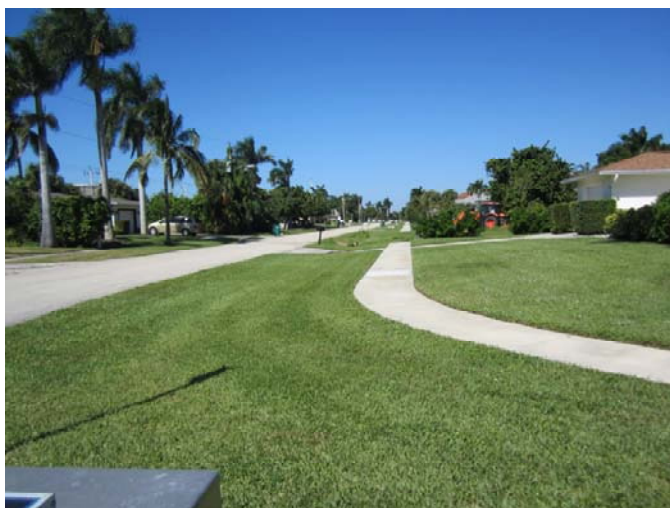
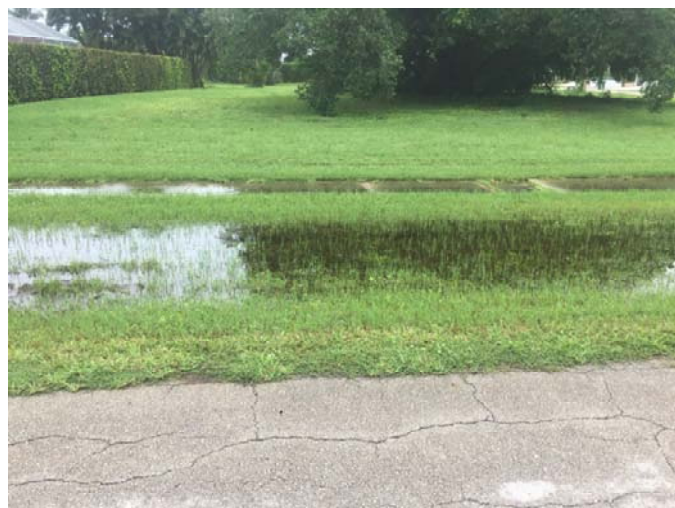
a. Swale system between storm events

b. Swale system during storm events

Figure 7-2. Typical Grassed Swale Systems Used at Marco Island.

The primary method of conveying runoff in Marco Island is through the extensive system of grassed swales used in virtually all areas except commercial and multi-family land use. Photographs of a typical swale system under dry and wet conditions are given in Figure 7-2. Swales provide extremely good pre-treatment for runoff by removing particulate matter and slightly reducing inorganic nitrogen. Swales have a tendency to become filled over time from accumulated particles present in runoff and adjacent streets, and maintenance of swales is critical to proper conveyance and runoff attenuation. Swales are often considered to be a Low Impact Development (LID) technique to reduce runoff impacts.
