MARCO ISLAND NUTRIENT SOURCE EVALUATION PROJECT

Final Report – September 2021

EXECUTIVE SUMMARY

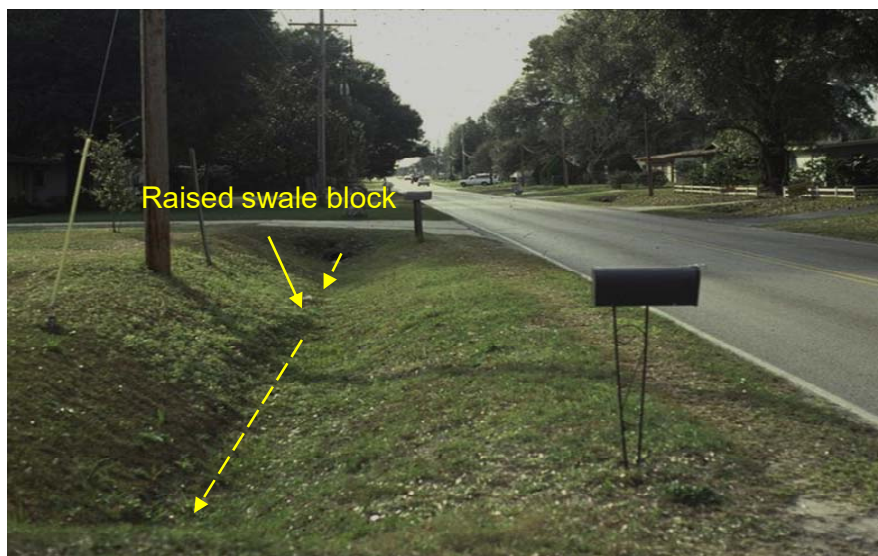
Figure 7-3.
Example of a Typical
Swale Block.

A photograph of a swale block installed in a swale drainage system in Orlando is given on Figure 7-3. The swale block was constructed at a height of approximately 12 inches but is hardly visible due to the sloping sides. Swale blocks can be constructed to accommodate virtually any swale configuration. The retained runoff receives filtration in the soil and reduces runoff loadings compared with runoff which discharges to tide.

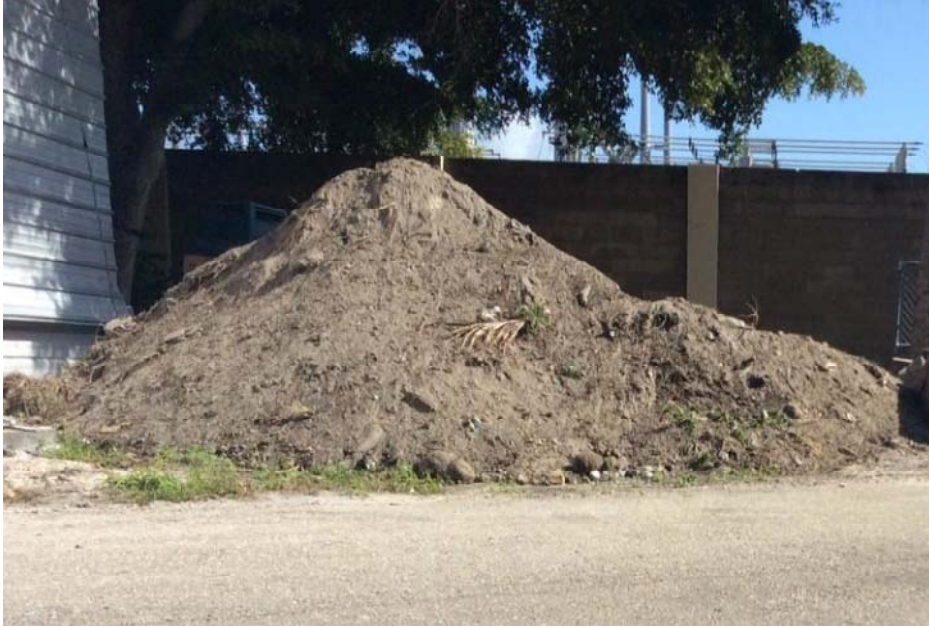
Solids Collected from Inlet Baskets by City Personnel.

The inlet baskets are maintained on an annual basis by the City Public Works Department using the City-owned vacuum truck and current staff. Annual maintenance includes replacement of the absorbent mat and removal of collected debris in the baskets. During 2016, the City removed 13,599 lbs of debris from the 1,324 inlets, with 8,000 lbs removed during 2017 and 13,560 lbs removed during 2018. A photograph of solids collected from the units by City personnel is given on Figure 7-7.

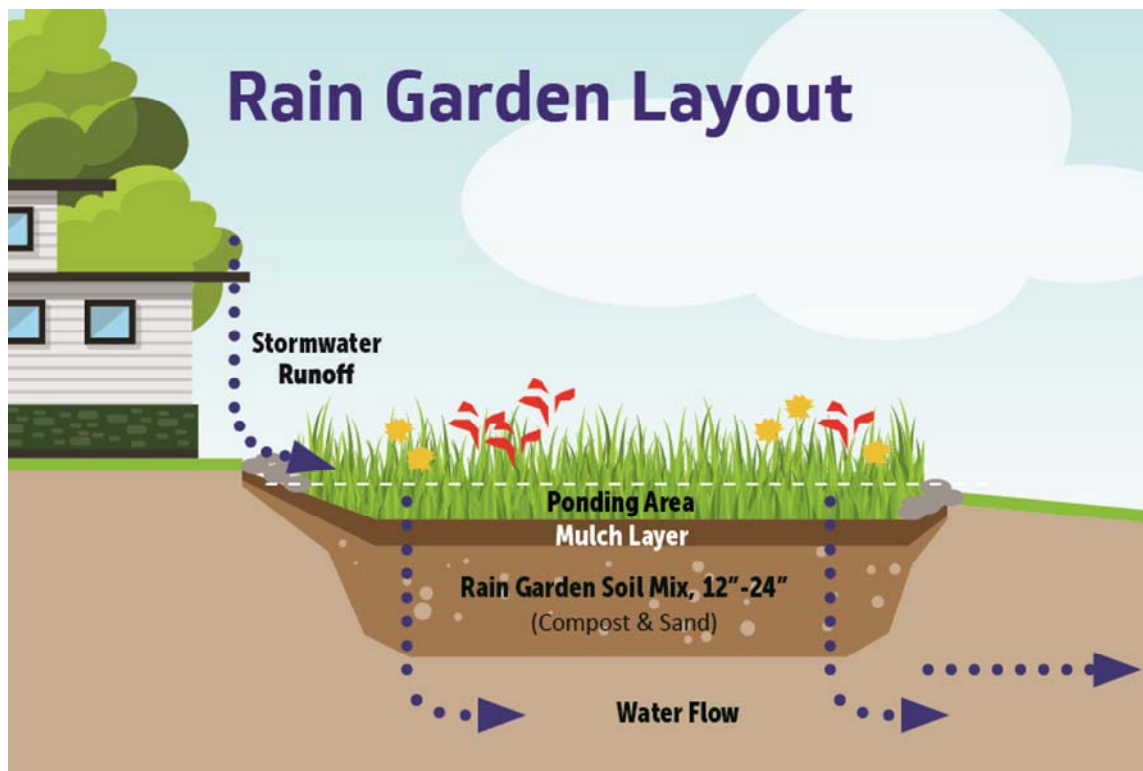
Figure 7-8. Typical Rain Garden Layout.

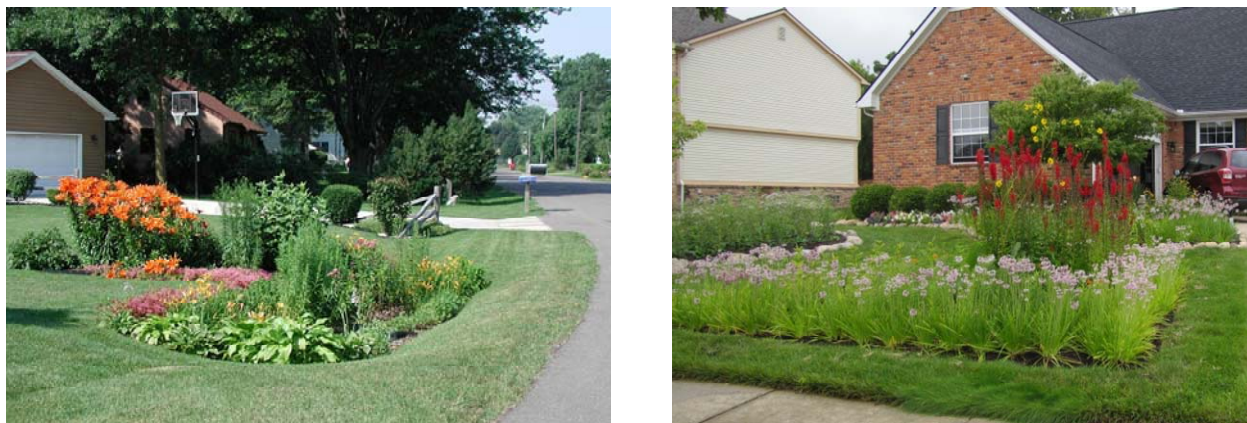
Figure 7-9. Photographs of Rain Gardens.

Rain gardens are a popular stormwater management technique, and design criteria for rain gardens are available from multiple sources. Photographs of rain gardens are provided in Figure 7-9. These systems would fit nicely into the existing landscaping themes currently used on Marco Island. The rain gardens should provide a volume capable of storing 1-inch of runoff over the contributing areas, including rooftops, which would achieve a removal efficiency of more than 85-90%.

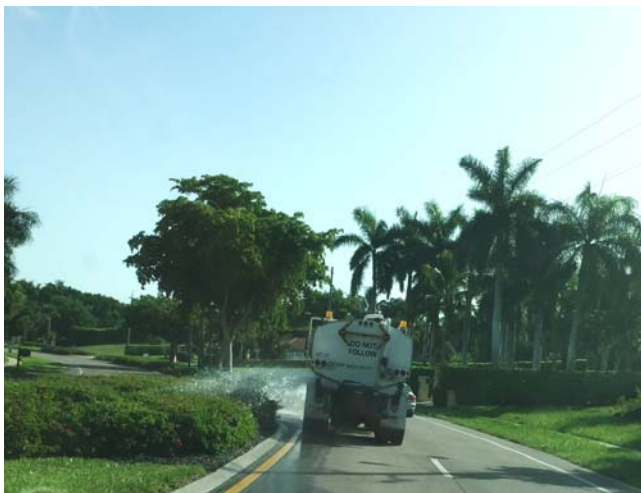
a. Median irrigation with reuse water

b. Overspray of reuse irrigation along Collier Blvd.

Figure 7-11. Reuse Water Applications.

During the field monitoring program, ERD observed multiple instances of application of reuse irrigation water which resulted in either overspray or direct runoff into stormsewer systems. Photographs of examples are given on Figure 7-11. Figure 7-11a was taken in Sub-basin 5 showing a City water truck using reuse water to irrigate the landscaped median, and water flowing onto the roadway surface is clearly visible. The photograph on Figure 7-11b was taken on April 29, 2020 at approximately midnight on Collier Blvd. During this event, much of the roadway surface was wet and irrigation water was visibly running along the gutters into the stormsewer system. Even if the excess irrigation water does not enter the stormsewer system, it dries on the roadway surface and the nutrients are available for transport with the next rain event.

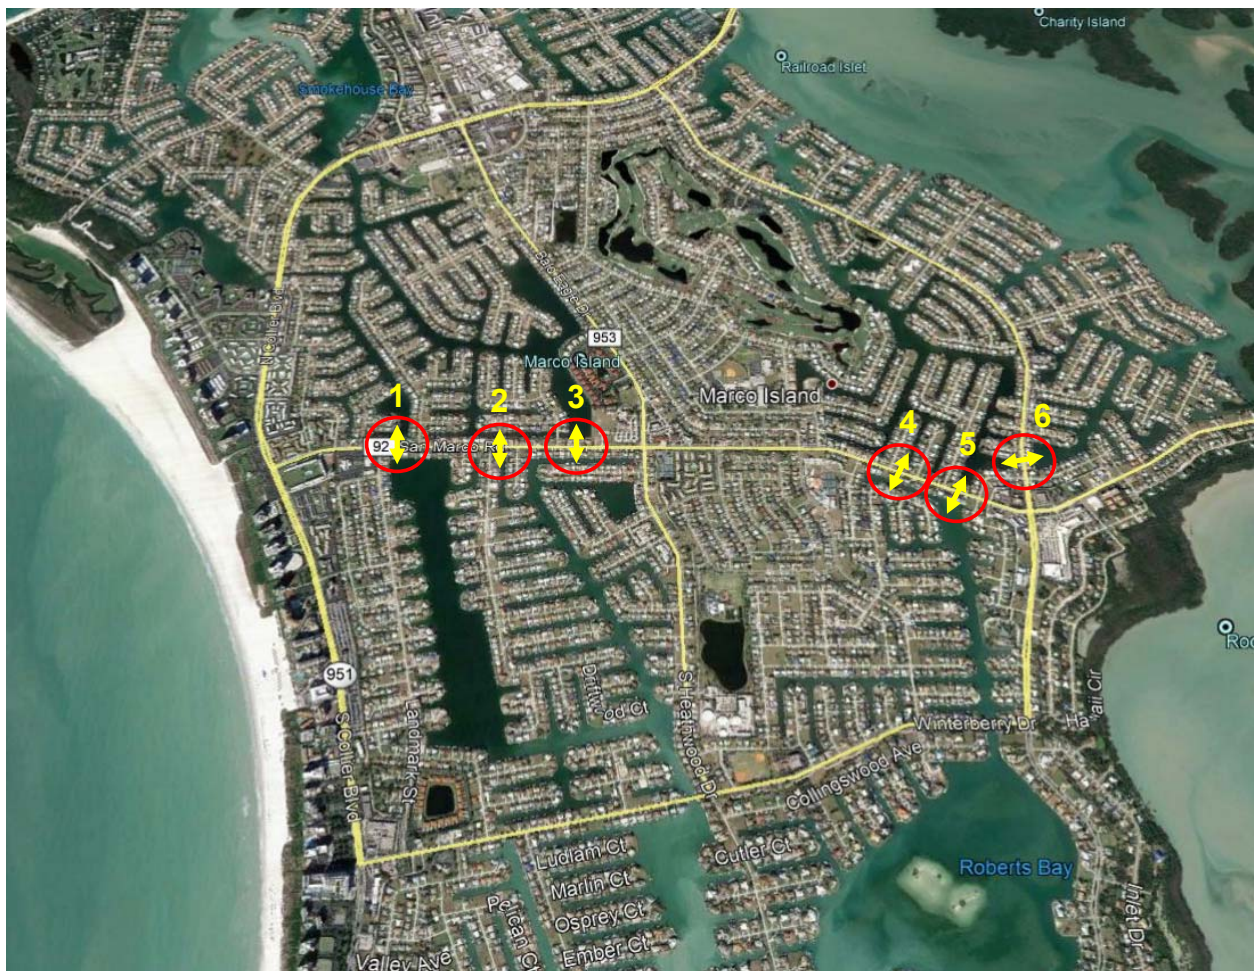
Figure 7-12. Proposed Area Options for Recirculation Improvements.

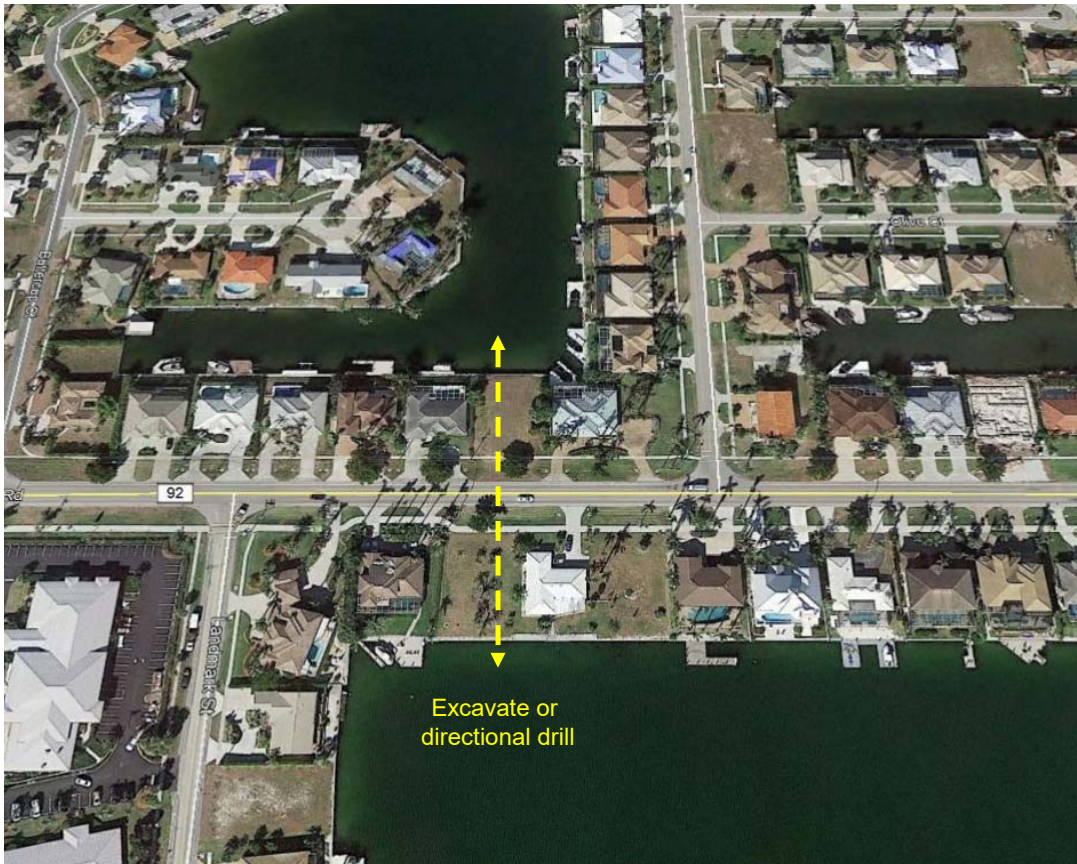
Figure 7-13.
Proposed Location
for Site 1
Interconnection.

The most obvious option to improve recirculation in the canals is to install new, replacement, or supplemental culvert connections between areas of good and poor flushing. Locations of potential sites for installation of flushing culverts are indicated on Figure 7-12, with 3 locations for each of the west and east side systems. A potential location for an interconnection at Site 1 on Figure 7-12 is given on Figure 7-13. Both the northern and southern canals are quite stagnant, and an interconnection at the location indicated would allow water to freely exchange between the 2 and possibly introduce cleaner water from tidal sources. Most culverts would need to be installed by horizontal directional drilling (HDD), but if the open lots in the photo are still undeveloped, the culvert could possibly be installed by open cut excavation. Any piping placed in the ground would need to be able to physically support future development.
