City of Marco Island

# Seawall Owner's Manual

Waterways Advisory Committee

April 2014

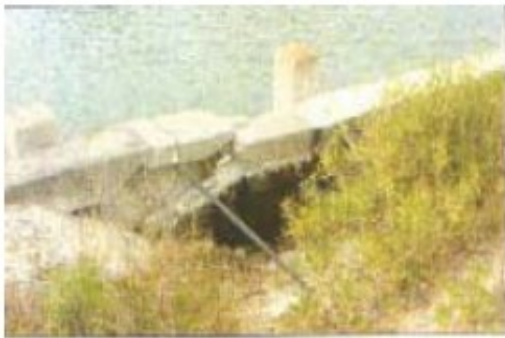
The backfill leaking through the wall creates a sinkhole on the land side of the seawall.

**Cause:** Age, settling, structural failure or perhaps insufficient berm at the slab toe of the wall. Slabs move apart vertically and horizontally, allowing backfill to migrate through the openings into the water, and salt water to enter behind the wall. Uneven hydrostatic pressure is exerted on the slabs, particularly at low tide. This may be critical during heavy rain and low tide conditions.

**Symptoms:** Sinkholes behind the wall, visible seawall back-fill in the water on the canal side seawall joints (most visible at low tide). Rust on the cap or slabs would also indicate corrosion from salt water.

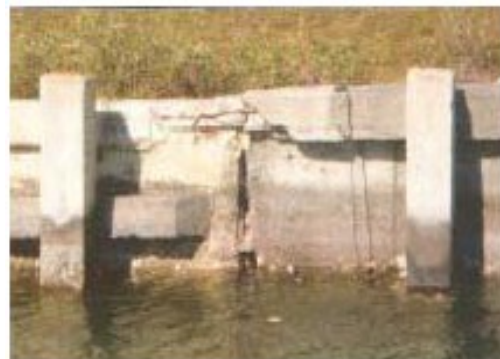
The canal side of the same seawall shows a wide separation between slabs. More backfill is washed away from the fill side daily as the tide flows in & out through the separation.

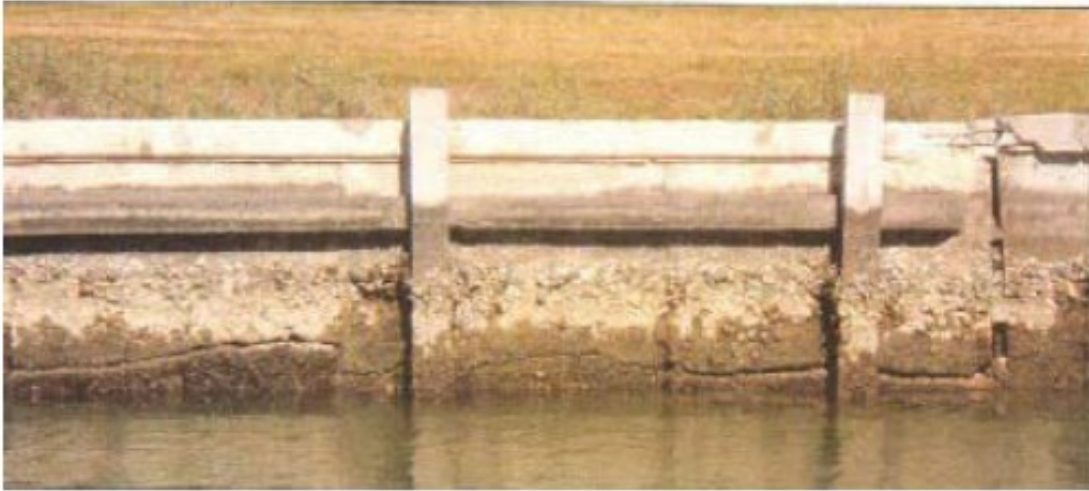
Note the horizontal crack just above the water line and the wide gap between slabs at the right. Concrete pilings have been driven in to attempt to stabilize the wall.

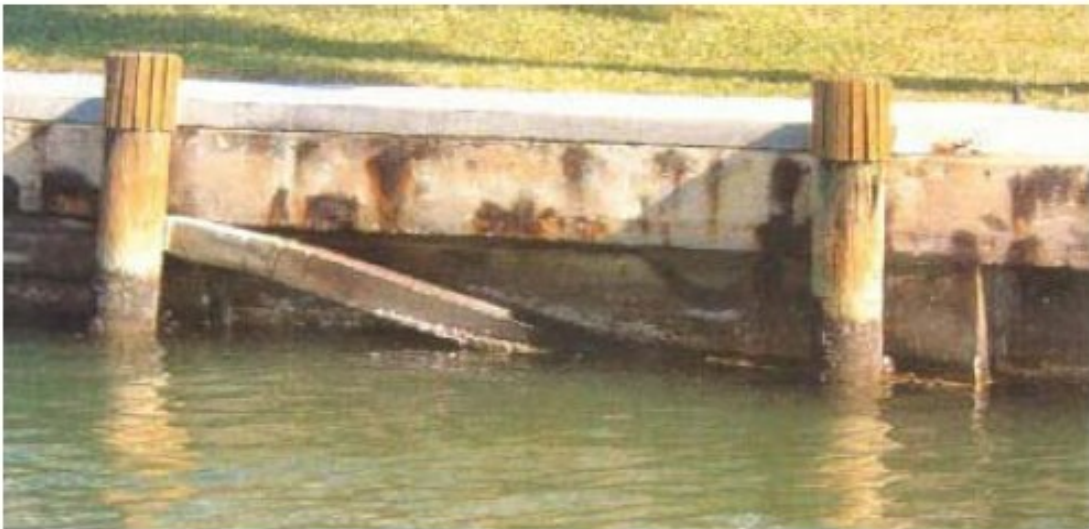
The tie-back rods to the reinforced concrete wall have rusted through and the unsupported wall is useless and falling into the water.

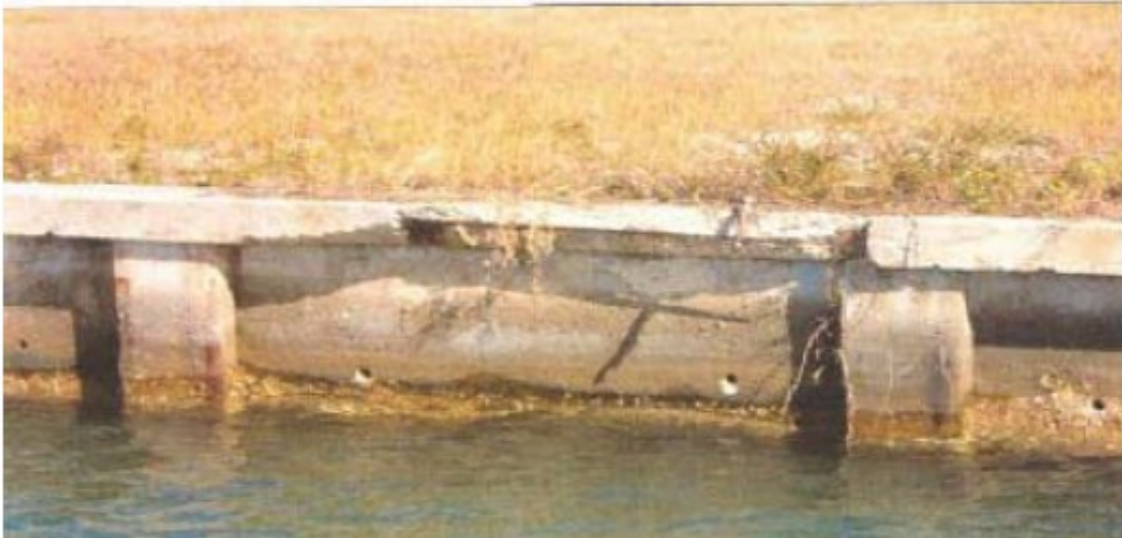
The concrete cap on this seawall has failed. As the cap comes apart tie-back rods will have no anchor point. Also, without a solid cap there will be nothing to hold the vertical walls in alignment.

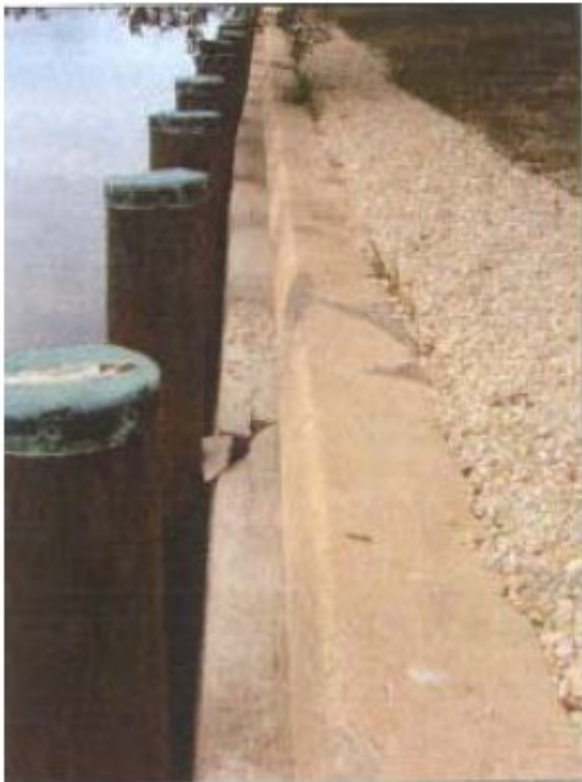
Note the tipped cap on this seawall. The berm has failed and the toe has moved out toward the canal tipping the whole structure. The pilings are the only thing retaining the toe of the wall. The concrete waler is also starting to fail

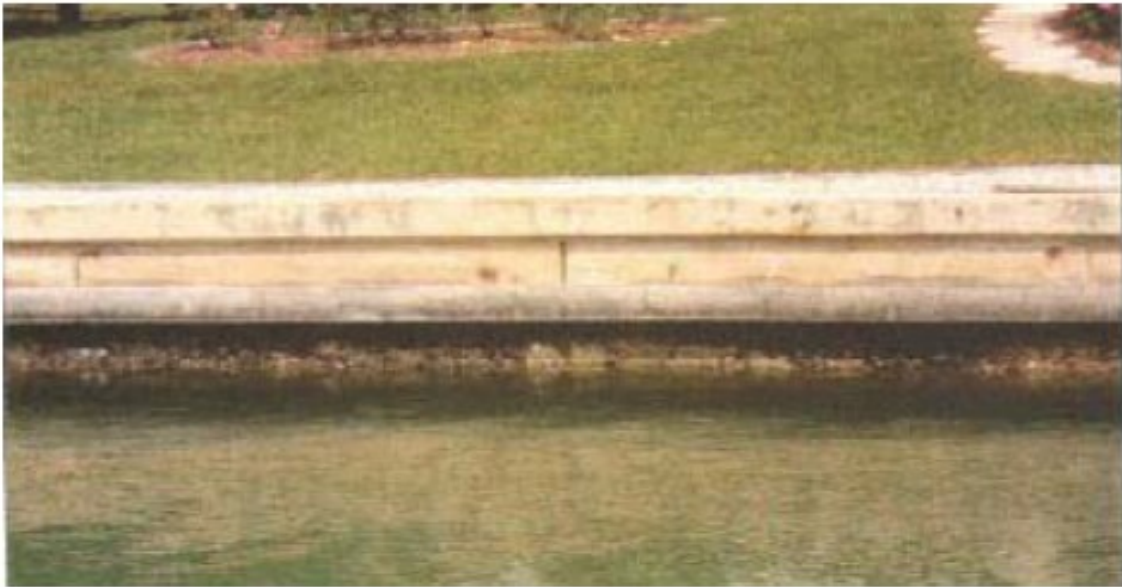
A waler is installed about 2 ft. below the seawall cap. The waler is a reinforced concrete beam which is connected to tie-back rods anchored to deadman. A waler is usually added as reinforcement when it is suspected the original tie-back rods to the cap have rusted through.

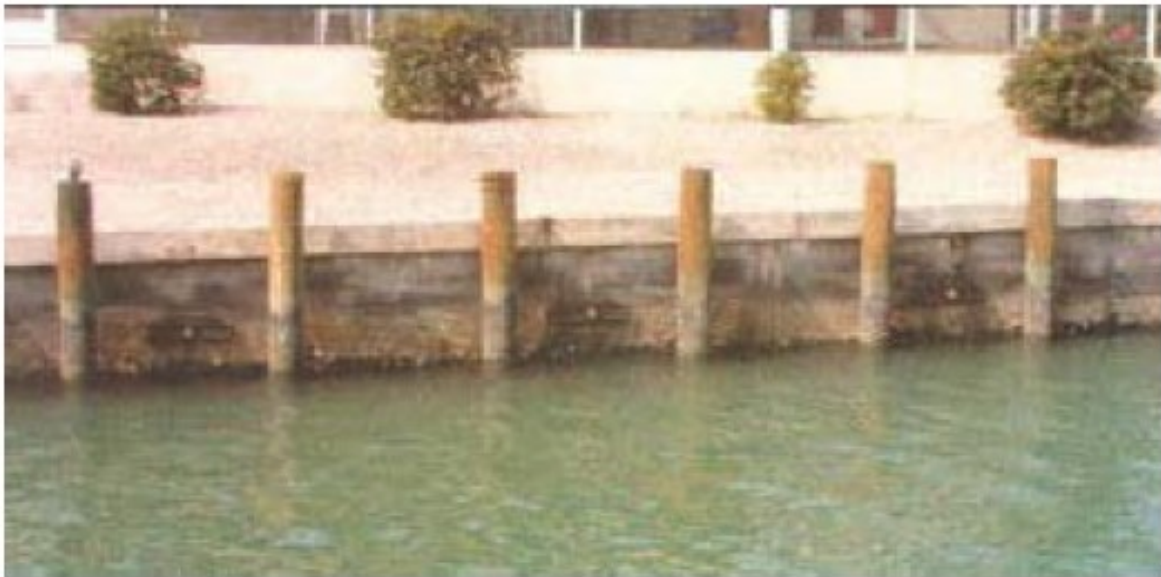
Wood pilings are also used for stabilization. This seawall also has galvanized steel channels just above water level which are anchored to the deadman in the same manner as a waler.

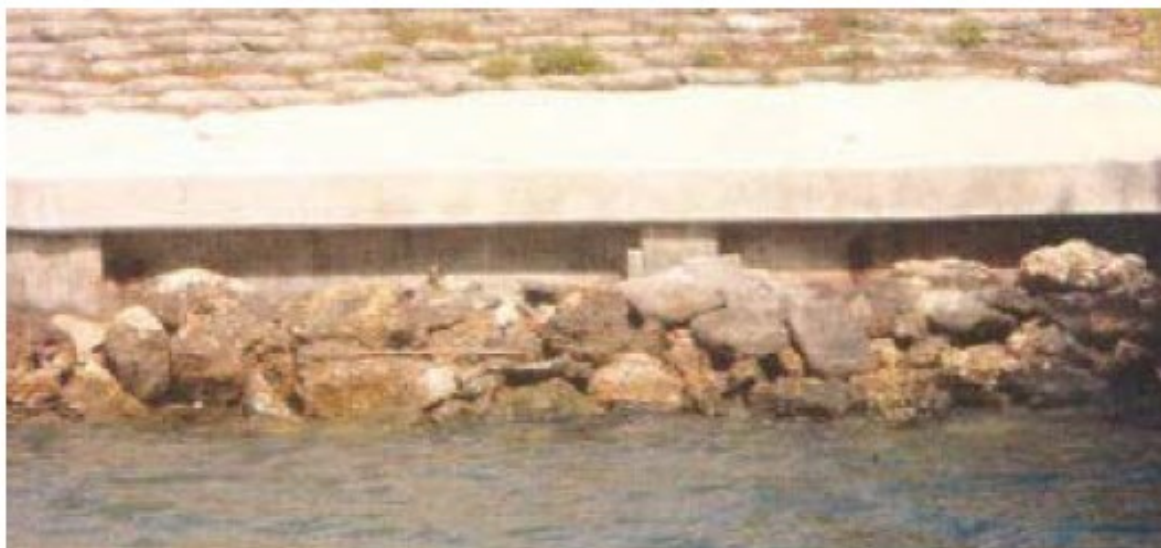
Rip-Rap (stone piled against the seawall) is particularly useful in areas of high tidal velocity to keep berm from washing away. The negative of Rip-Rap is that it extends out from the wall and can hamper boat docking unless there is a dock extending out over the Rip-Rap.
