Seawall Manual

City of Marco Island

Prepared By:
Waterways Advisory Committee
May 2018

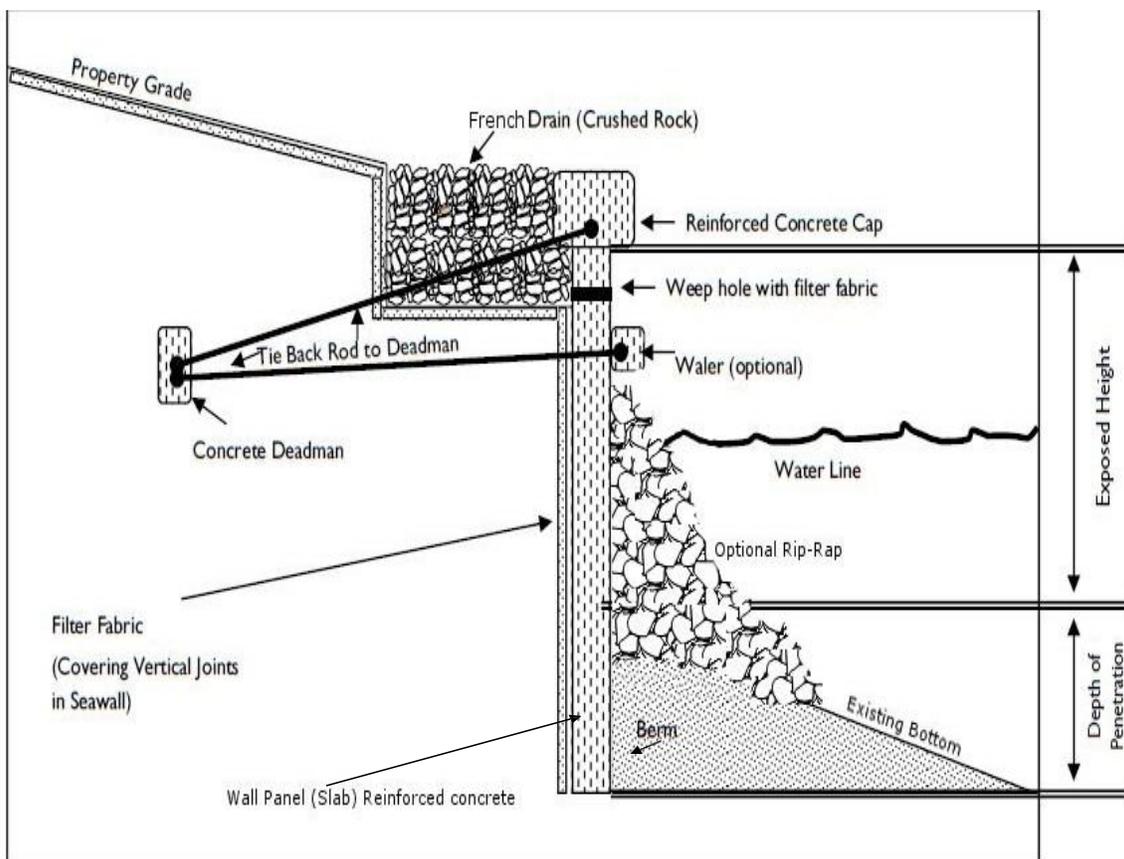
TYPICAL SEAWALL AND COMPONENTS

To help visualize the seawall structure, an illustration, modeled on the Collier County and City of Marco Island seawall ordinances, is included below.

An essential point to remember is that our seawalls are intended to keep “land in” rather than the “water out”. A seawall is actually not one unit; rather it is designed and constructed from a number of distinct components such as panels, cap, tieback rods, and deadmen.

Generally, a seawall consists of a series of interlocked panels (concrete, composite, PVC, metal) that are not watertight. A cap (usually concrete) ties individual panels together. The panels extend vertically from below the water floor (berm) to above the land elevation. Traditional construction methods include tie-back rods that anchor the vertical structure to concrete blocks call deadmen which are embedded in the landside soil.

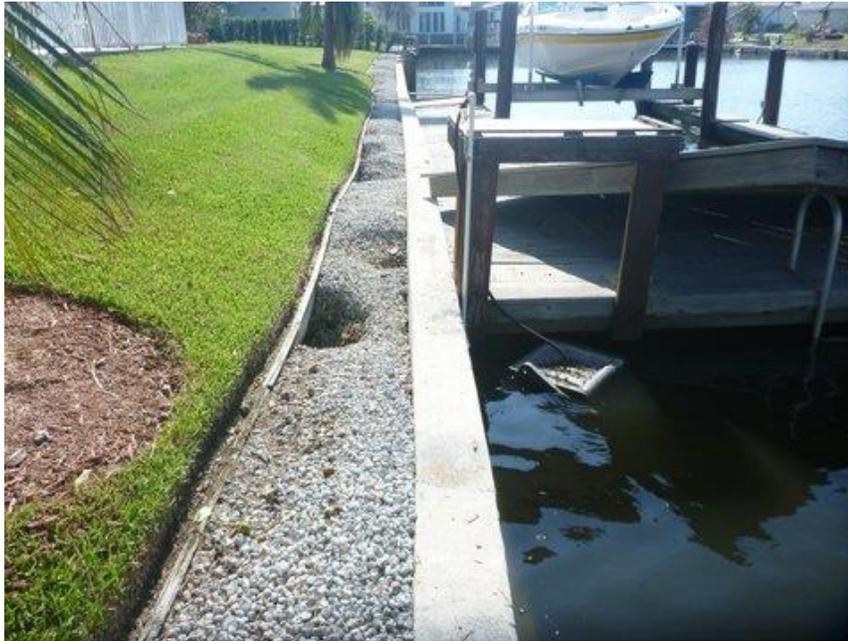
SINKHOLES:

Symptoms: Sinkholes upland of the wall, visible back-fill mounds in the water near seawall joints (most visible at low tide)

Cause: Age, settling, structural failure, insufficient berm at the slab toe of the wall. Slab separation allowing backfill to migrate through openings into the water. Frequently occur after heavy rains.

Remedies: Replenish or add rock to the French Drains if fill loss is excessive. Installation of a French Drain may be appropriate if not already present. Maintain water passage through weep holes by cleaning or add supplemental drainage. Add filter fabric to vertical slab joints. If berm is lacking at the slab bottoms, may require replenishment.

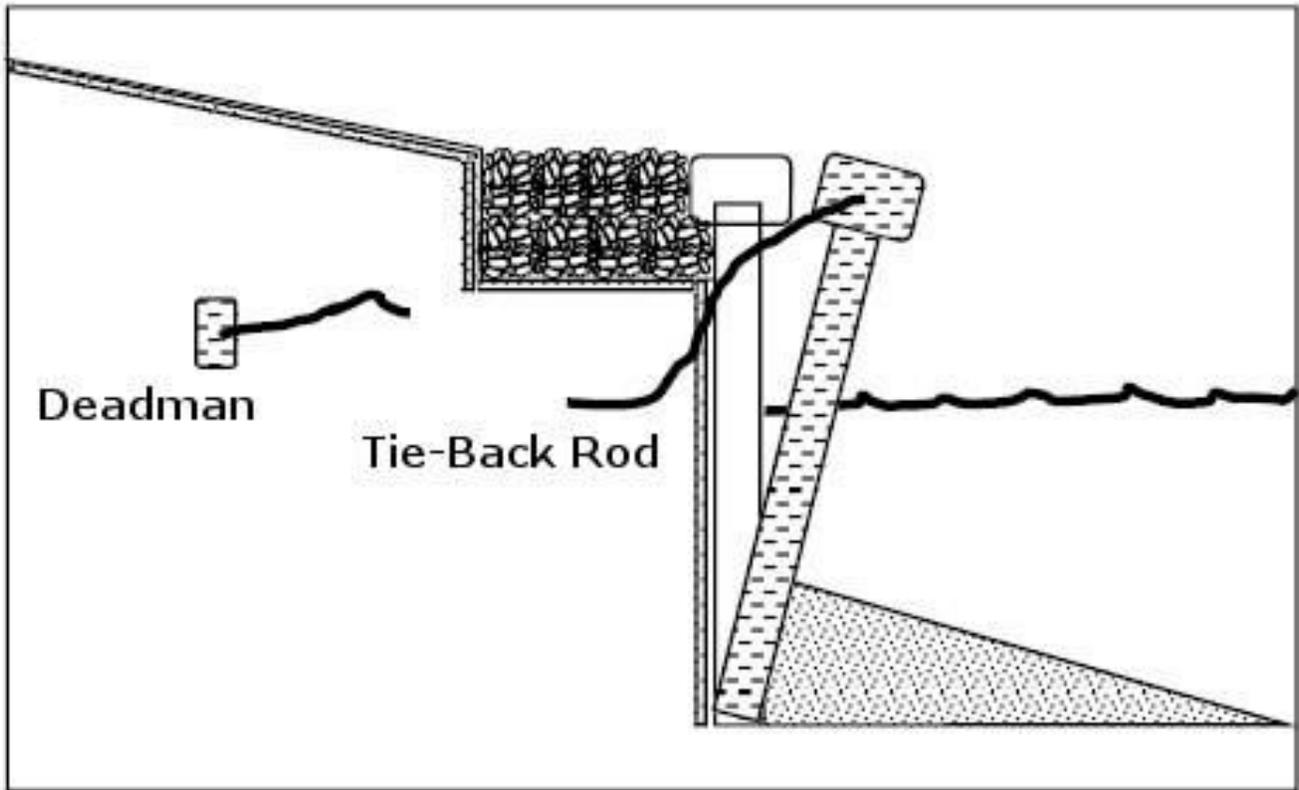
TIEBACK FAILURE

Symptoms: A deteriorating cap, wavy or sagging panels, cracks / spalling and backfill settlement.

Cause: This is the result of salt water corrosion and oxidation in the cap reinforcing or tie-back rods. It could also stem from movement of the structure. The results are upper rotation, cracking or crumbling of the concrete cap and its ability to keep the slabs aligned, and/or the slabs moving out of vertical (plumb).

Remedies: If tie-back rods are heavily corroded, excavation may be necessary for their replacement and integration into a newly poured cap. On many older seawalls, owners faced with tieback rod failure have installed a new set of tie-back rods and a waler -- a concrete structure that runs the length of the seawall about 2' below the top on the water side of the panels. Supplemental helical tiebacks are also a common remedy.

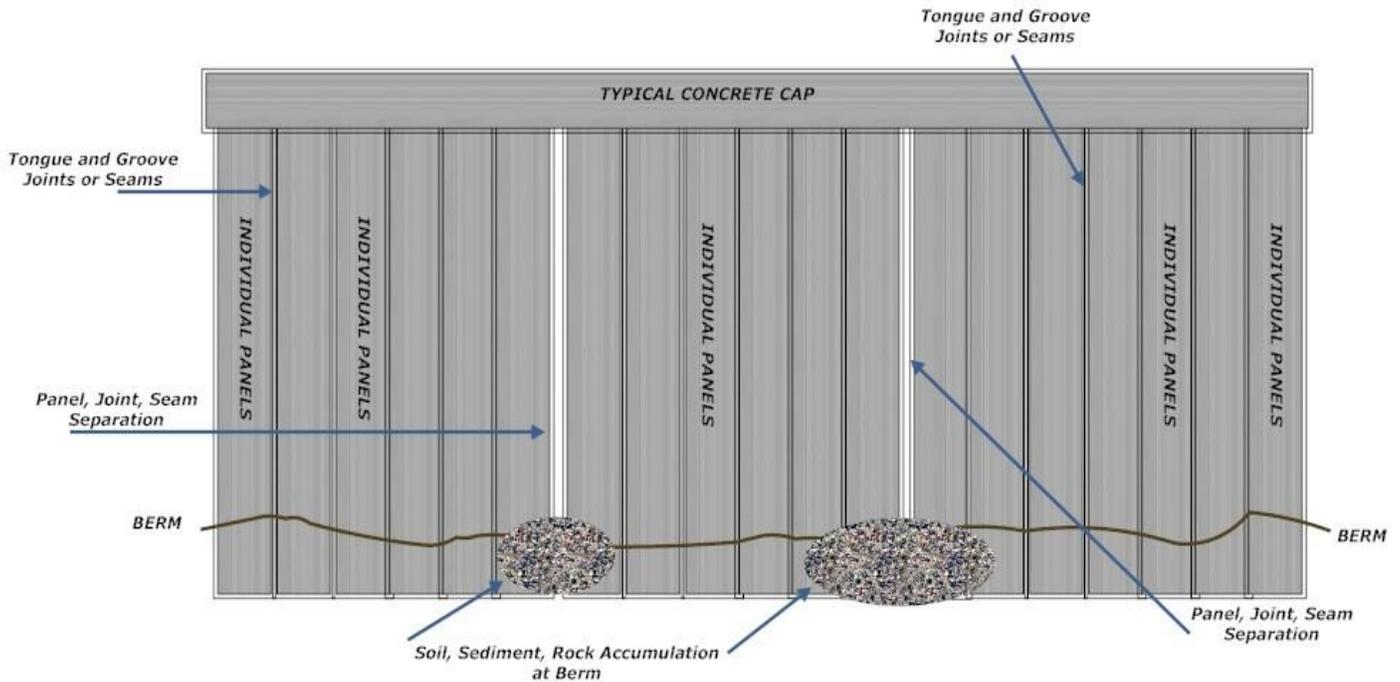
SLAB JOINT (SEAM) SEPARATION

Symptoms: Sinkholes, separation in seams, accumulation of rock and sediment at base of affected joint.

Cause: Age, uneven exertion of hydrostatic pressure particularly during low tide. Tieback failures.

Remedies: Seal seams and cracks, install filter fabric, install supplemental tiebacks (traditional or helical) for additional support in crack areas. Ensure proper drainage and relief of hydrostatic pressure. To the extent possible, route storm water away from the seawall.

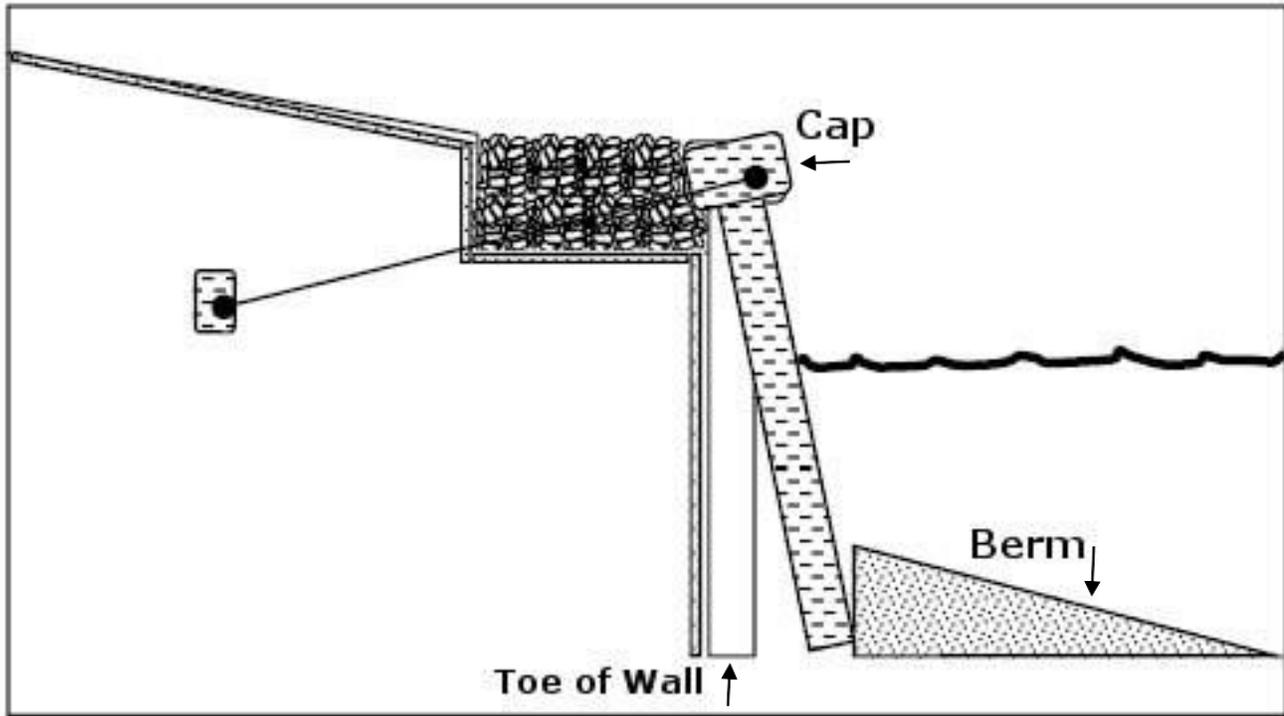
TOE & BERM FAILURE

Symptoms: Cap rotation, movement or cracking, a gap opening between seawall and dock (if present), and support pilings (if present) tight against the seawall indicating pressure on the structure from the failure.

Cause: Loss of supporting berm at the bottom of the slabs in the water. The panels tilt out, and sometimes crack or cause the cap to twist or break. Loss of berm is usually associated with wave action, either natural or from speeding boats. Insufficient panel penetration and /or improper placement in the berm may be the cause of such failures as well.

Remedies: Placement of additional berm, rip-rap or bags of dry concrete mix to stabilize the bottom of the structure if the toe-out is not too severe. In severe cases, the panels may be pulled and replaced, or reinserted if not badly damaged. If pilings are present along the seawall perimeter, dry concrete bags wedged between the piling and the wall may help.

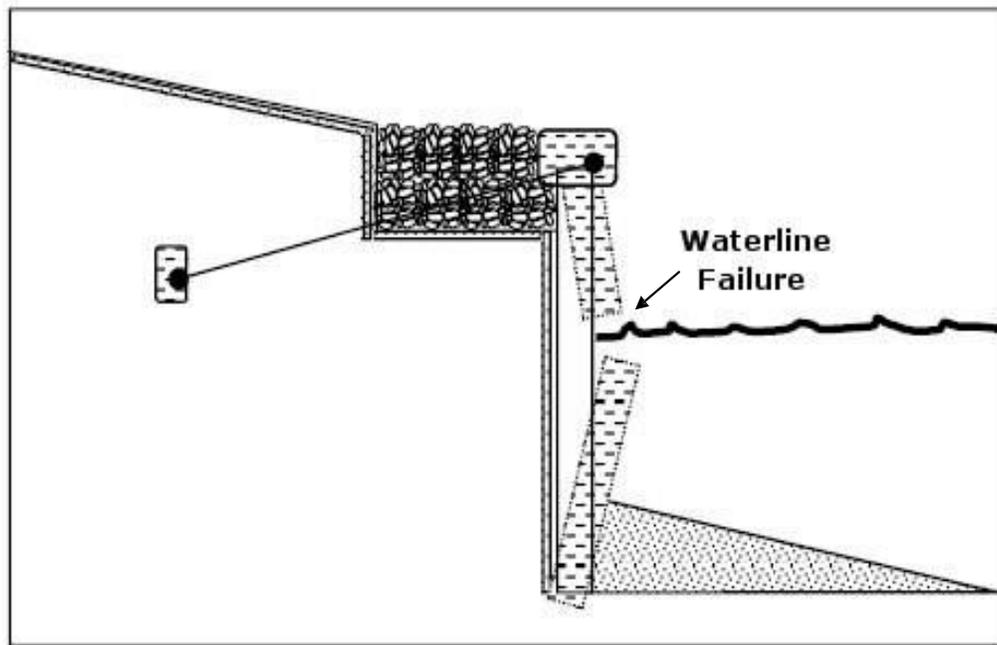
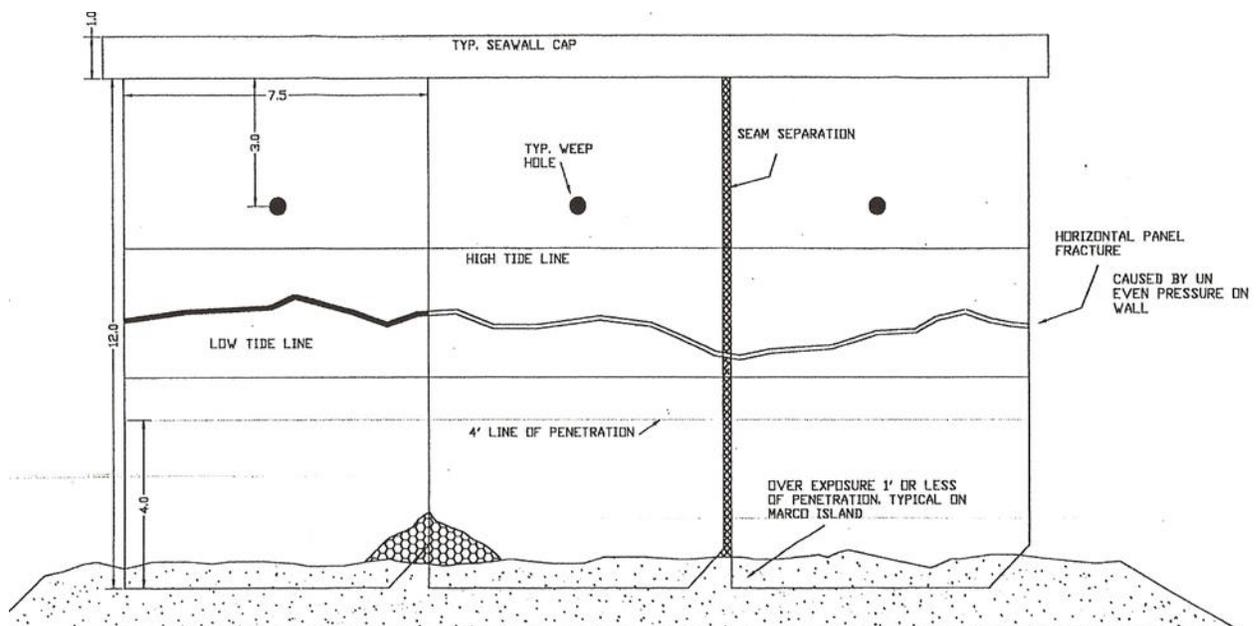
WATERLINE FAILURE

Symptoms: The principal symptom is cracking with rust marks on the panels facing the water.

Cause: Aging, corrosion of concrete and reinforcing rod and uneven hydrostatic pressure. Slabs or panels develop horizontal cracks usually along the water line, and the panels eventually break along these lines.

Remedies: Replace affected panels if possible. Potential for helical tieback usage.

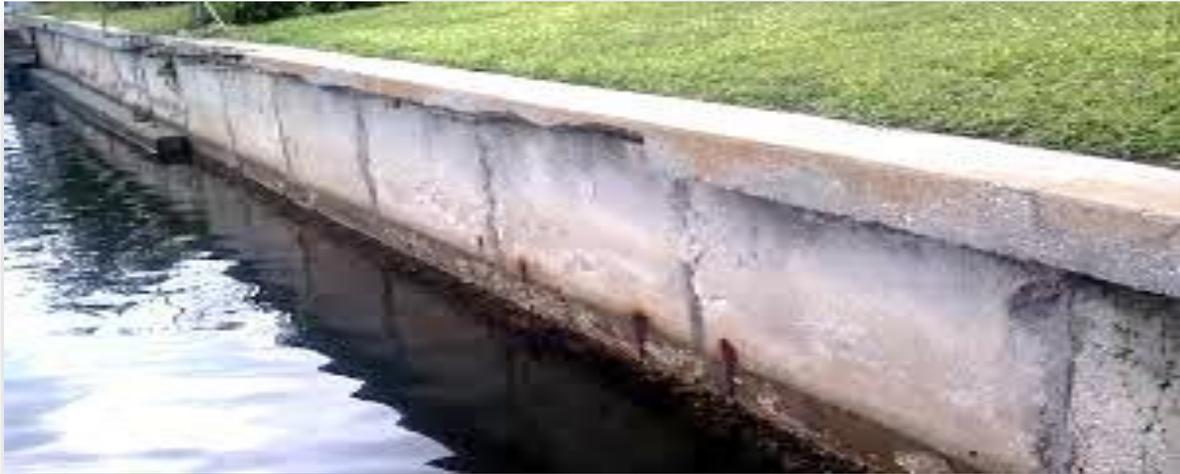
CAP FAILURE

Symptoms: The principal symptom is rust, spalling, exposed rebar, fractures.

Cause: Aging, corrosion of concrete and reinforcing rod and uneven hydrostatic pressure. Slabs or panels develop horizontal cracks usually along the water line, and the panels eventually break along these lines.

Remedies: Partial or full cap replacement.

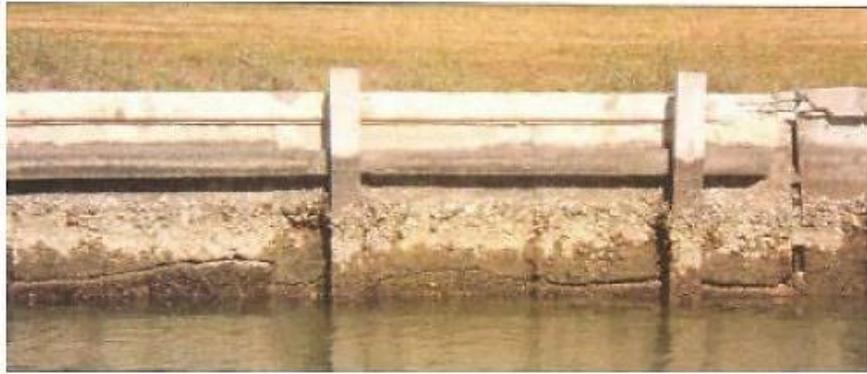
Note the horizontal crack just above the water line and the wide gap between slabs at the right. Concrete pilings have been driven to attempt to stabilize the wall.

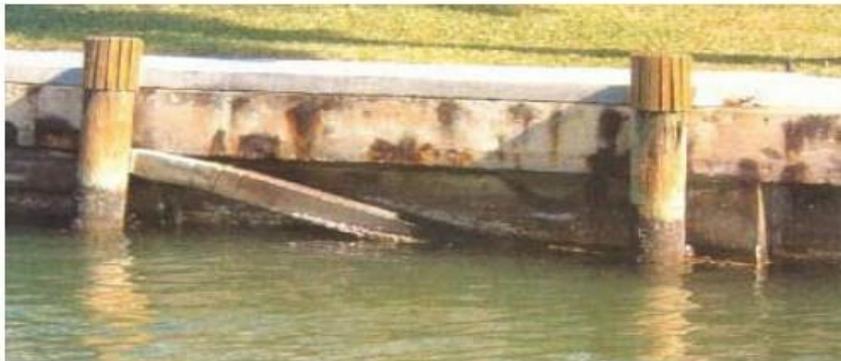
The tieback rods to the reinforced concrete wall have rusted through and the unsupported wall is useless and falling into the water.

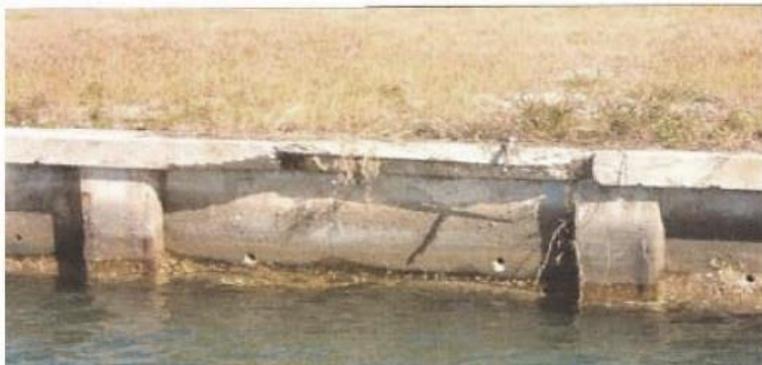
The concrete cap on this seawall has failed. As the cap comes apart, tie-back rods will have no anchor point. Without a solid cap there will be nothing to hold the vertical walls in alignment

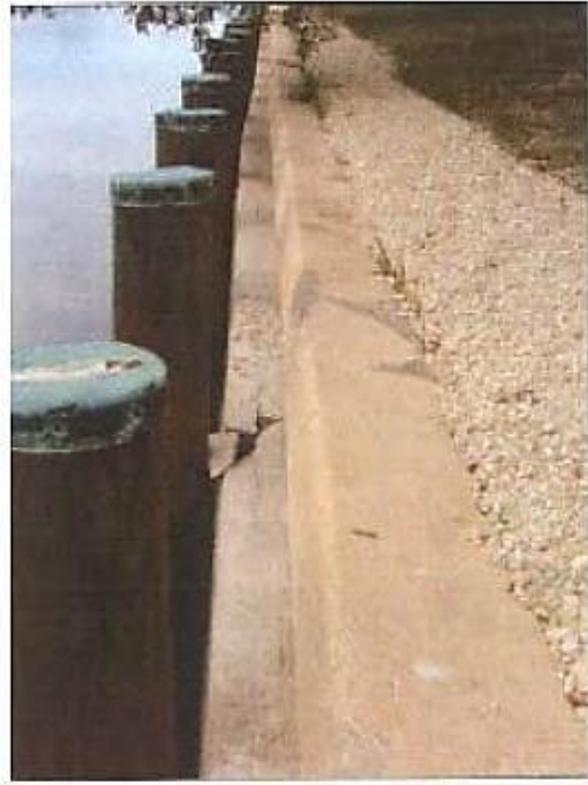
Note the back-leaning cap on this seawall. The berm has failed and the toe has moved out toward the canal tipping the whole structure. The piling are the only component retaining the toe of the wall. The concrete waler is also starting to fail.

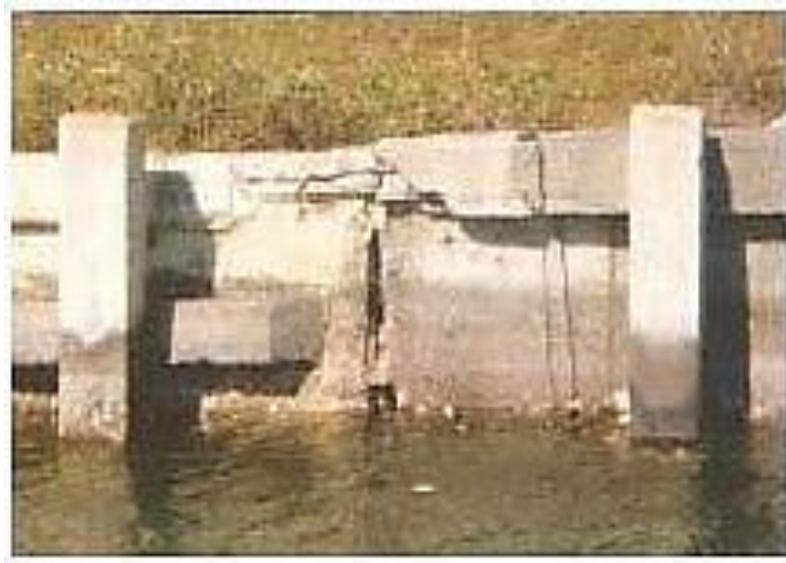
Note the extreme slab joint (seam) separation visible in this photograph taken at the property line. Rock and soil from behind the wall will be washed out from between the panels with wave and tidal action. Heavy rain will also contribute to erosion. Advanced cap deterioration is plainly visible. Concrete piling have been placed in front of the waler to attempt stabilization.

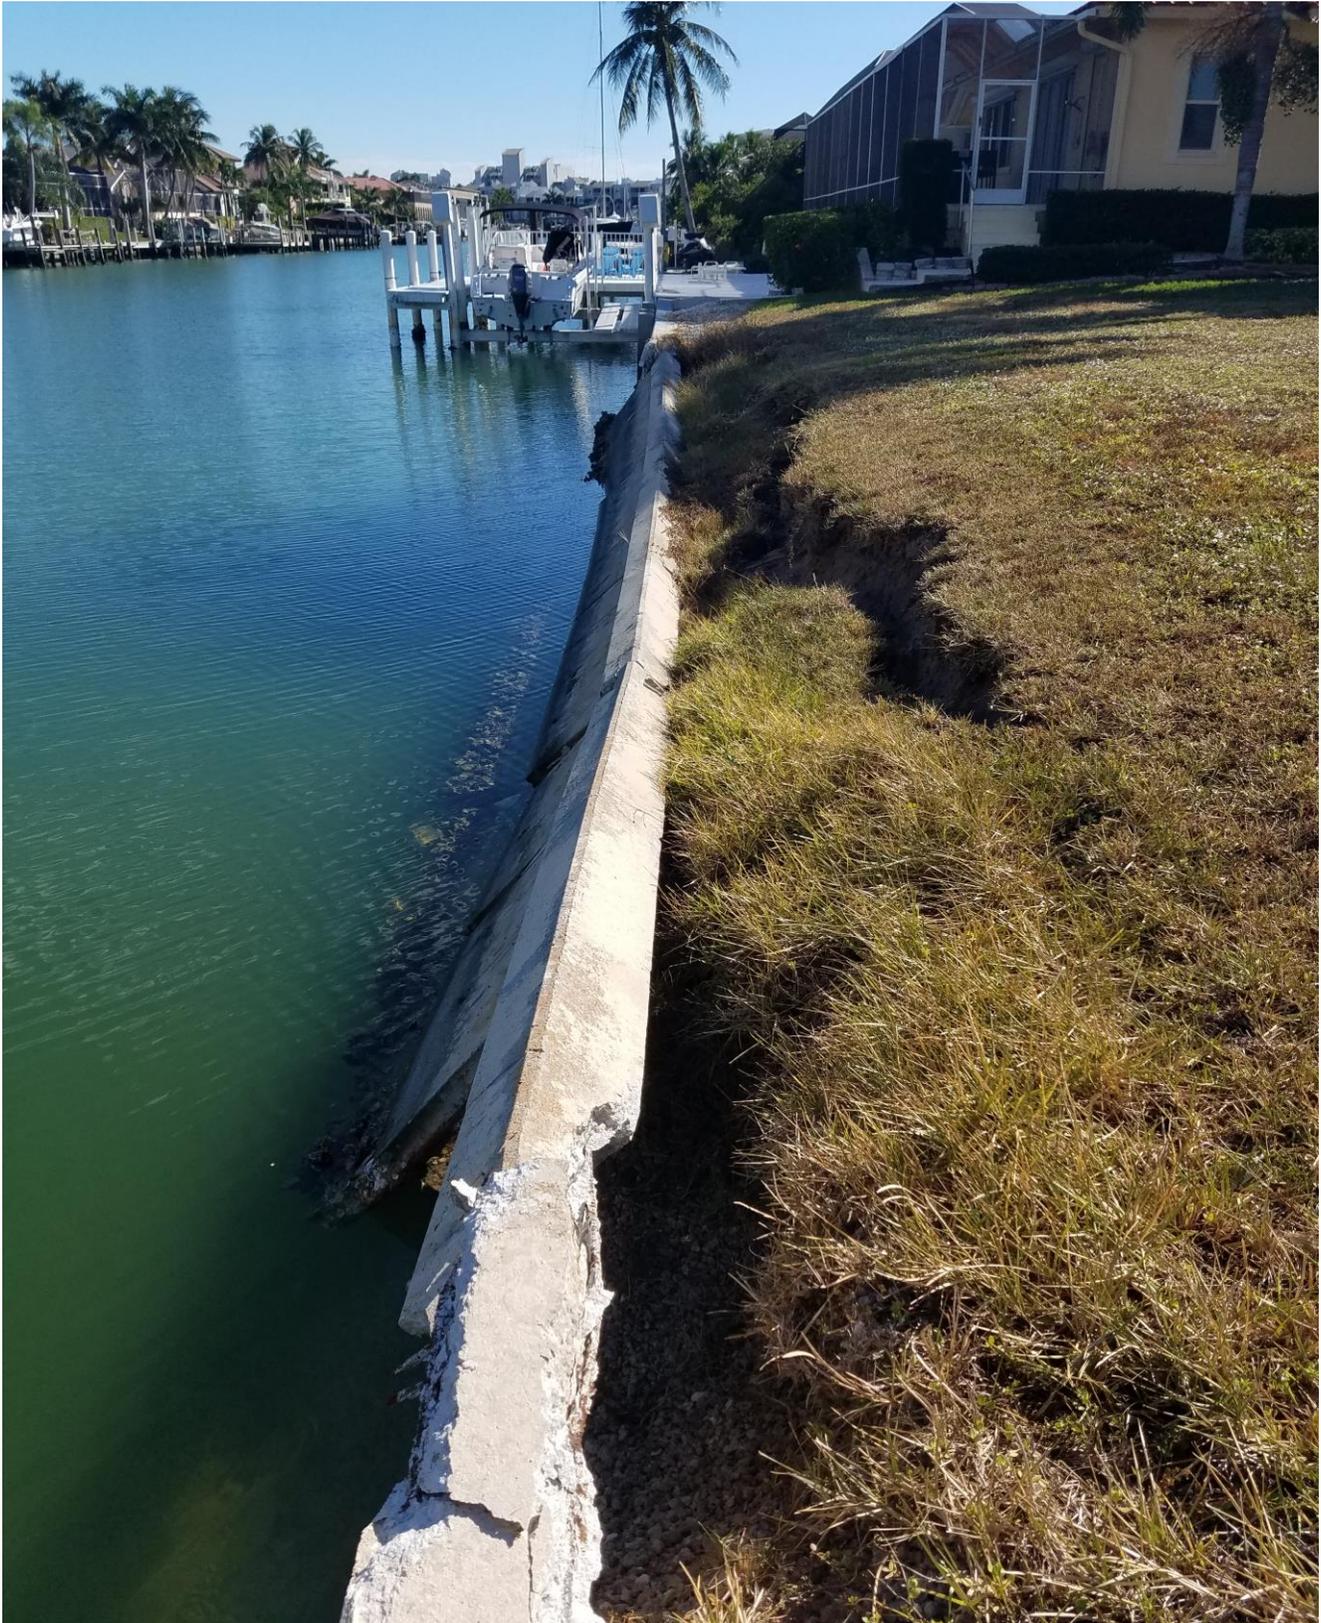
Berm failure (insufficient panel penetration during installation or scouring of berm due to tidal action) has caused the seawall to kick-out. Complete replacement of the seawall is necessary.

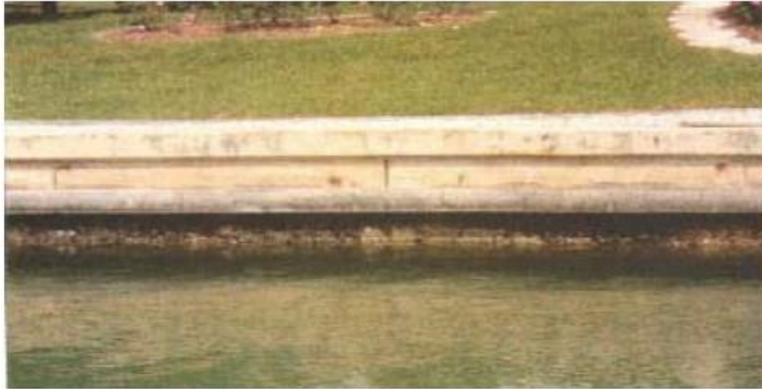
A waler is installed about 2 ft. below the seawall cap. The waler is a horizontally placed reinforced concrete beam which is connected to tie-back rods anchored to deadman. A waler is usually added as reinforcement when it is suspected that the original tie-back rods to the cap have rusted-through.

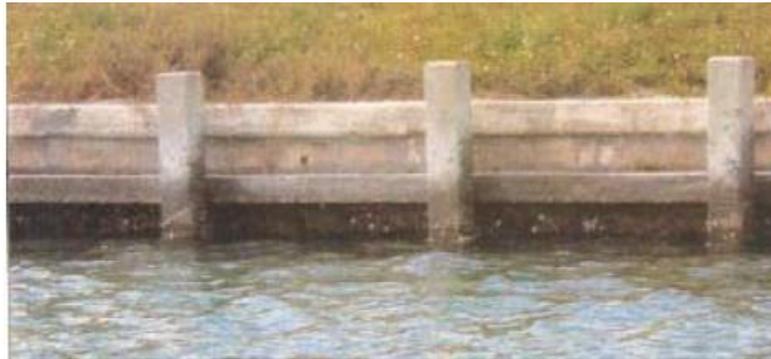
This seawall has a waler plus concrete pilings driven into the canal bottom for extra support. The pilings help stabilize the wall to keep the toe of the wall from moving out.

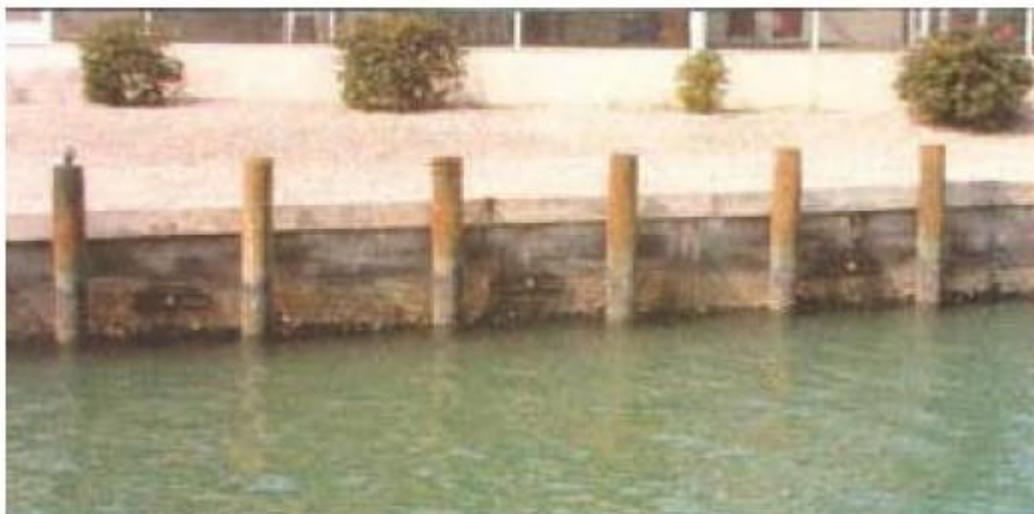
Wooden pilings are also used for stabilization. This seawall also has galvanized steel channels just above the water level which are anchored to the deadmen in the same manner as a waler.

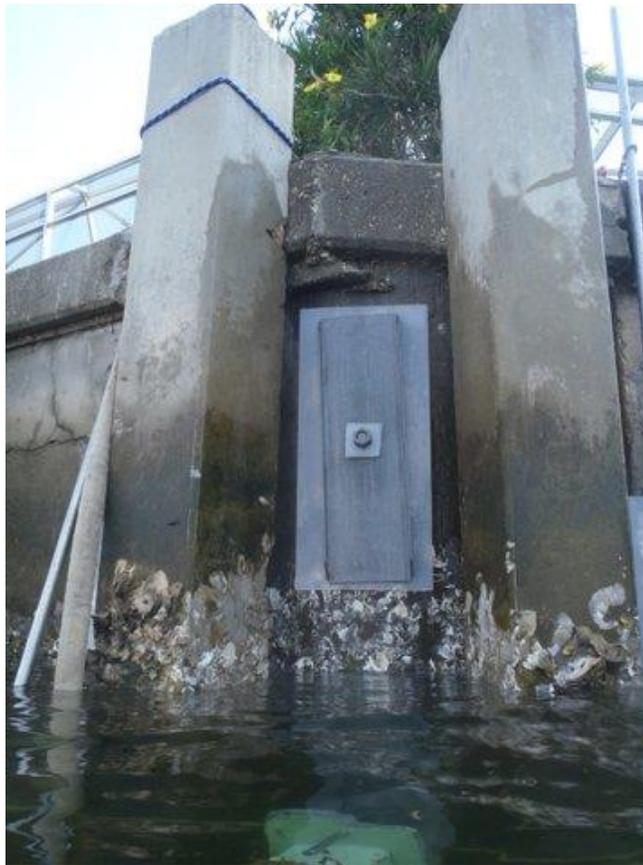
Supplemental tieback example – in this case, a helical tieback installed at corner point with vertical flange. The actual tieback is a solid rod with helices driven 14-21 feet into the ground at a specified angle.

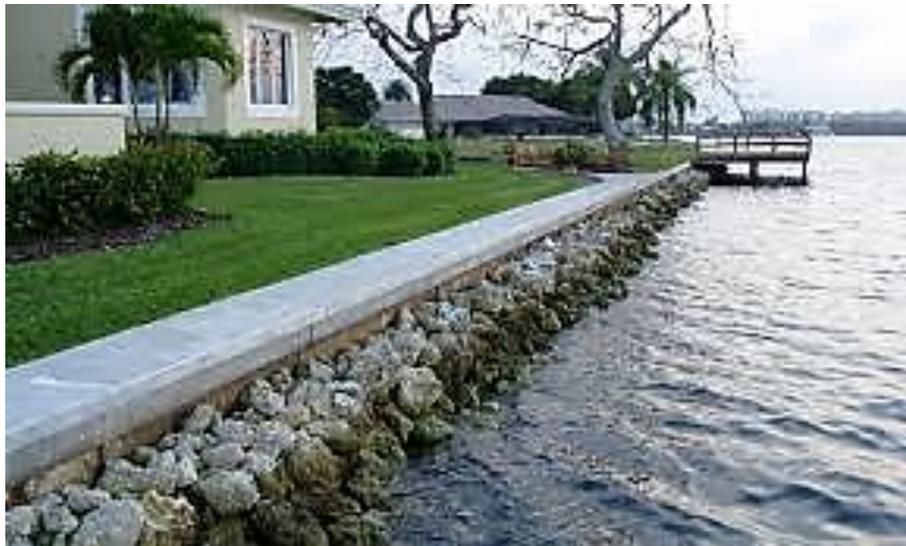
Rip-Rap (stone piled against the seawall) is particularly useful in areas of high tidal velocity to keep berm from washing away. Unfortunately, rip-rap can hamper boat docking and dock installation.

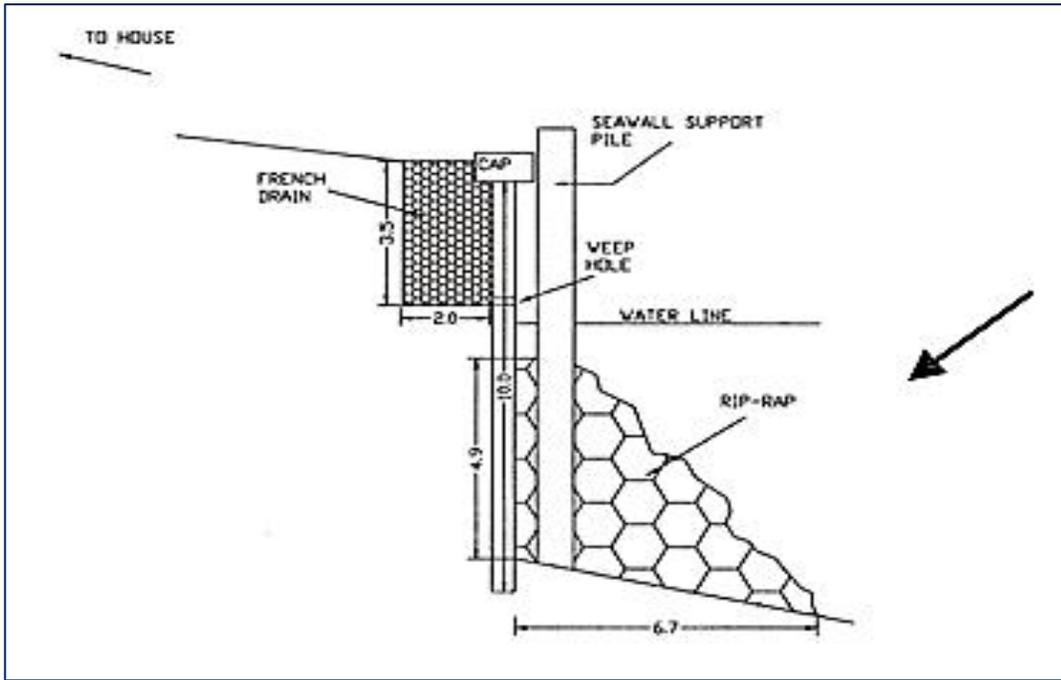
Profile illustration of rip-rap. Note degree of necessary protrusion into canal which may make installing a future dock difficult.

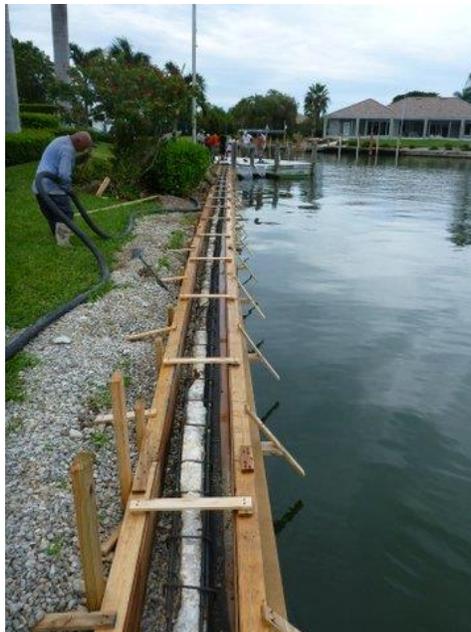
Framing and pouring of new (replacement) cap

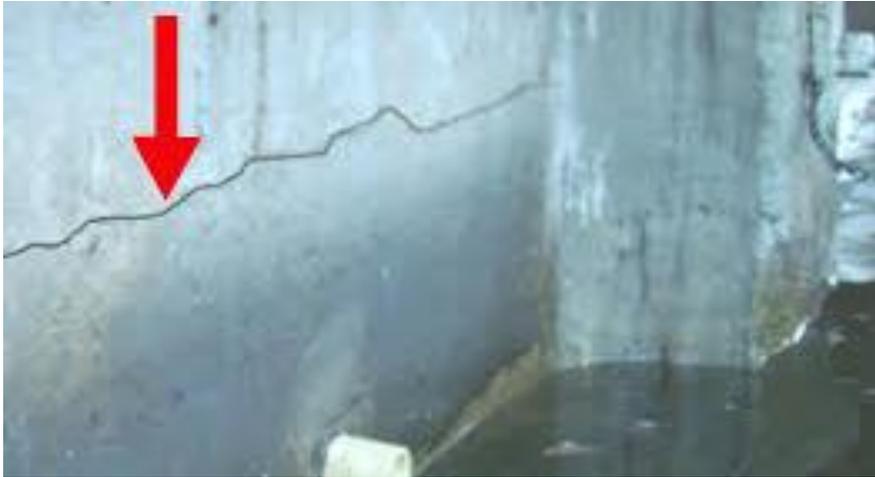
Note horizontal crack at mid-point of concrete panel – the weakest point of the seawall, particularly at low tide. Crack is likely caused by either excess hydrostatic pressure or possibly a tieback failure. Drain (bottom of picture) was likely installed in response.

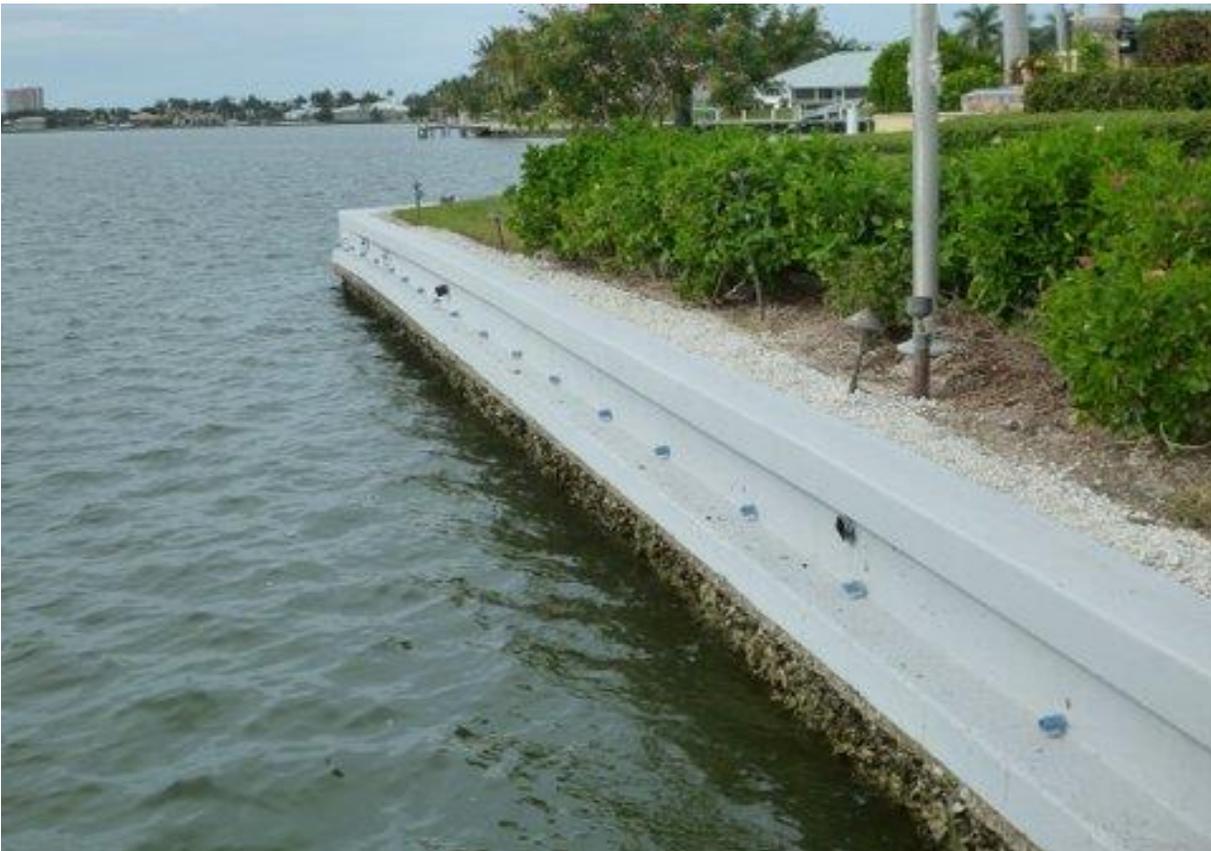
Supplemental drainage system designed to relieve hydrostatic pressure

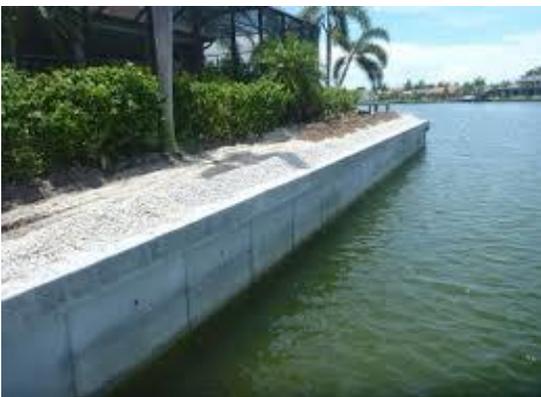
Concrete seawall

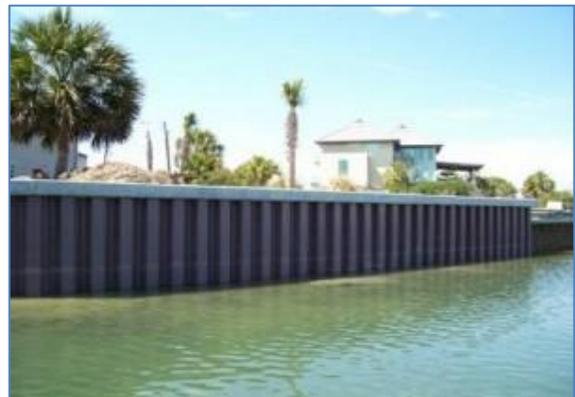
Vinyl Seawall with Concrete Cap
