ELEVATION CERTIFICATE

A2. Building Street Address (including Apt., Unit, Suite, and/or Bldg. No.) or P.O. Route and Box No.
 1795 HUMMINGBIRD COURT

A3. Property Description (Lot and Block Numbers, Tax Parcel Number, Legal Description, etc.)
 LOT 20, BLOCK 79, MARCO BEACH UNIT THREE

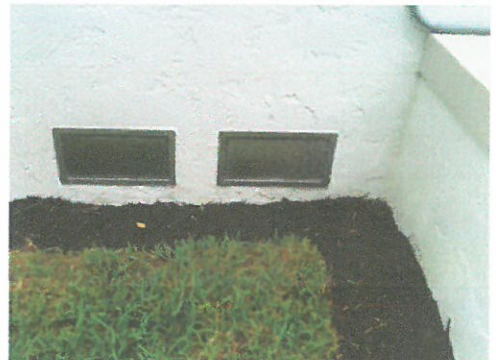
VENT

- a) Square footage of attached garage 927 sq ft
- b) Number of permanent flood openings in the attached garage within 1.0 foot above adjacent grade 5
- c) Total net area of flood openings in A9.b 1000 sq in
- d) Engineered flood openings? Yes No
