Marco Island Hydrologic/Nutrient Budgets and Water Quality Management Plan

Results and Recommendations

City Council Meeting
September 20, 2021

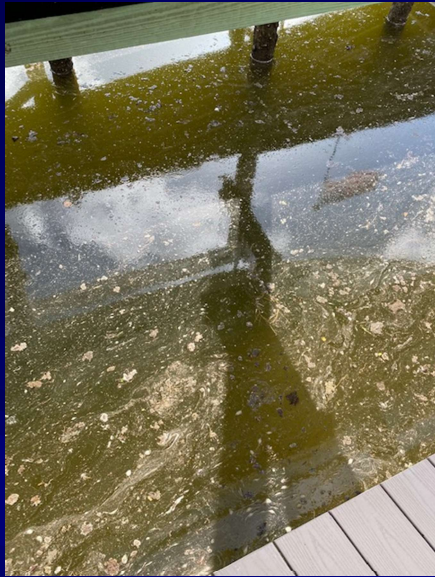
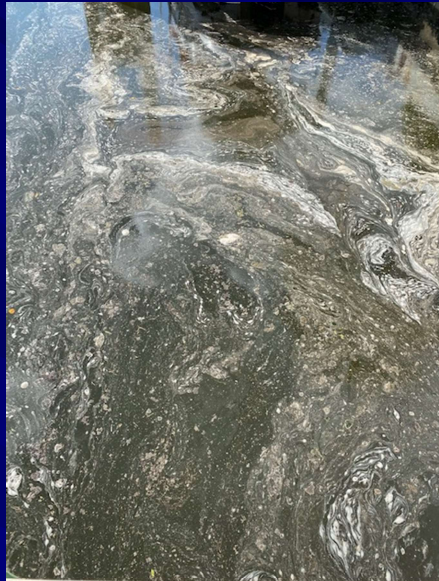
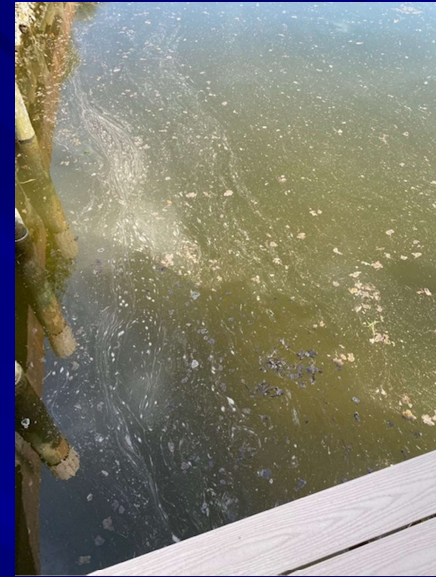
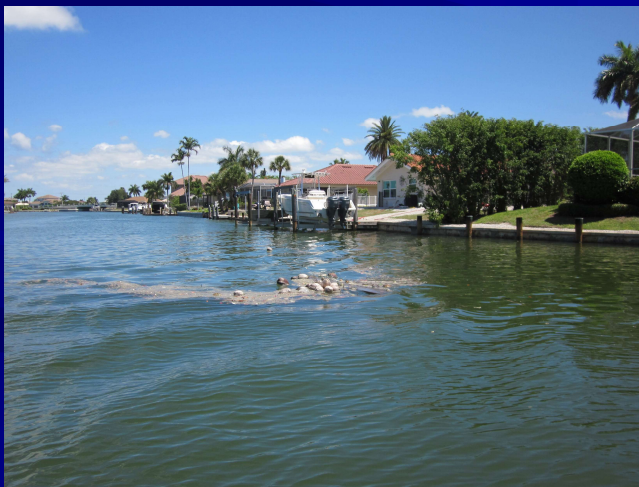
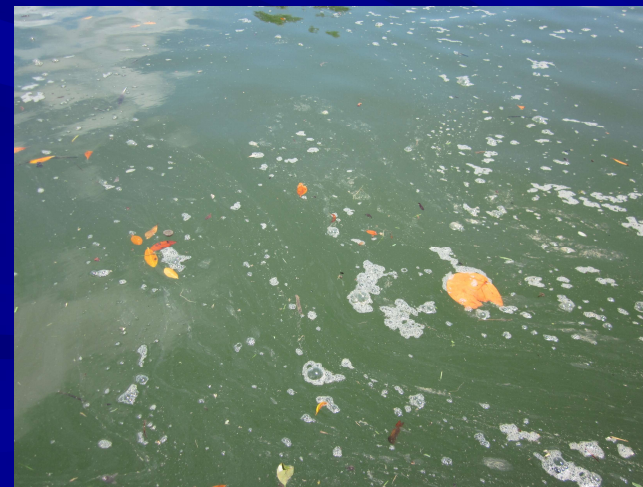
Observed Water Quality Issues

a. Photographs provided by residents

b. Photographs taken by ERD

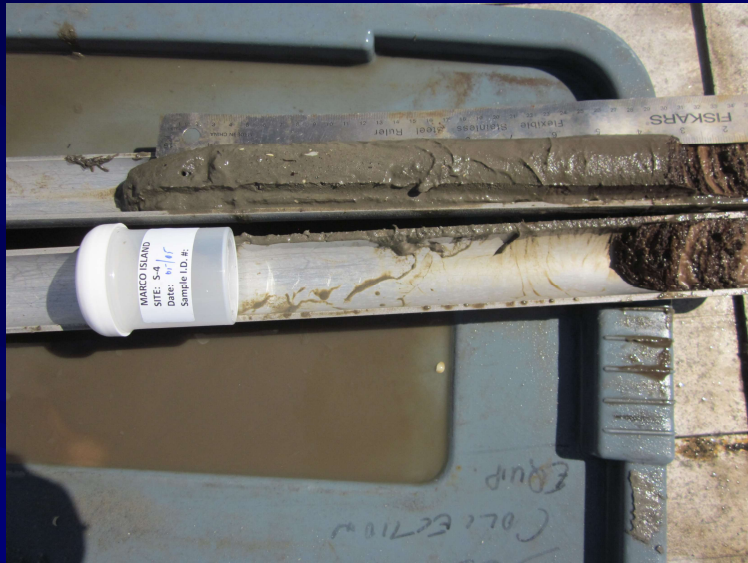
Site 4 – Waterway by Factory Bay

Sediment Core Sample Photos

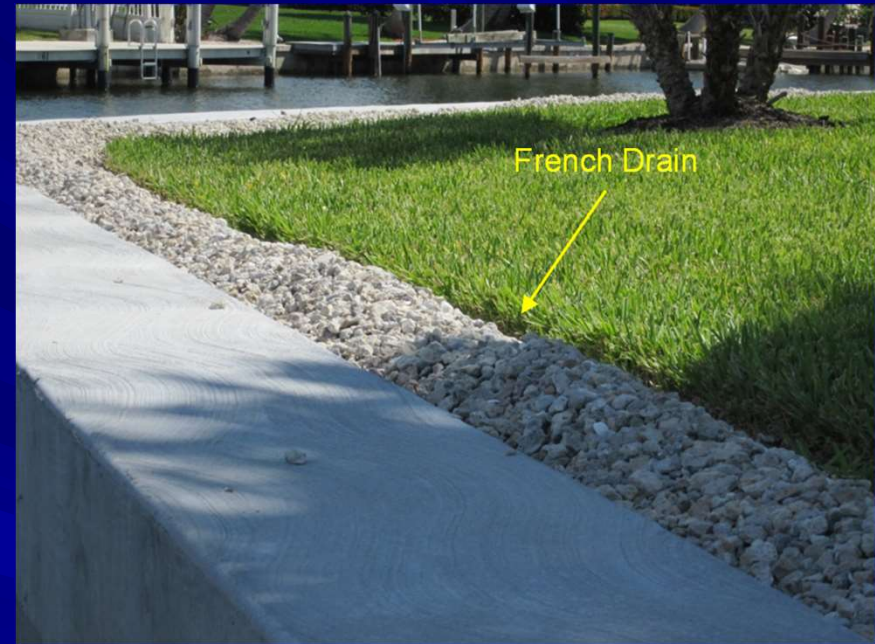
Typical Rear Yard French Drain

- Designed to reduce hydrostatic pressure behind the wall
- Essentially diverts all rear yard runoff into groundwater

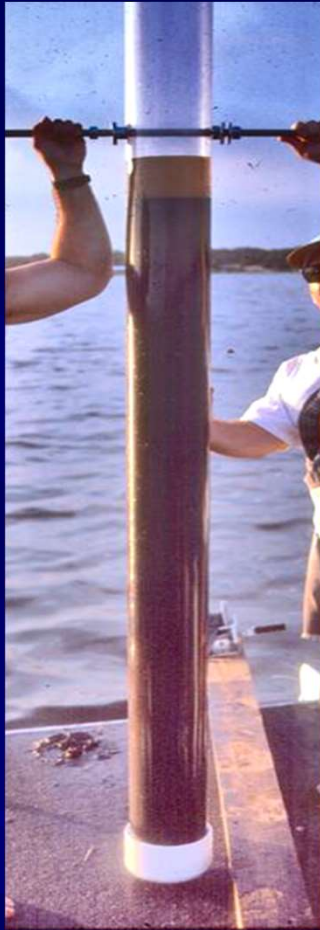
Schematic of Sediment Incubation Apparatus

- ERD has conducted measurements of sediment benthic release rates in more than 50 Florida waterbodies

- Large diameter core samples collected at 9 sites
- Core samples incubated under aerobic and anoxic conditions
- Samples collected every 2 days and analyzed for phosphorus and nitrogen

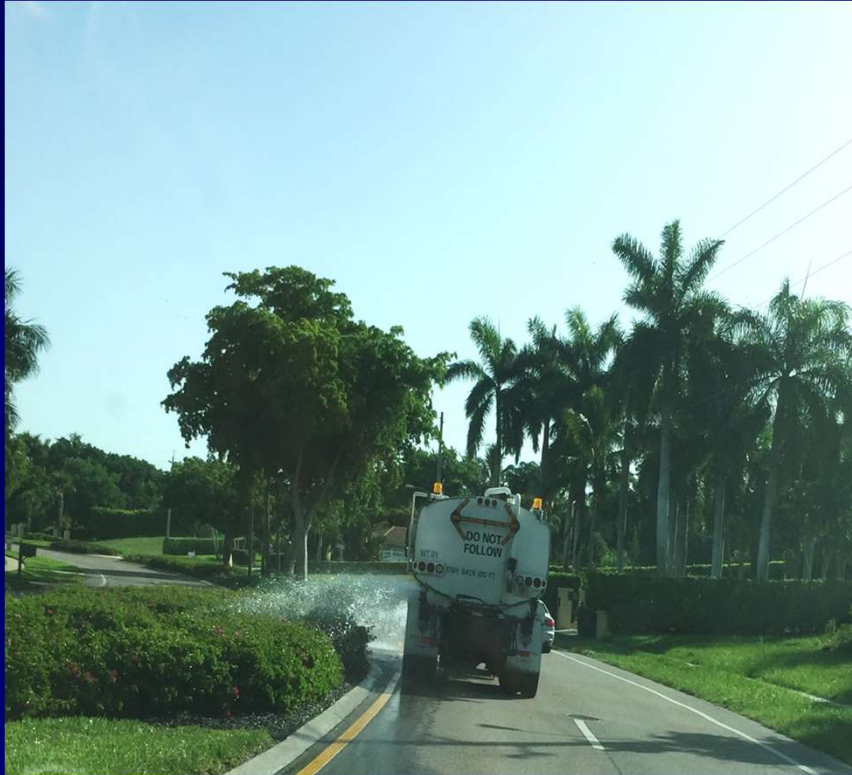
Median irrigation with reuse water

- Overspray of 7.5% generates a N load equivalent to the annual runoff loading
- Recommend routine inspection and repair of system to keep spray off impervious surfaces

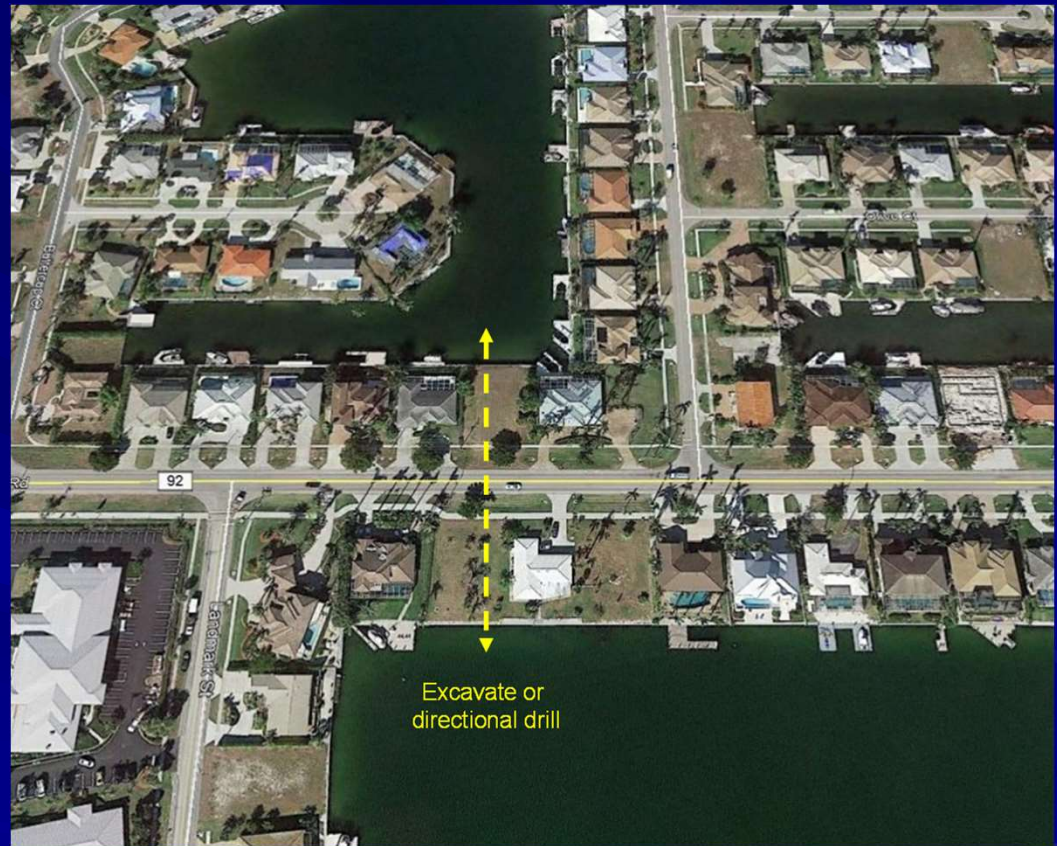
Proposed Site 1 Location

Pipe Size (inches)	Installation Cost (\$/inch diameter/ft)	Pipe Length (ft)	Estimated Cost (\$)
24	45	350	378,000
36	45	350	567,000
48	45	350	756,000
54	45	350	850,500
60	45	350	945,000

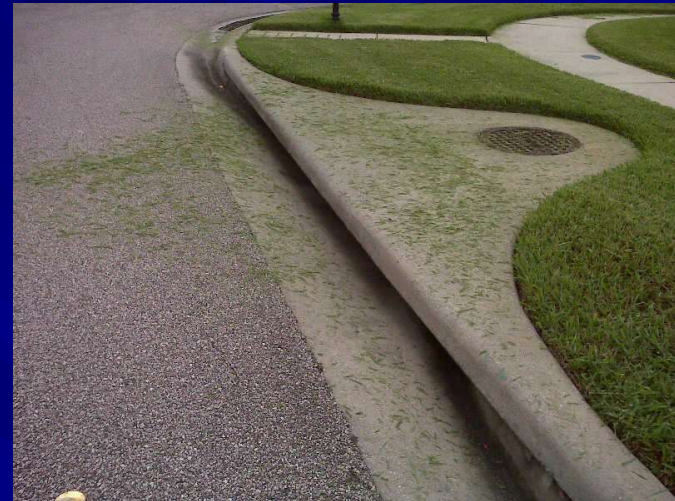
- Improper landscape maintenance activities have a potential for significant impacts to adjacent waterbodies:
 - Blowing grass clippings, leaves and other vegetation onto roadways
 - Improper application of fertilizers/pesticides
- Instances of improper landscaping activities were observed by ERD during this project
- Discharge of grass clippings and other landscaping wastes onto roadway surfaces or into stormsewers is a senseless and irresponsible practice

After entering water, leaves exhibit a rapid nutrient release

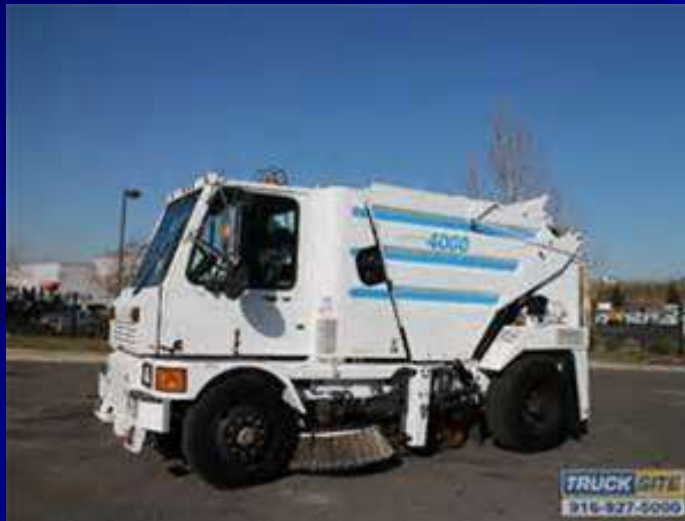
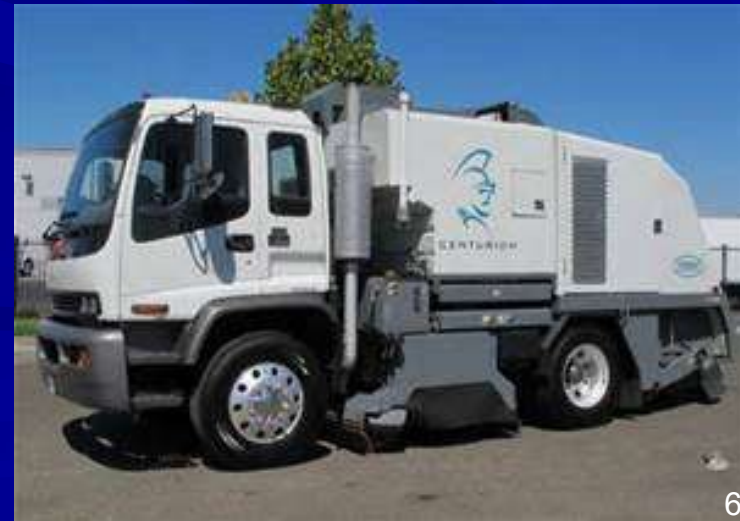
a. Street Sweeping

- Most applicable for paved streets having curbs and gutters, but can be used on any impervious surface
- Particularly applicable to urban built-out areas where space for conventional stormwater treatment is unavailable or too expensive
- Best types of street sweepers:
 - Vacuum (plus mechanical)
 - Provides air vacuum over entire path with mechanical broom assist
 - Some particles do not receive sufficient agitation to become air-entrained
 - Regenerative Air
 - Air is forced down onto the pavement, suspending particles, which are then picked up by the vacuum
